## PROPOSED DEVELOPMENT

Proposed Development consist of 2 Residential buildings - one five storey and the other four storey.

PROJECT INFO:  
 APARTMENT BUILDING AT 5535  
 SHORNCLIFFE AVE  
 SECHELT BC  
 CLIENT:  
 GENARIS

As requested, Braun Geotechnical Ltd. (BGL) has carried out a geotechnical exploration for the above-referenced project. The geotechnical work has been performed in general accordance with the terms and conditions of the BGL Fee Estimate dated June 21, 2021 (our Ref. no. 21-9115). The scope of work included subsurface exploration and provision of geotechnical recommendations for the proposed development. No consideration has been given to any environmental aspects.

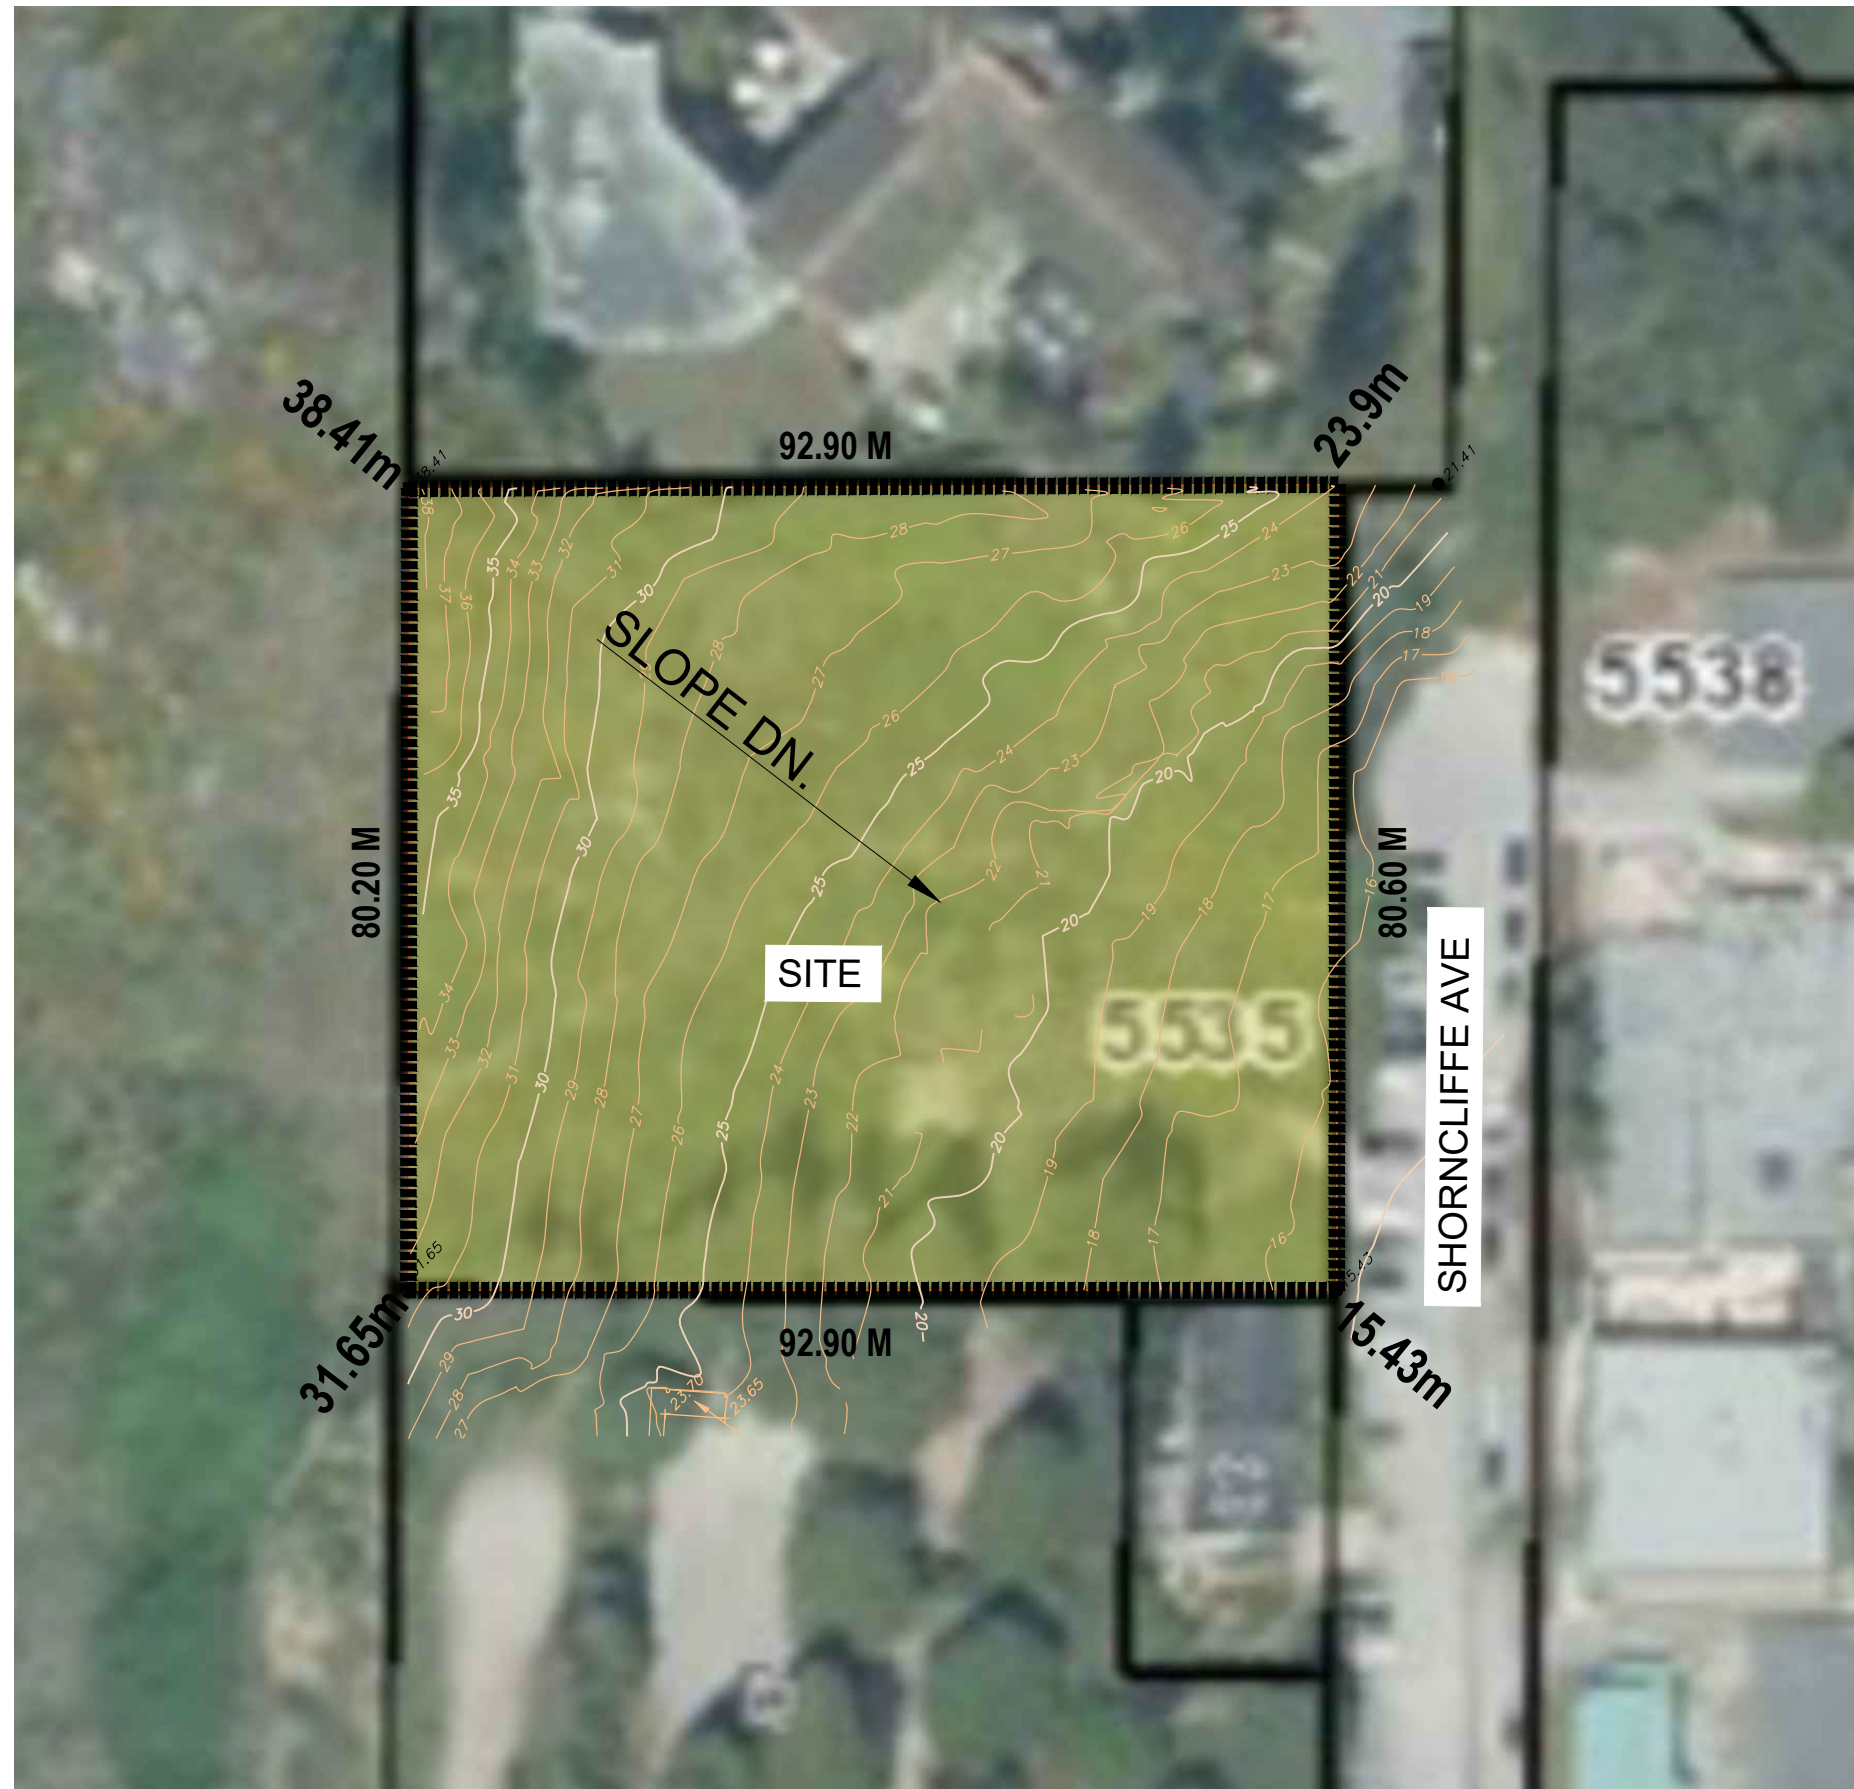
CONTOUR MAP

The proposed site is an existing residential lot located at Shorncliffe Ave, adjacent to the Rockwood centre grounds. The Site is part of the primary growth areas within the Urban containment boundary. It is squarish, with an approximate dimension of 92.90m x 80.60m. The area of the site is 7365 sq.m (79279 sf). It has a distinct slope similar to many sites in its immediate vicinity. The site slopes down diagonally from north-west to south-west. However the slope of the site is quite steep, with the fall from north-west corner to south-west being approximately 23.0m, making it fairly challenging to develop the site .

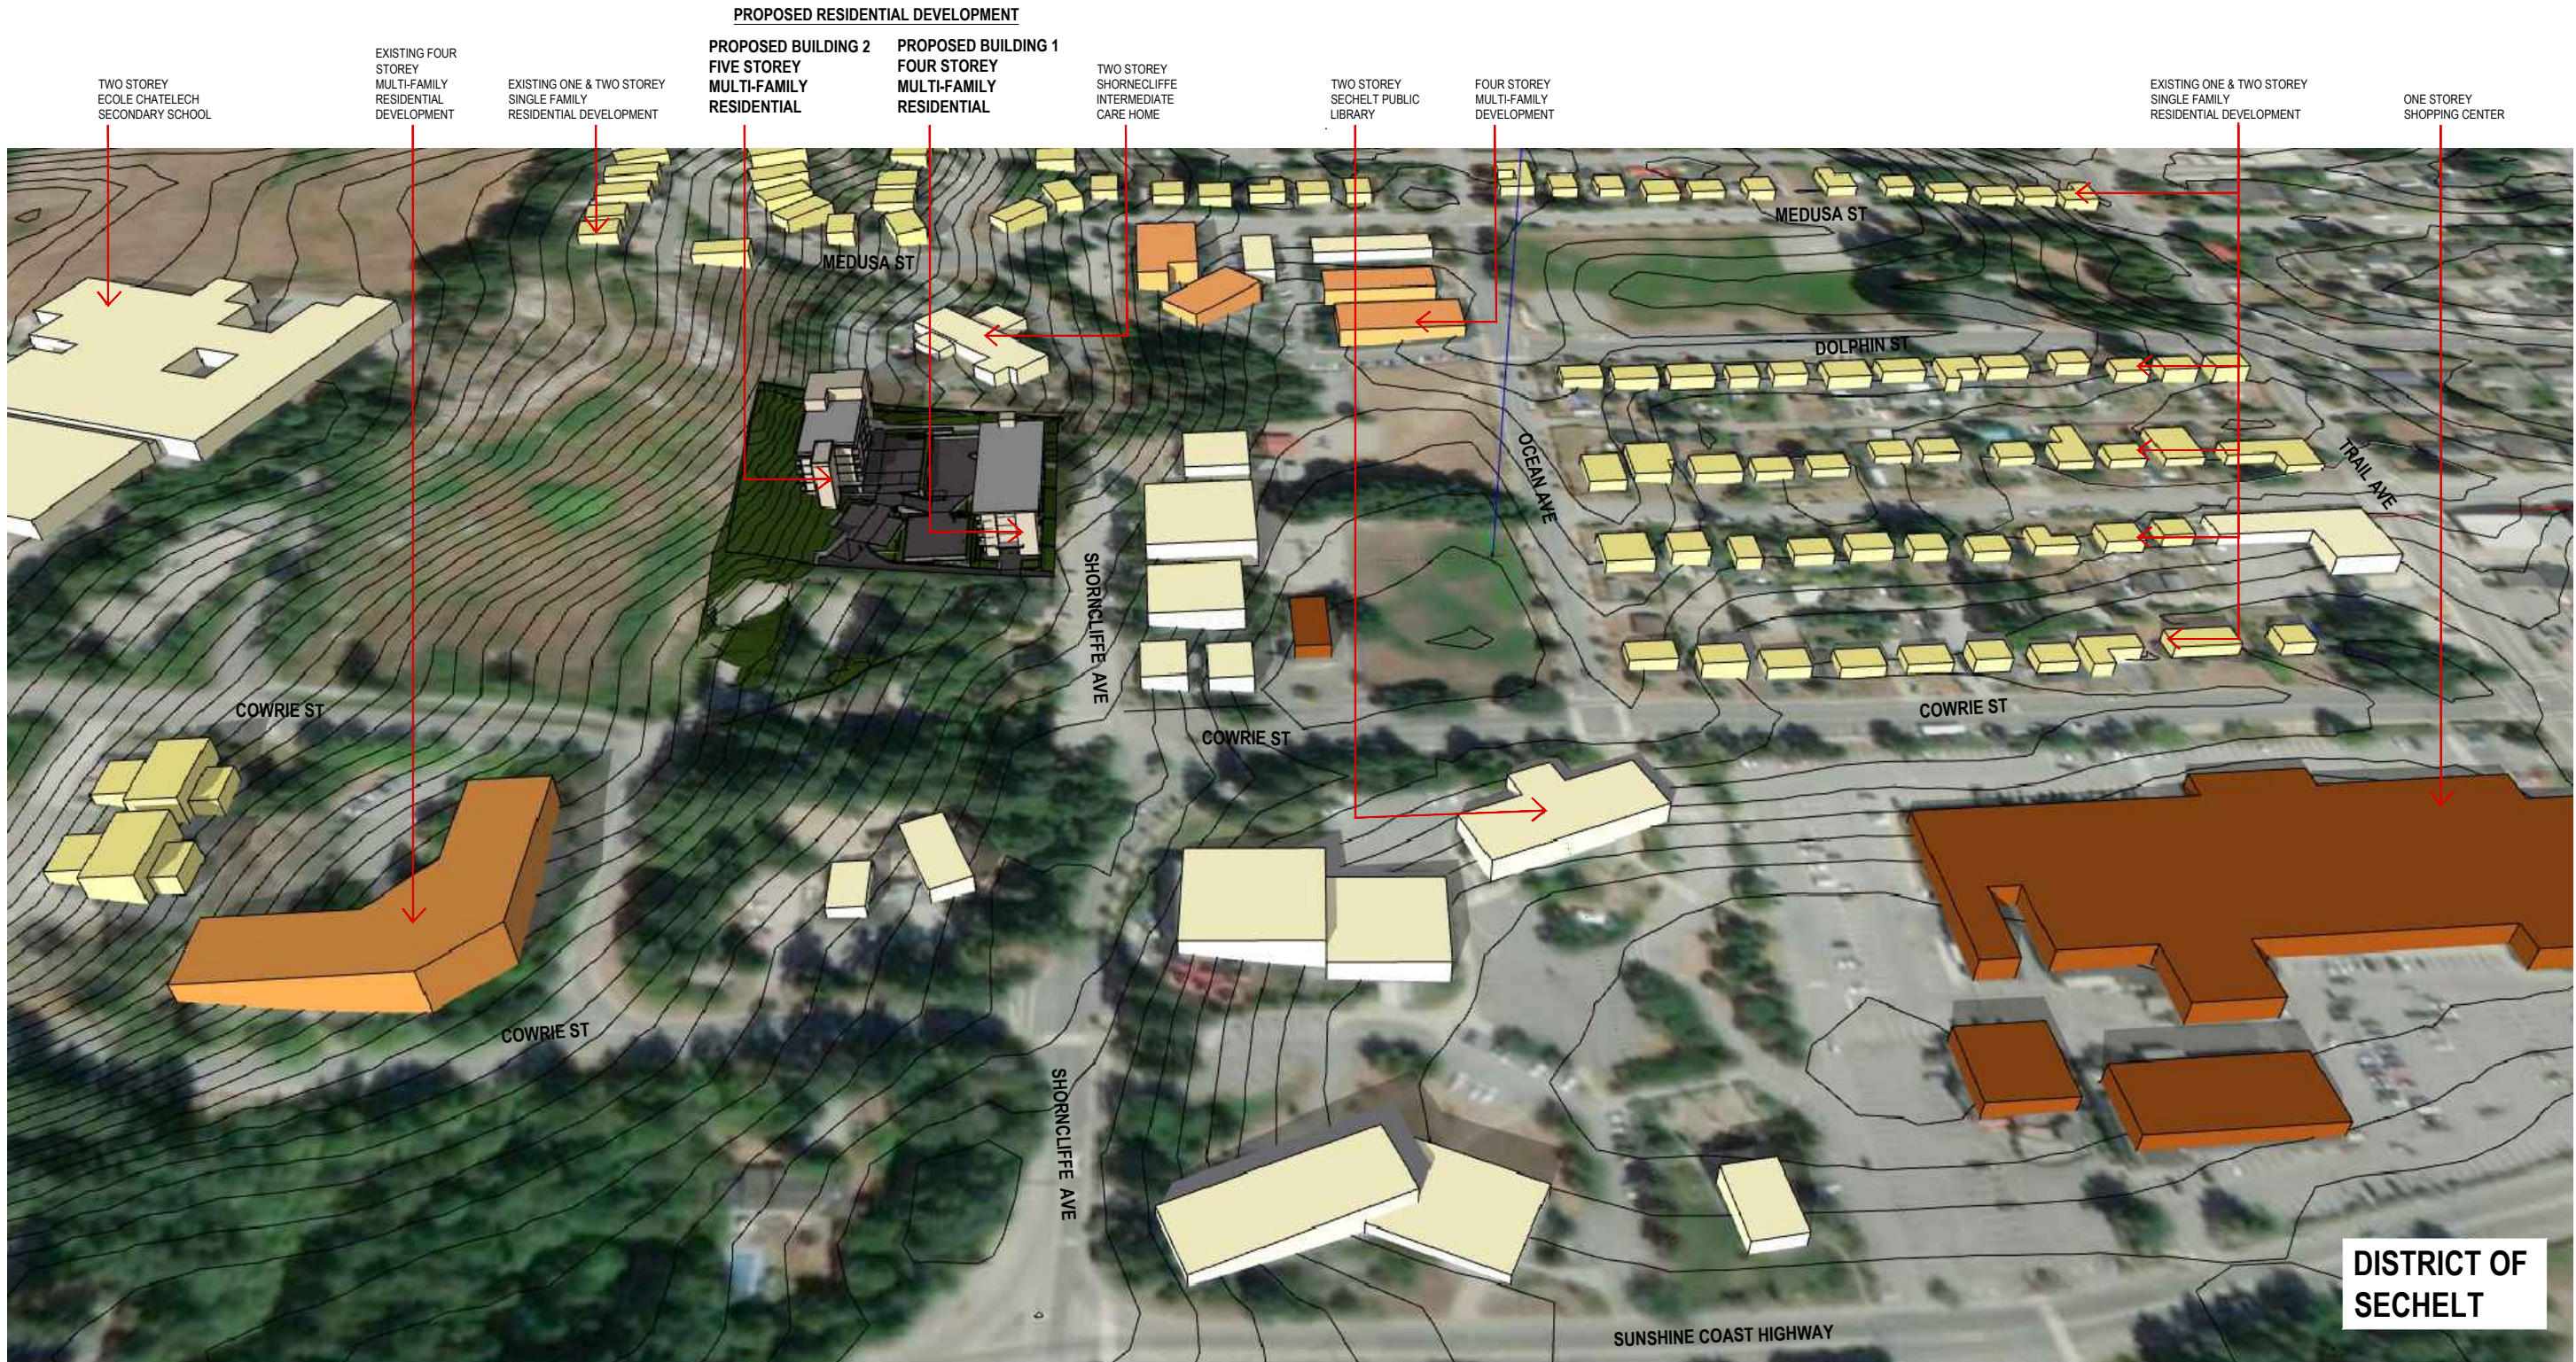
1 PROPOSED DENSITY ANALYSIS

DENSITY ANALYSIS

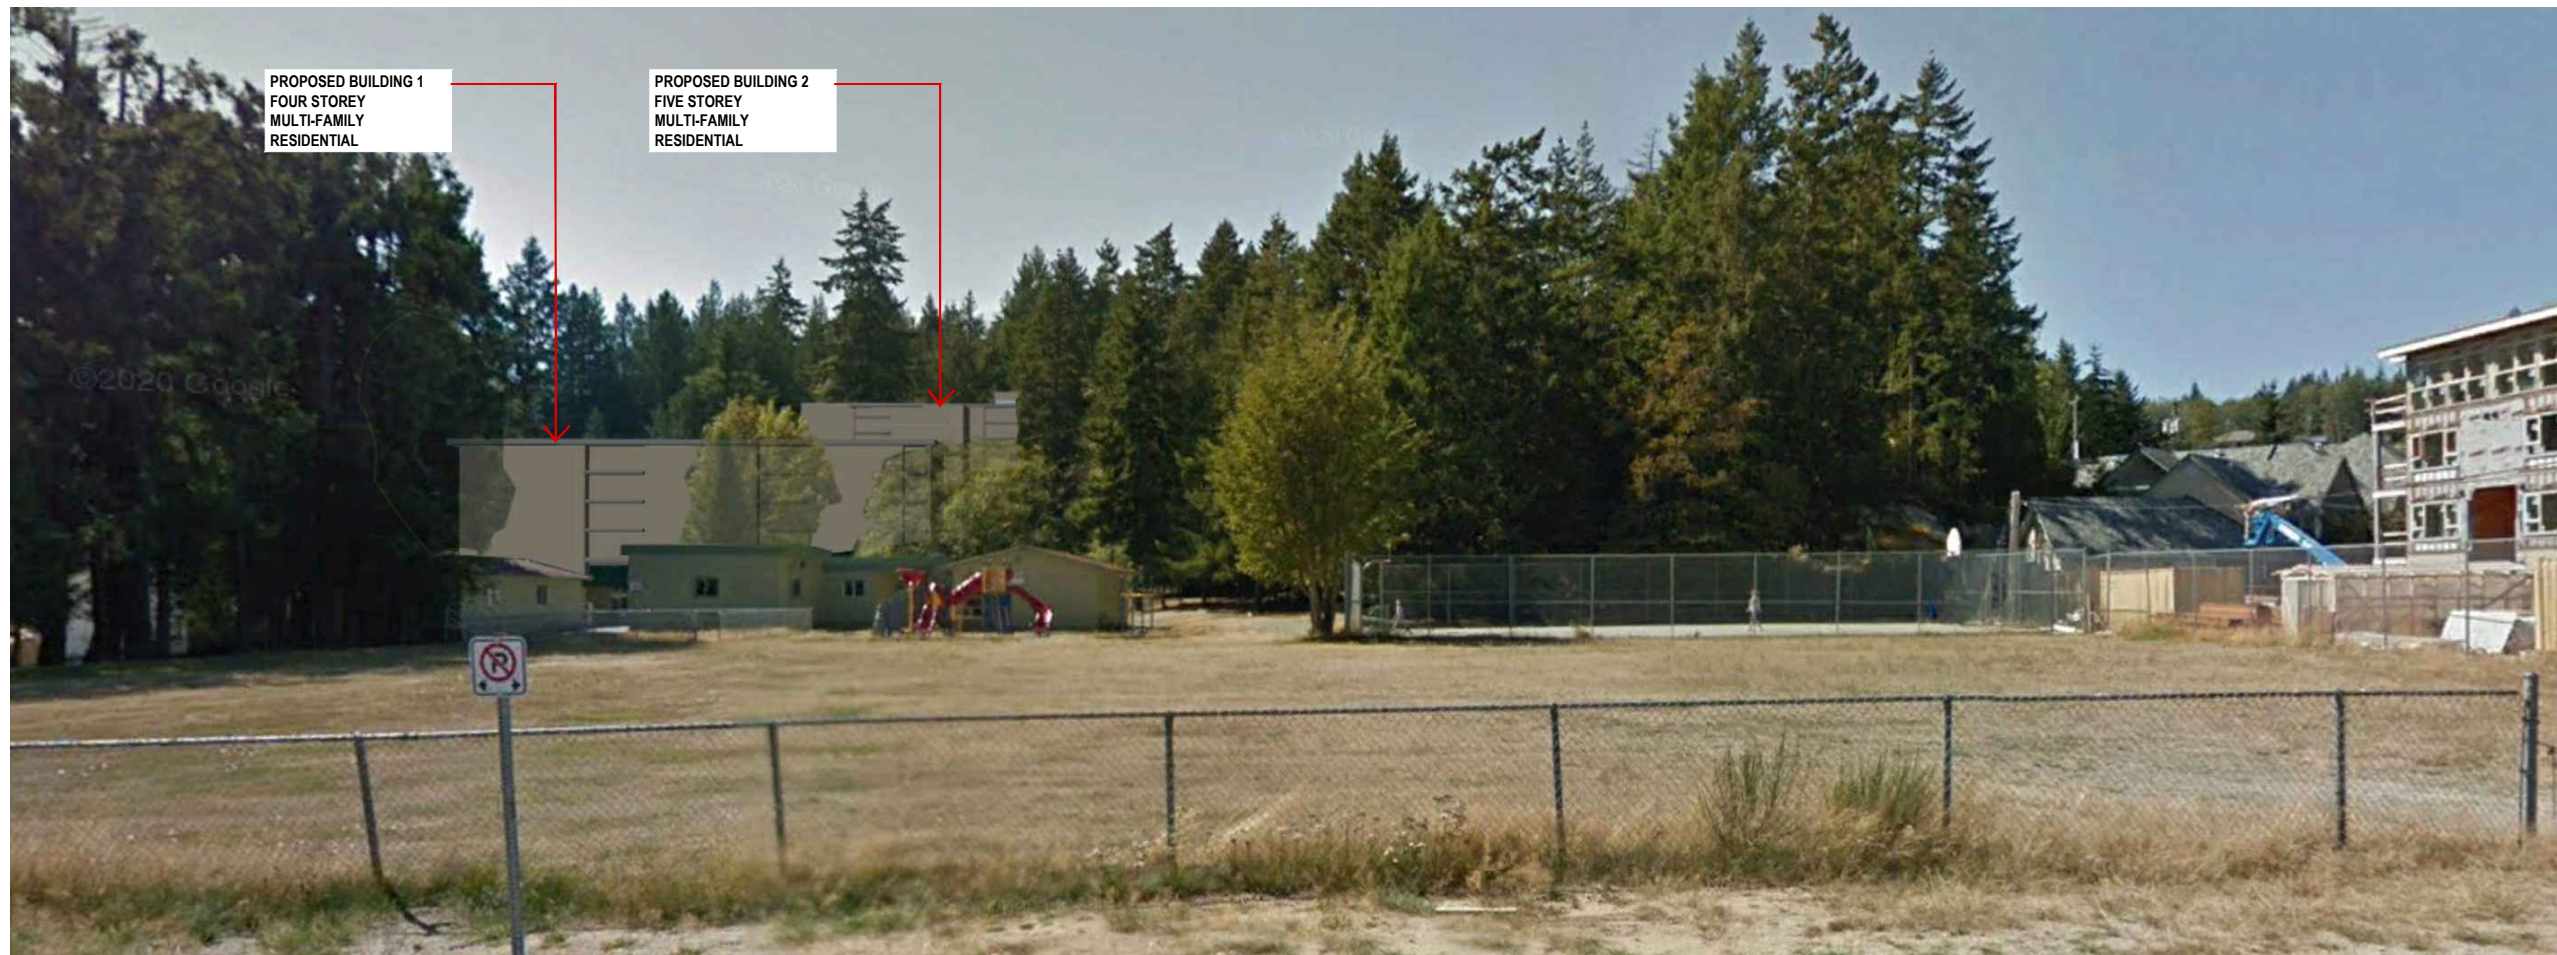
1 EAST VIEW FROM OCEAN AVE  
SCALE: N.T.S.

PROPOSED BUILDING 1  
FOUR STOREY  
MULTI-FAMILY  
RESIDENTIAL

PROPOSED BUILDING 2  
FIVE STOREY  
MULTI-FAMILY  
RESIDENTIAL

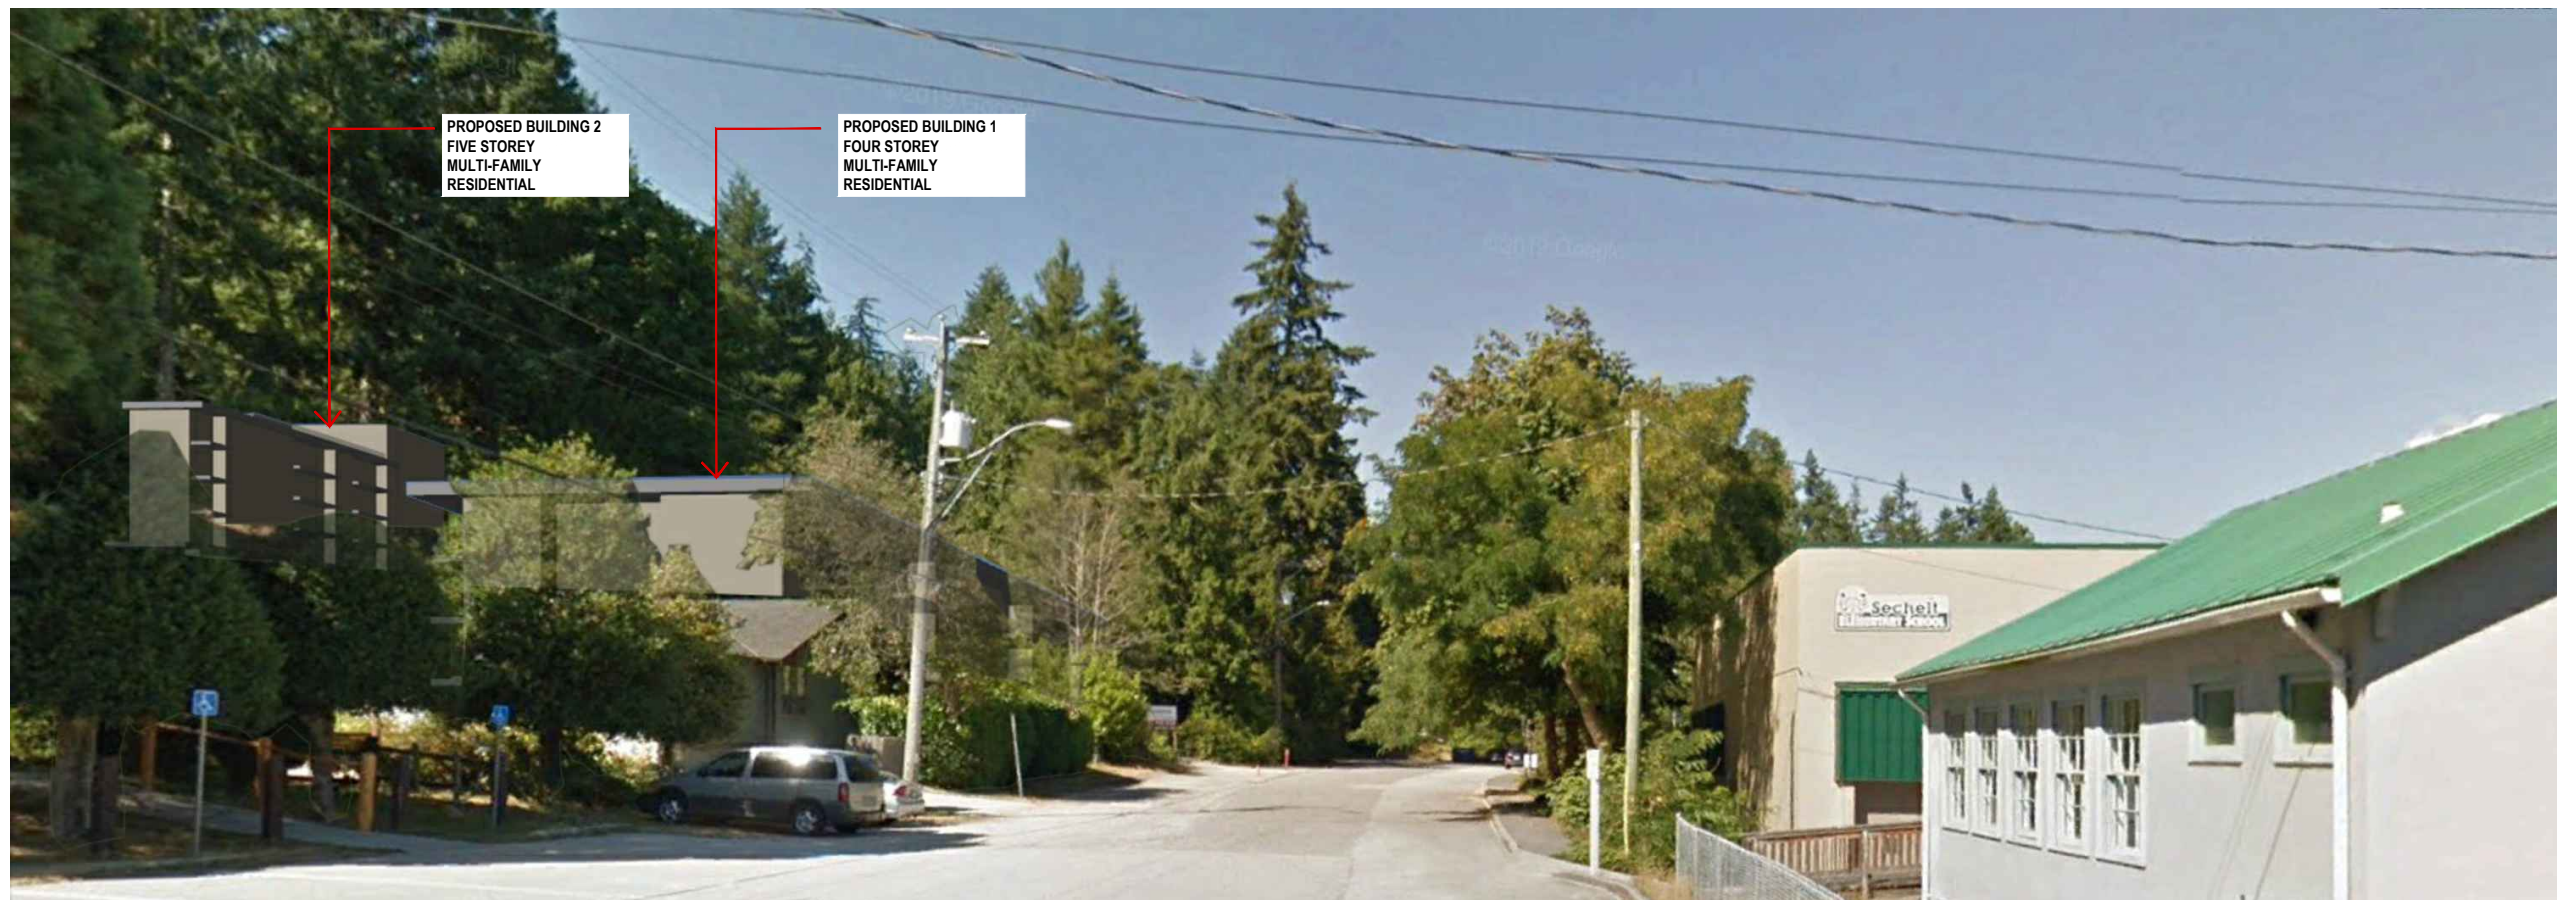
2 SOUTH-EAST VIEW ALONG SHORNCLIFFE AVE  
SCALE: N.T.S.

PROPOSED BUILDING 2  
FIVE STOREY  
MULTI-FAMILY  
RESIDENTIAL

PROPOSED BUILDING 1  
FOUR STOREY  
MULTI-FAMILY  
RESIDENTIAL

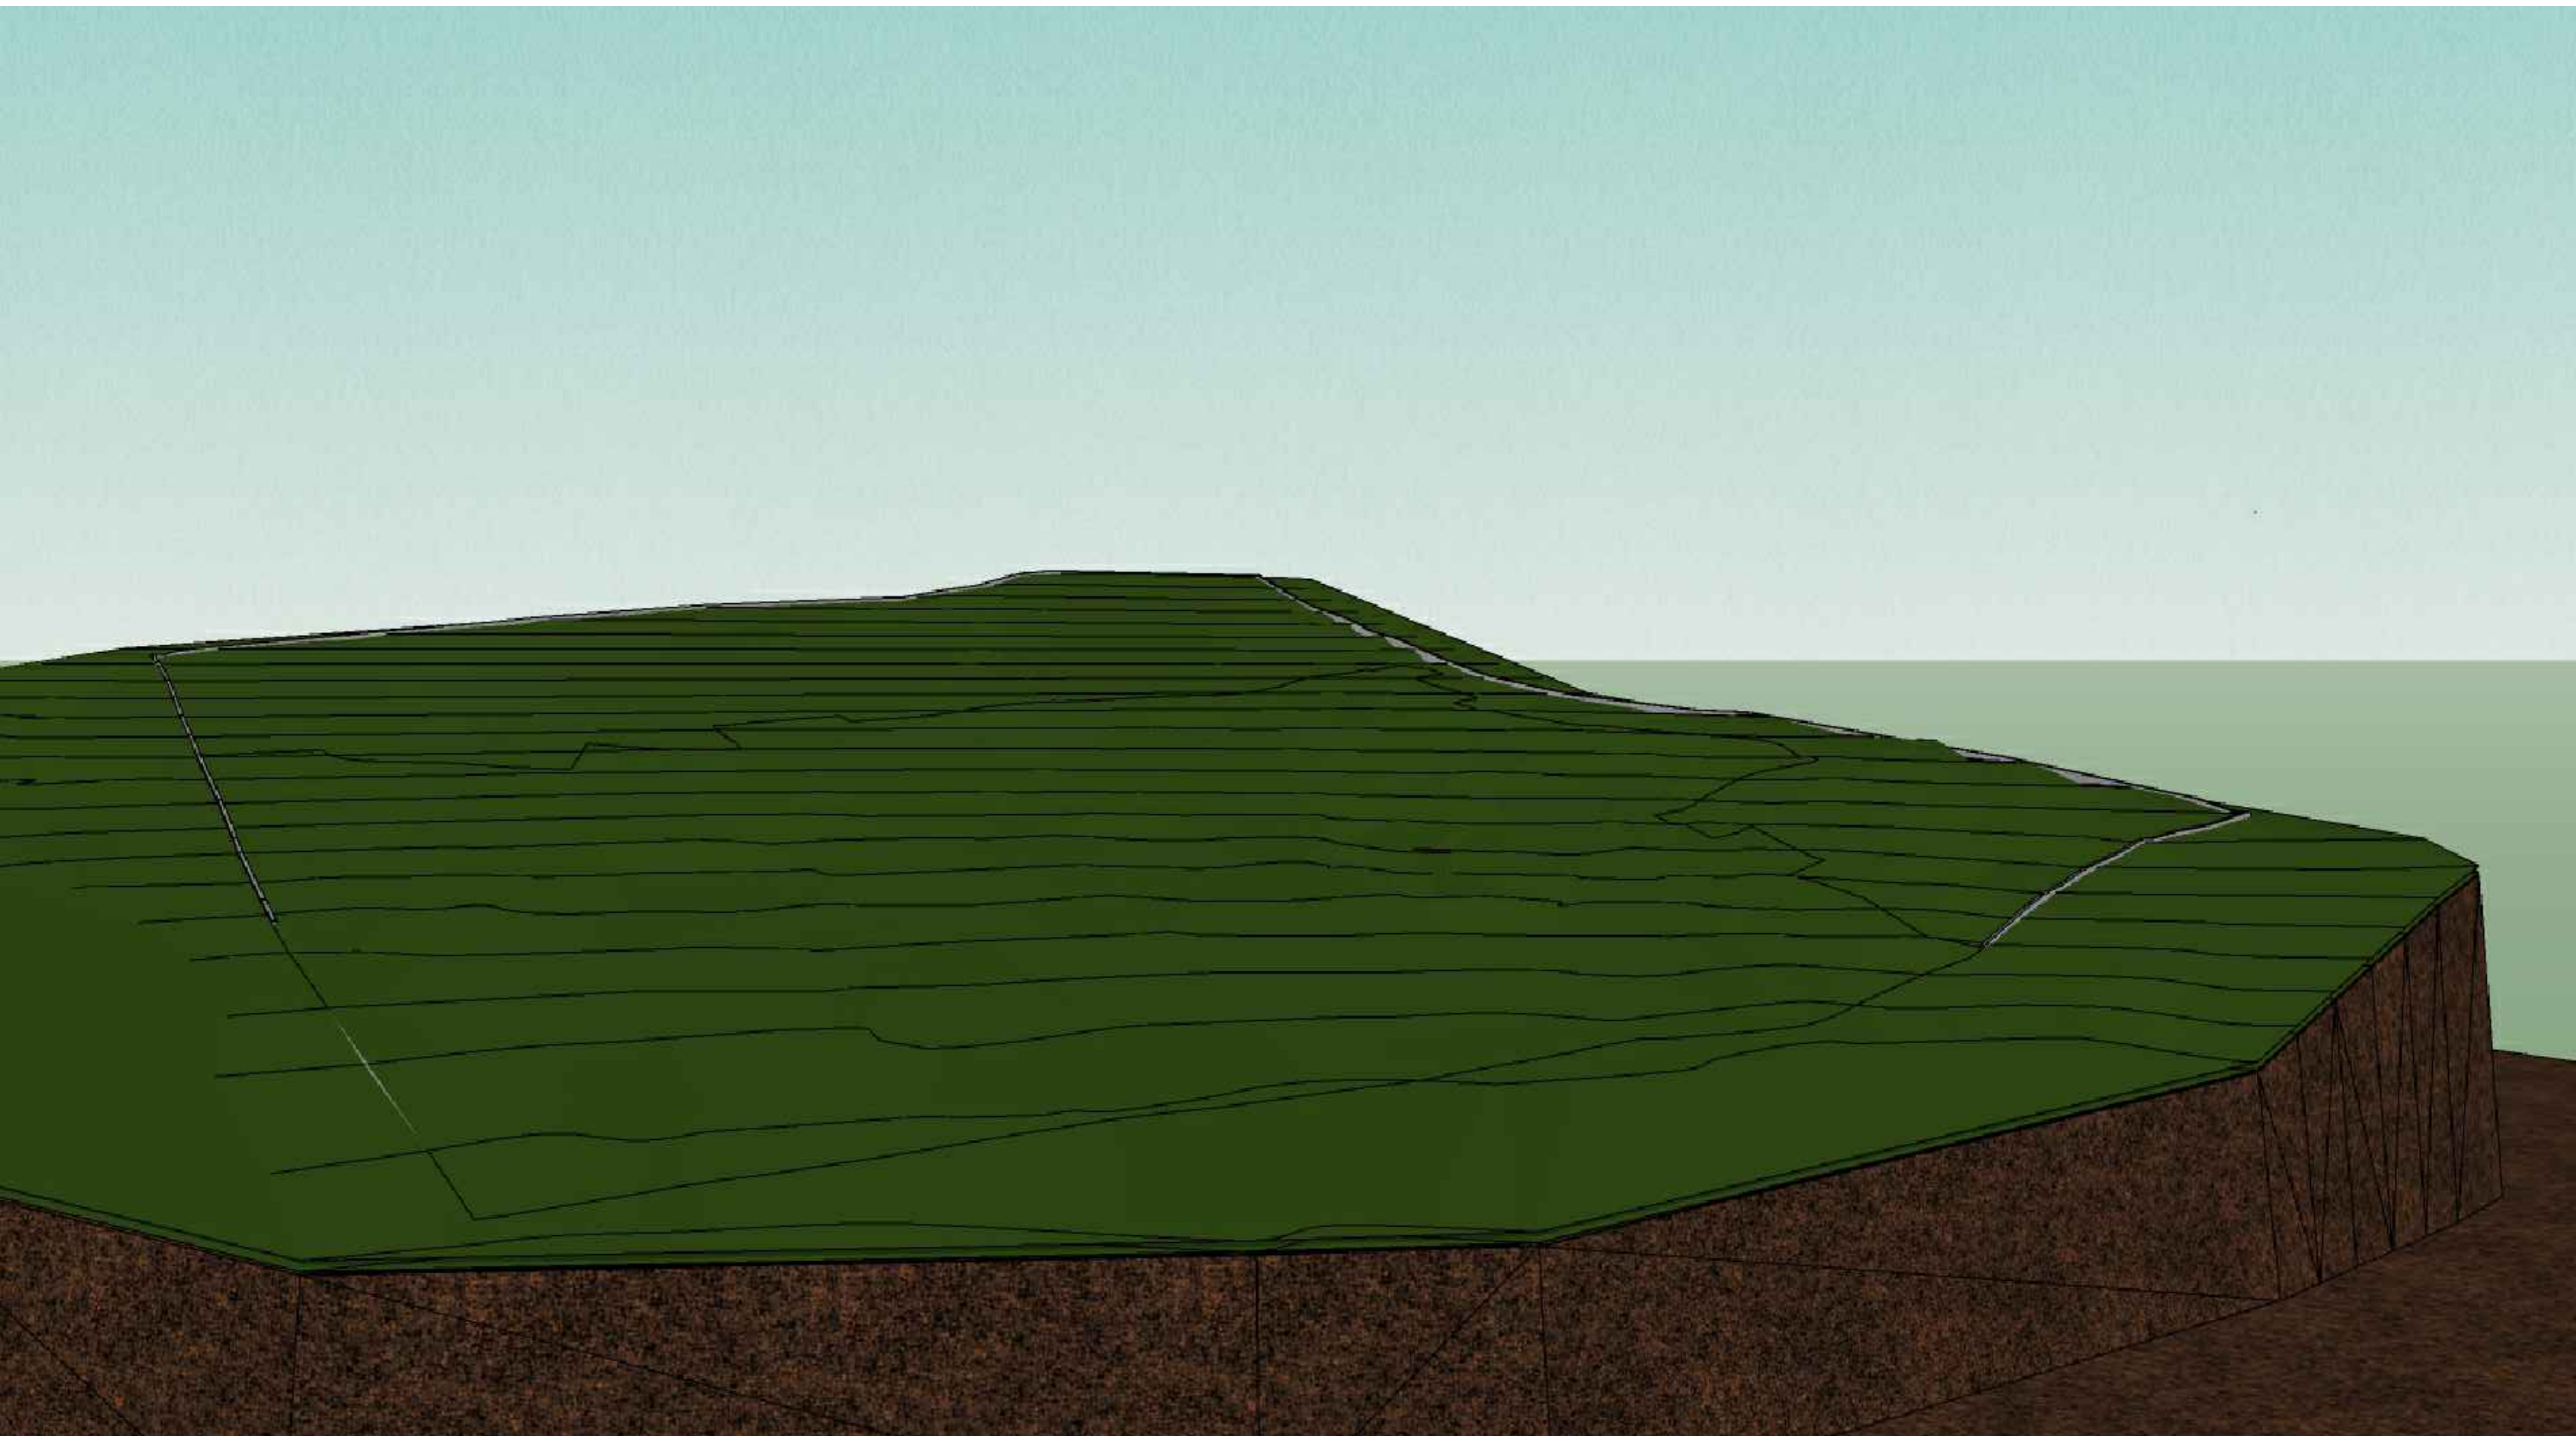
① VIEW FROM SOUTH-EAST

SITE BOUNDARY WITH  
BASIC CONTOURS

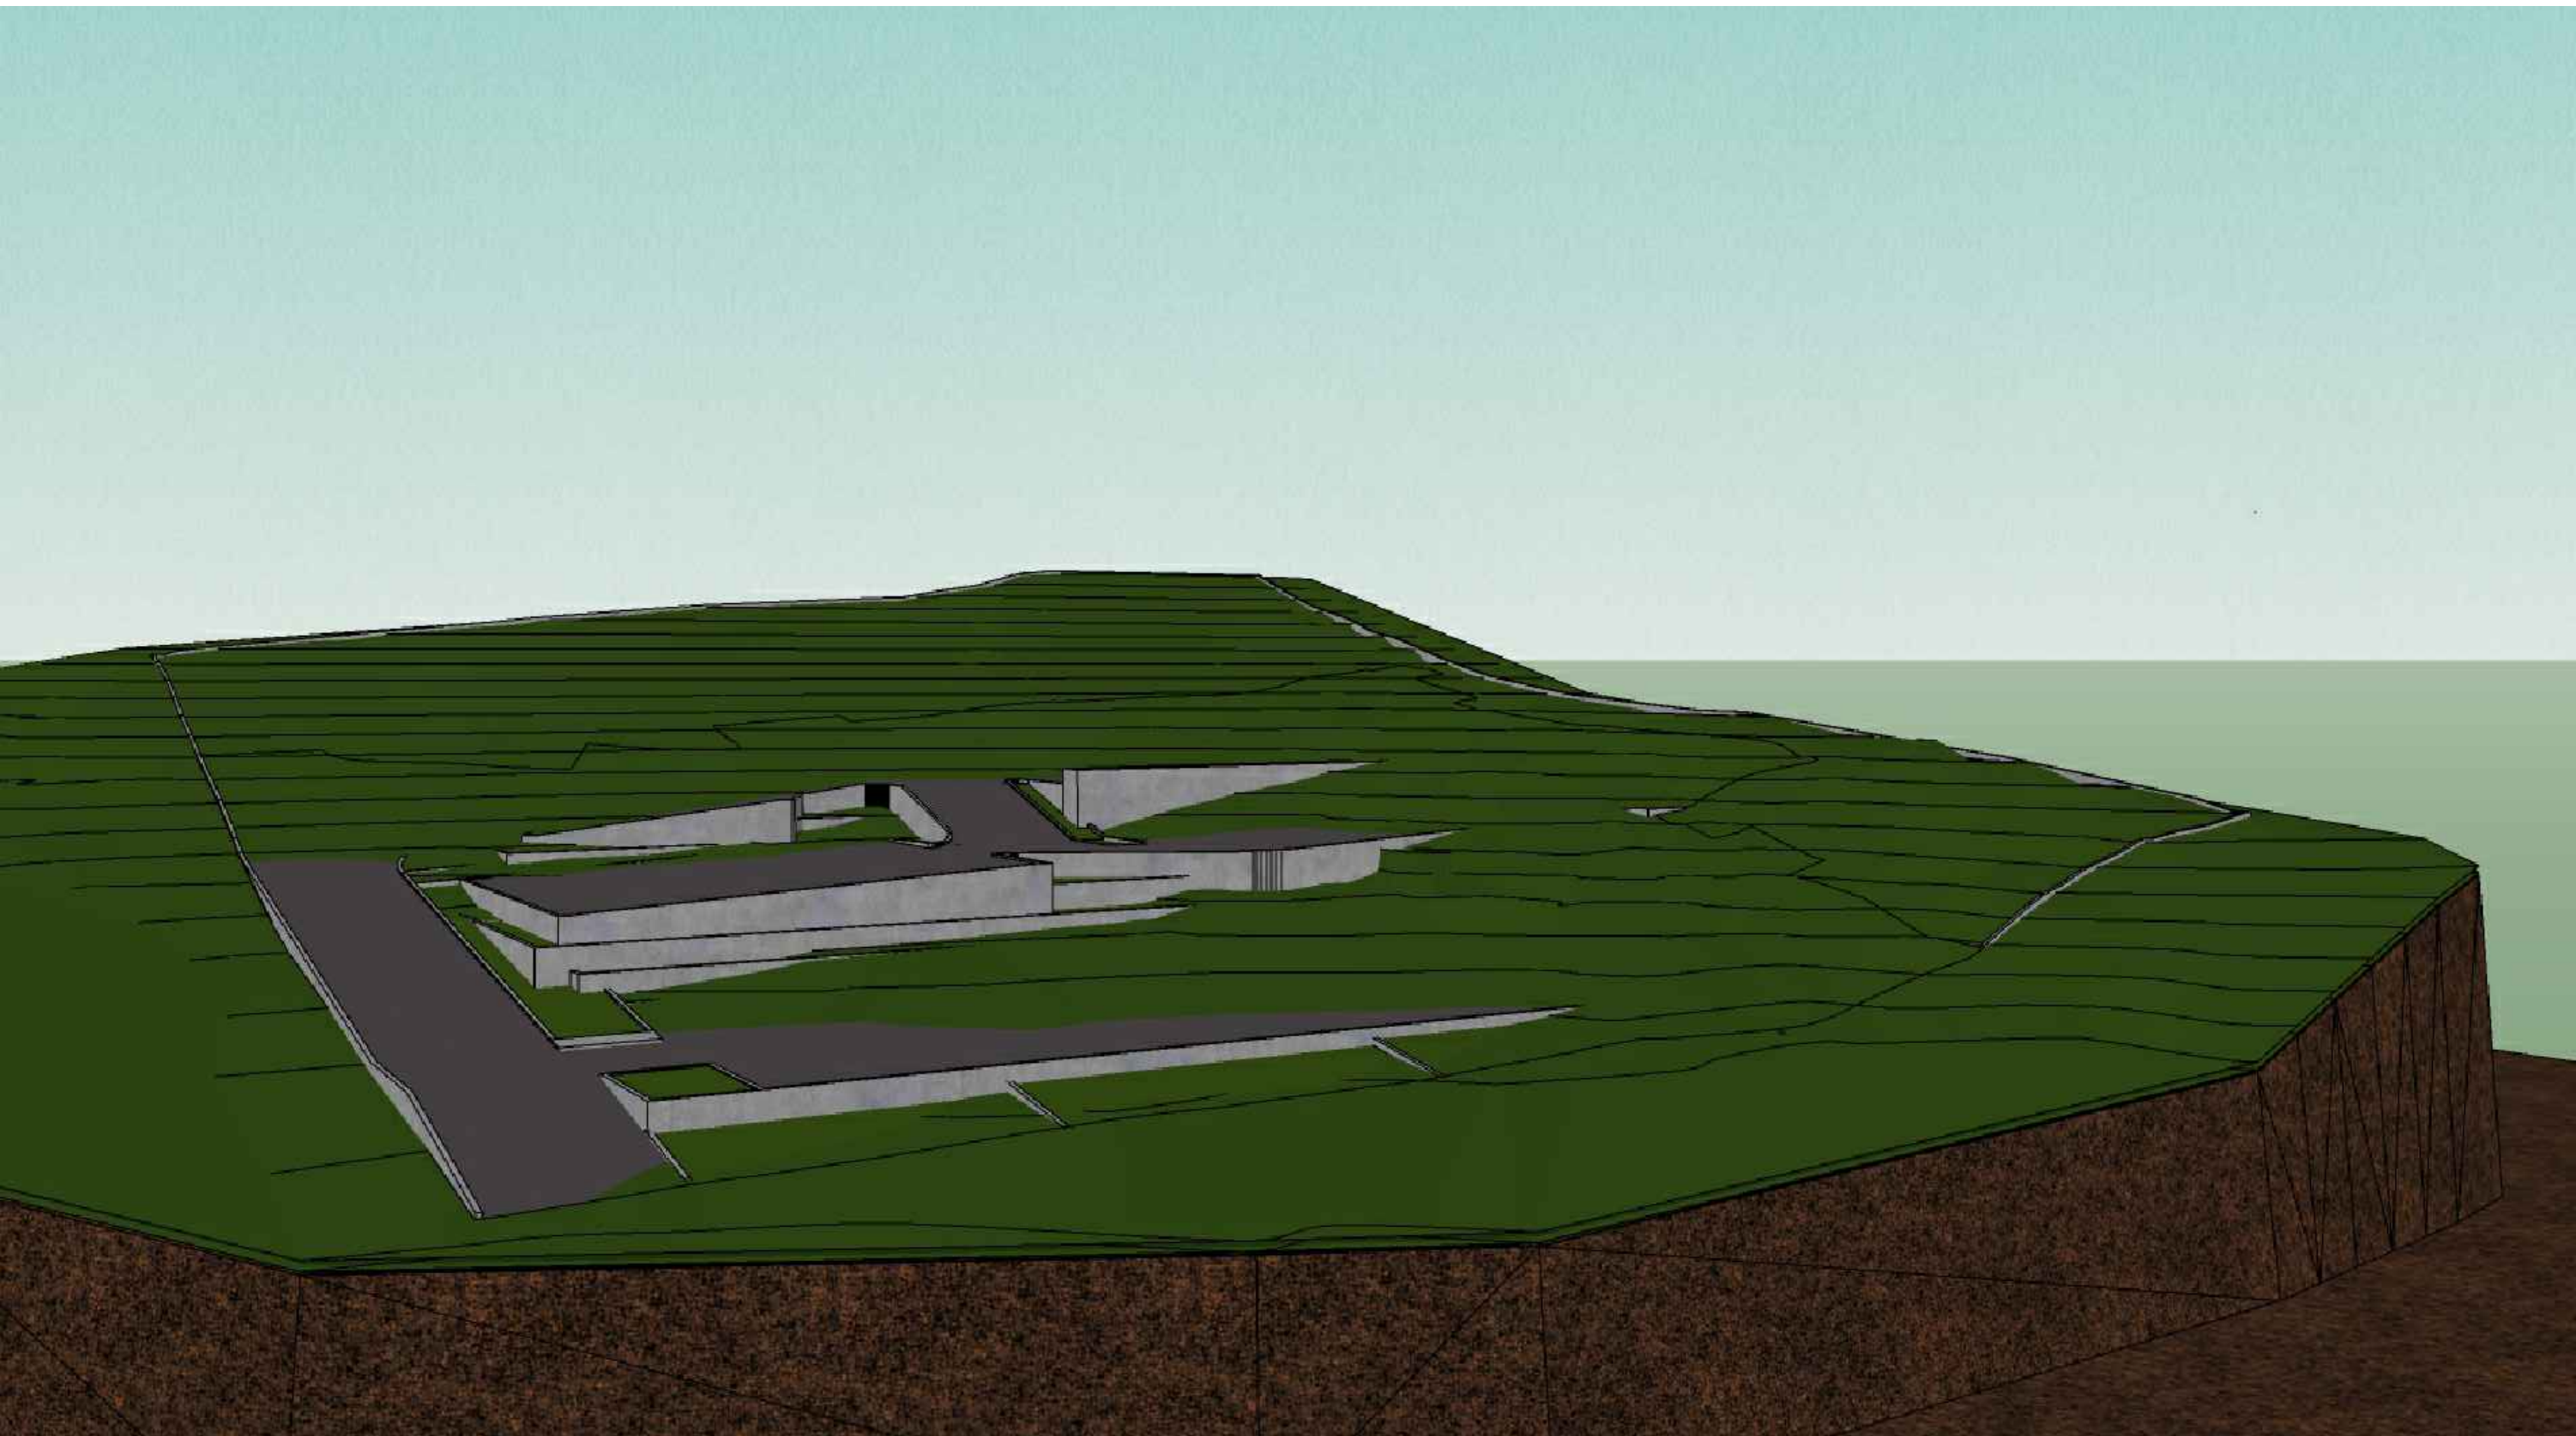
2 VIEW FROM SOUTH-EAST

SITE WITH FILL

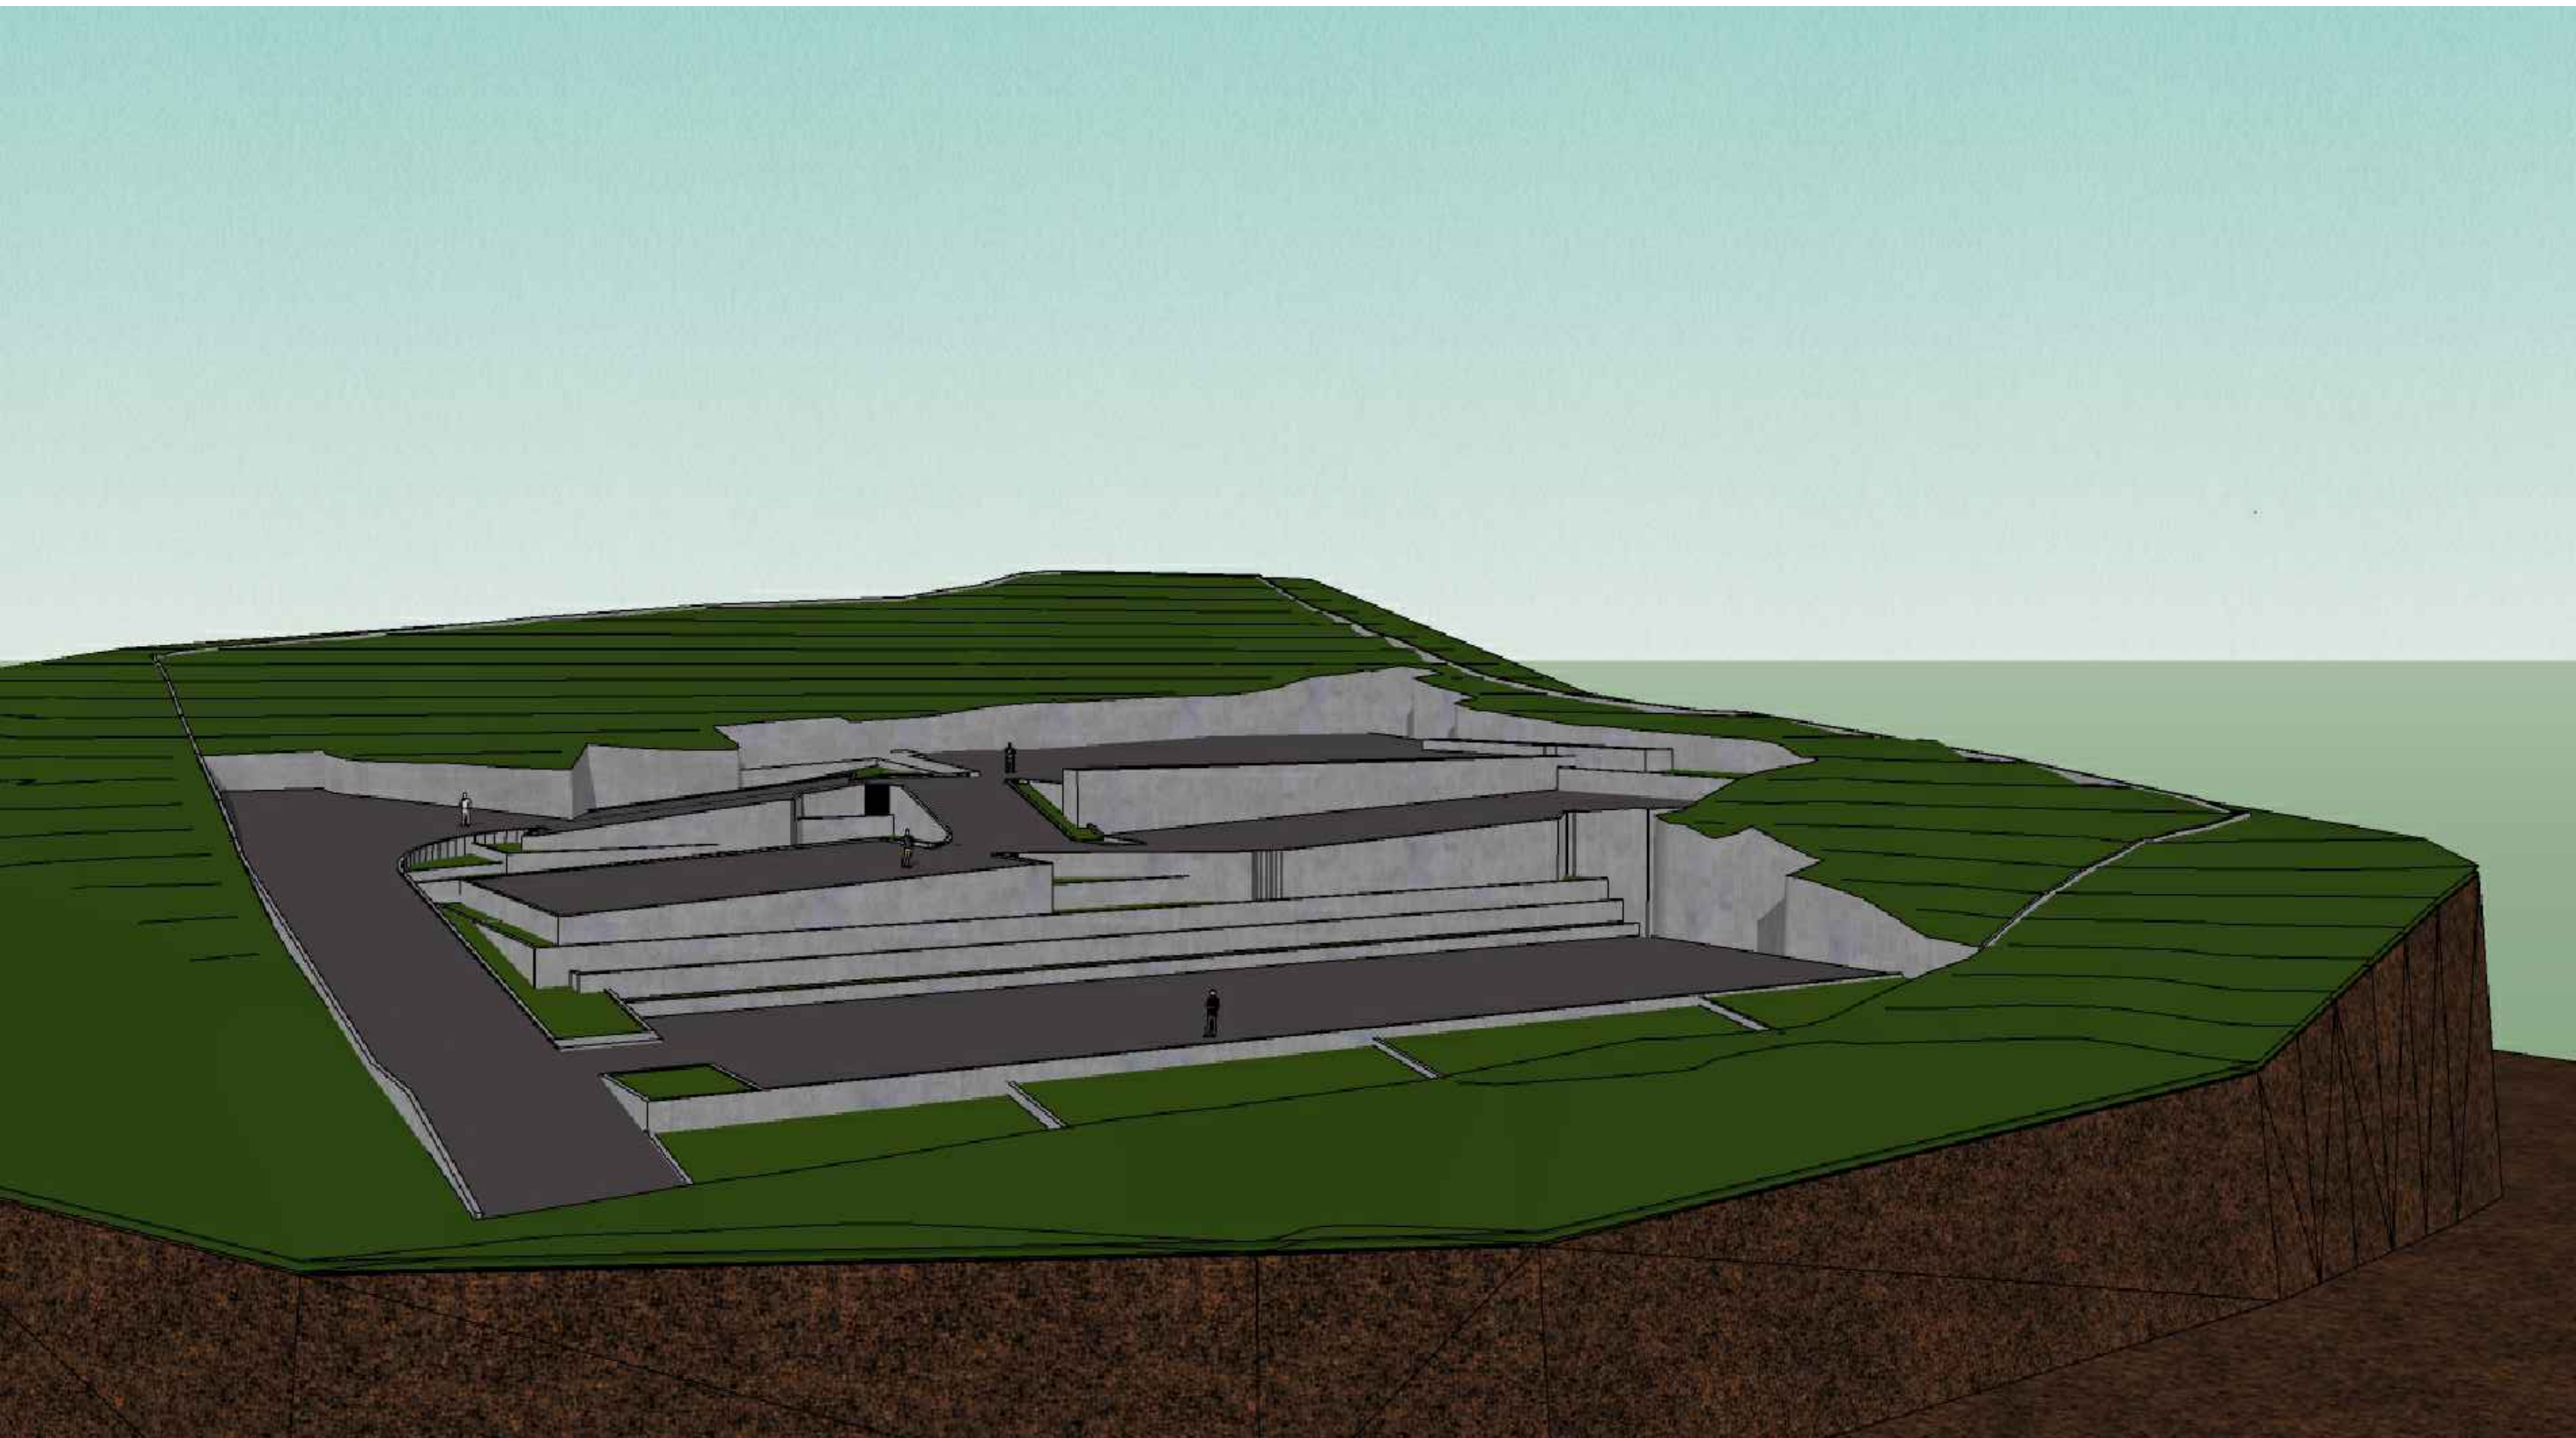
3 VIEW FROM SOUTH-EAST

SITE WITH CUT AND FILL
