## PROPOSED DEVELOPMENT

Proposed Development consist of 2 Residential buildings - one five storey and the other four storey.

PROJECT INFO:  
 APARTMENT BUILDING AT 5535  
 SHORNCLIFFE AVE  
 SECHELT BC  
 CLIENT:  
 GENARIS

As requested, Braun Geotechnical Ltd. (BGL) has carried out a geotechnical exploration for the above-referenced project. The geotechnical work has been performed in general accordance with the terms and conditions of the BGL Fee Estimate dated June 21, 2021 (our Ref. no. 21-9115). The scope of work included subsurface exploration and provision of geotechnical recommendations for the proposed development. No consideration has been given to any environmental aspects.

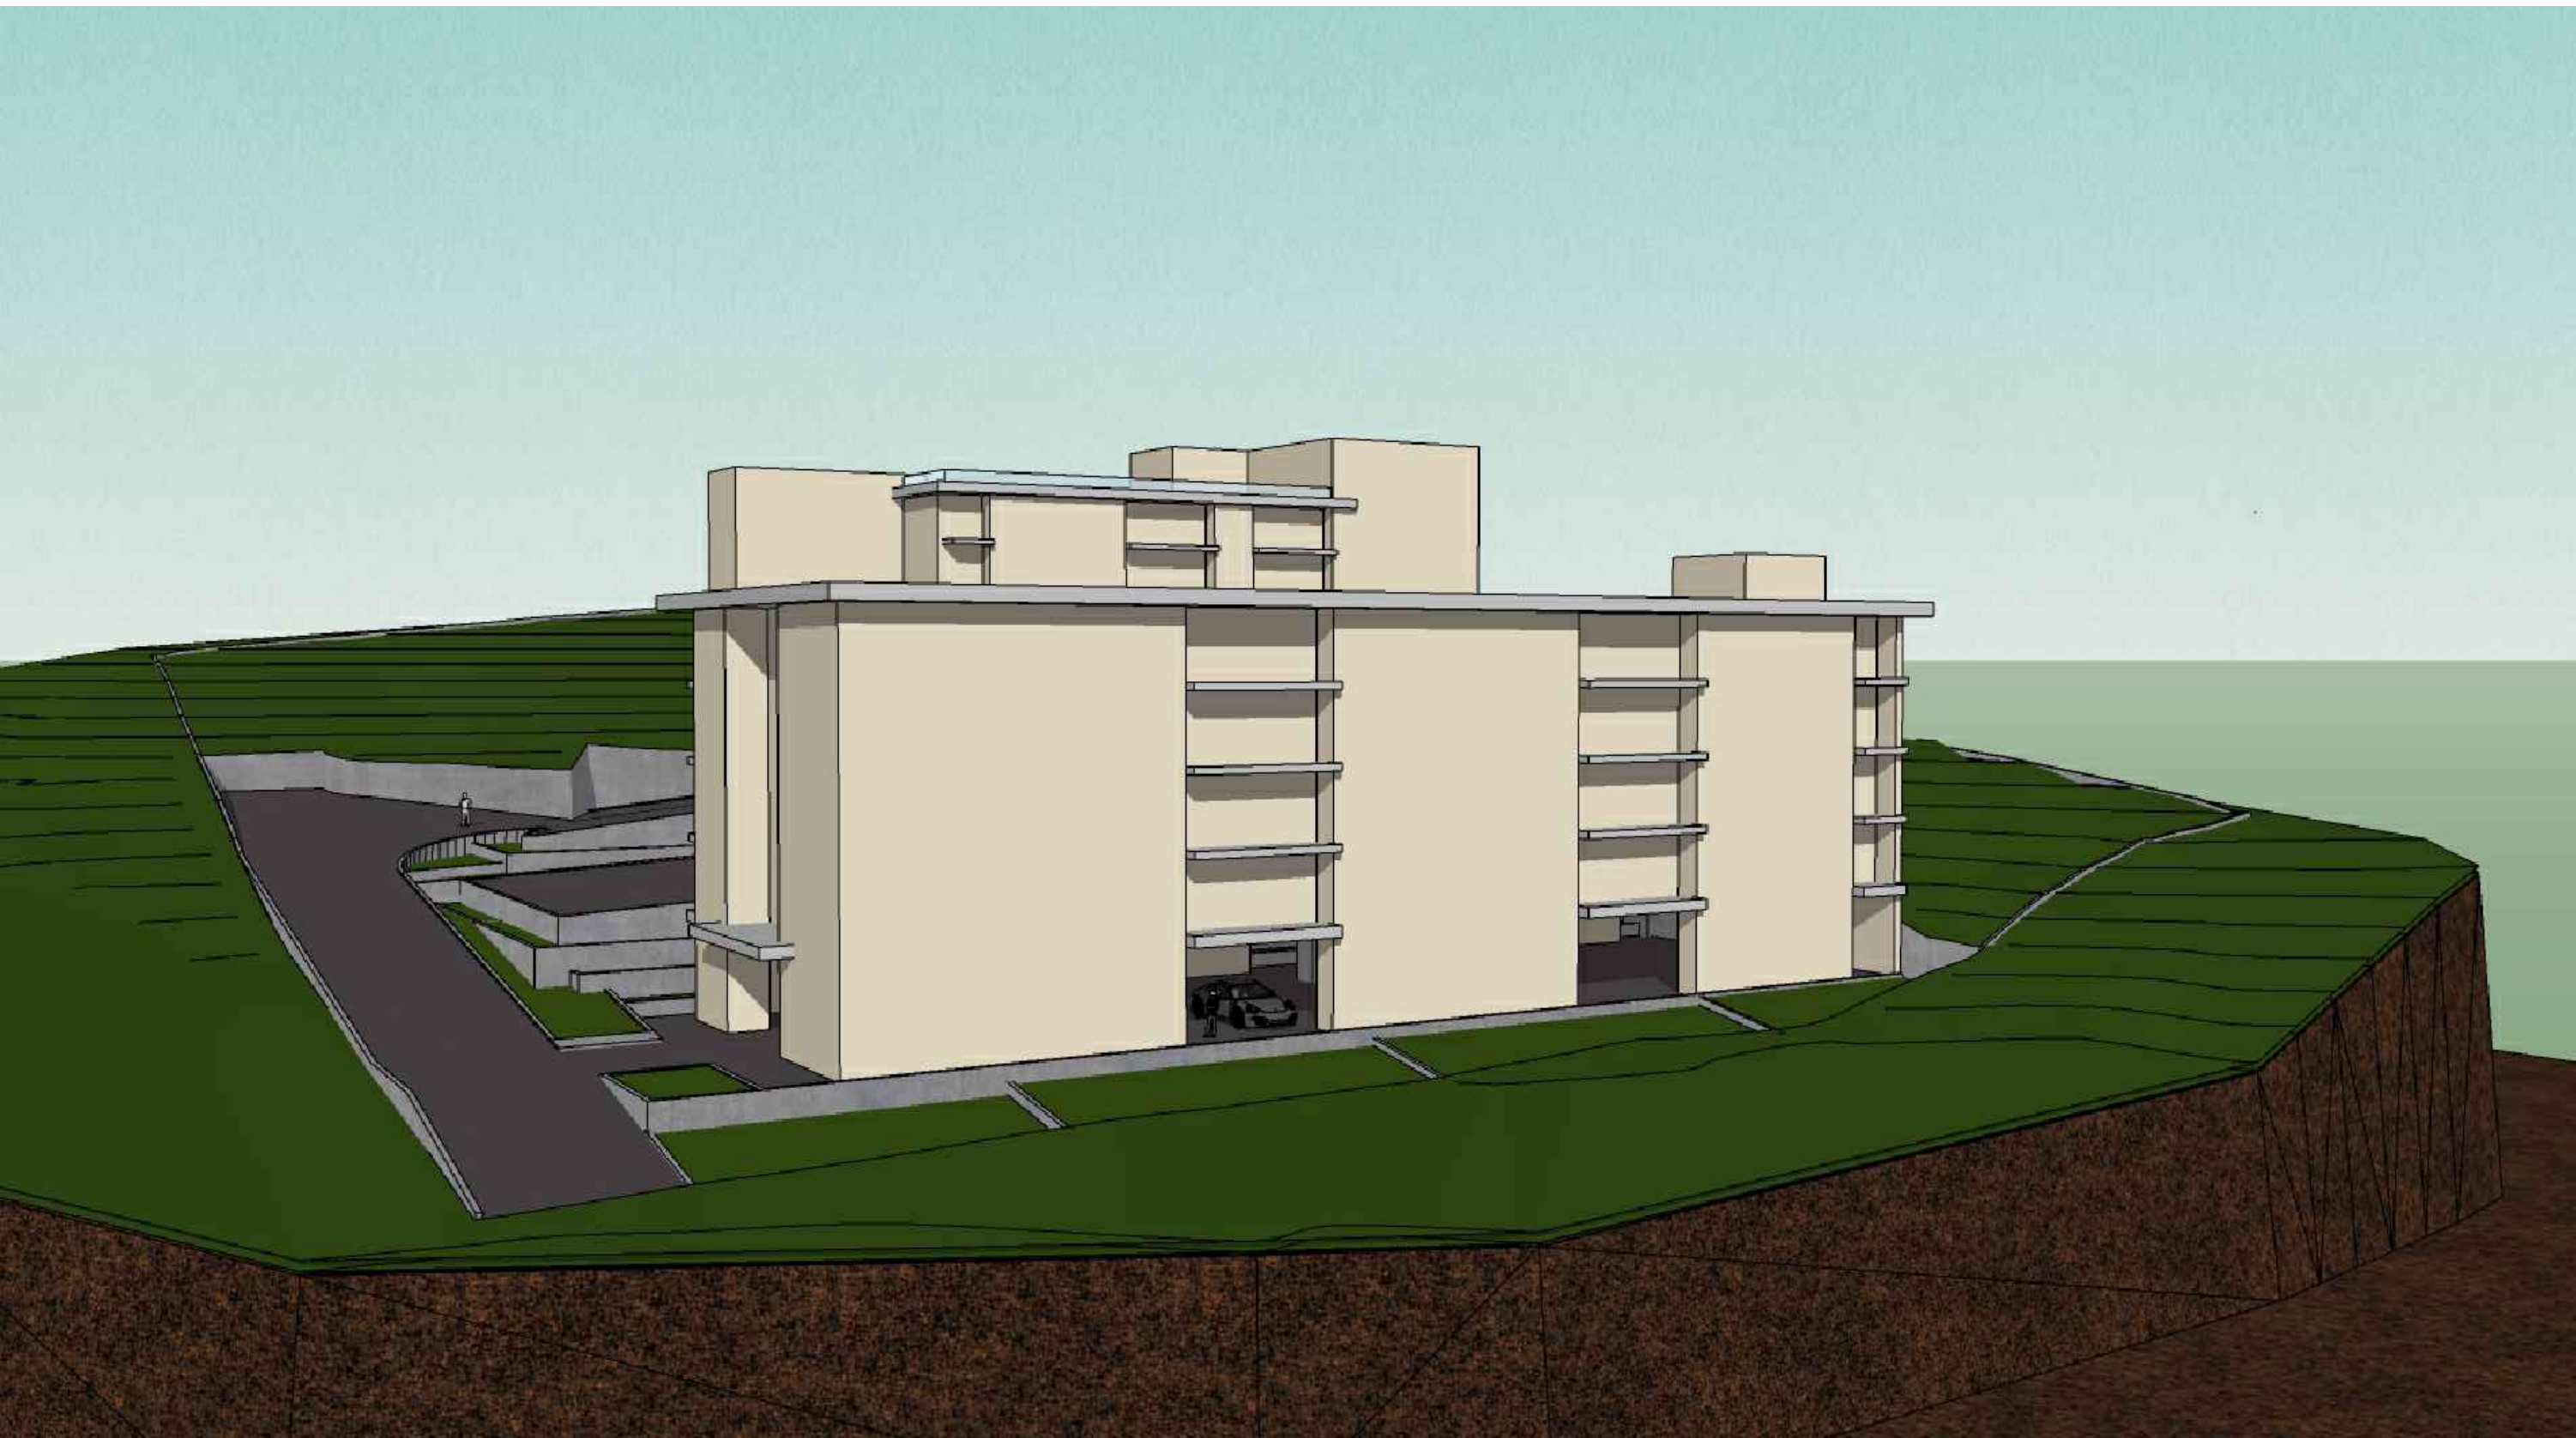
4 VIEW FROM SOUTH-EAST

SITE WITH BUILDING BLOCK

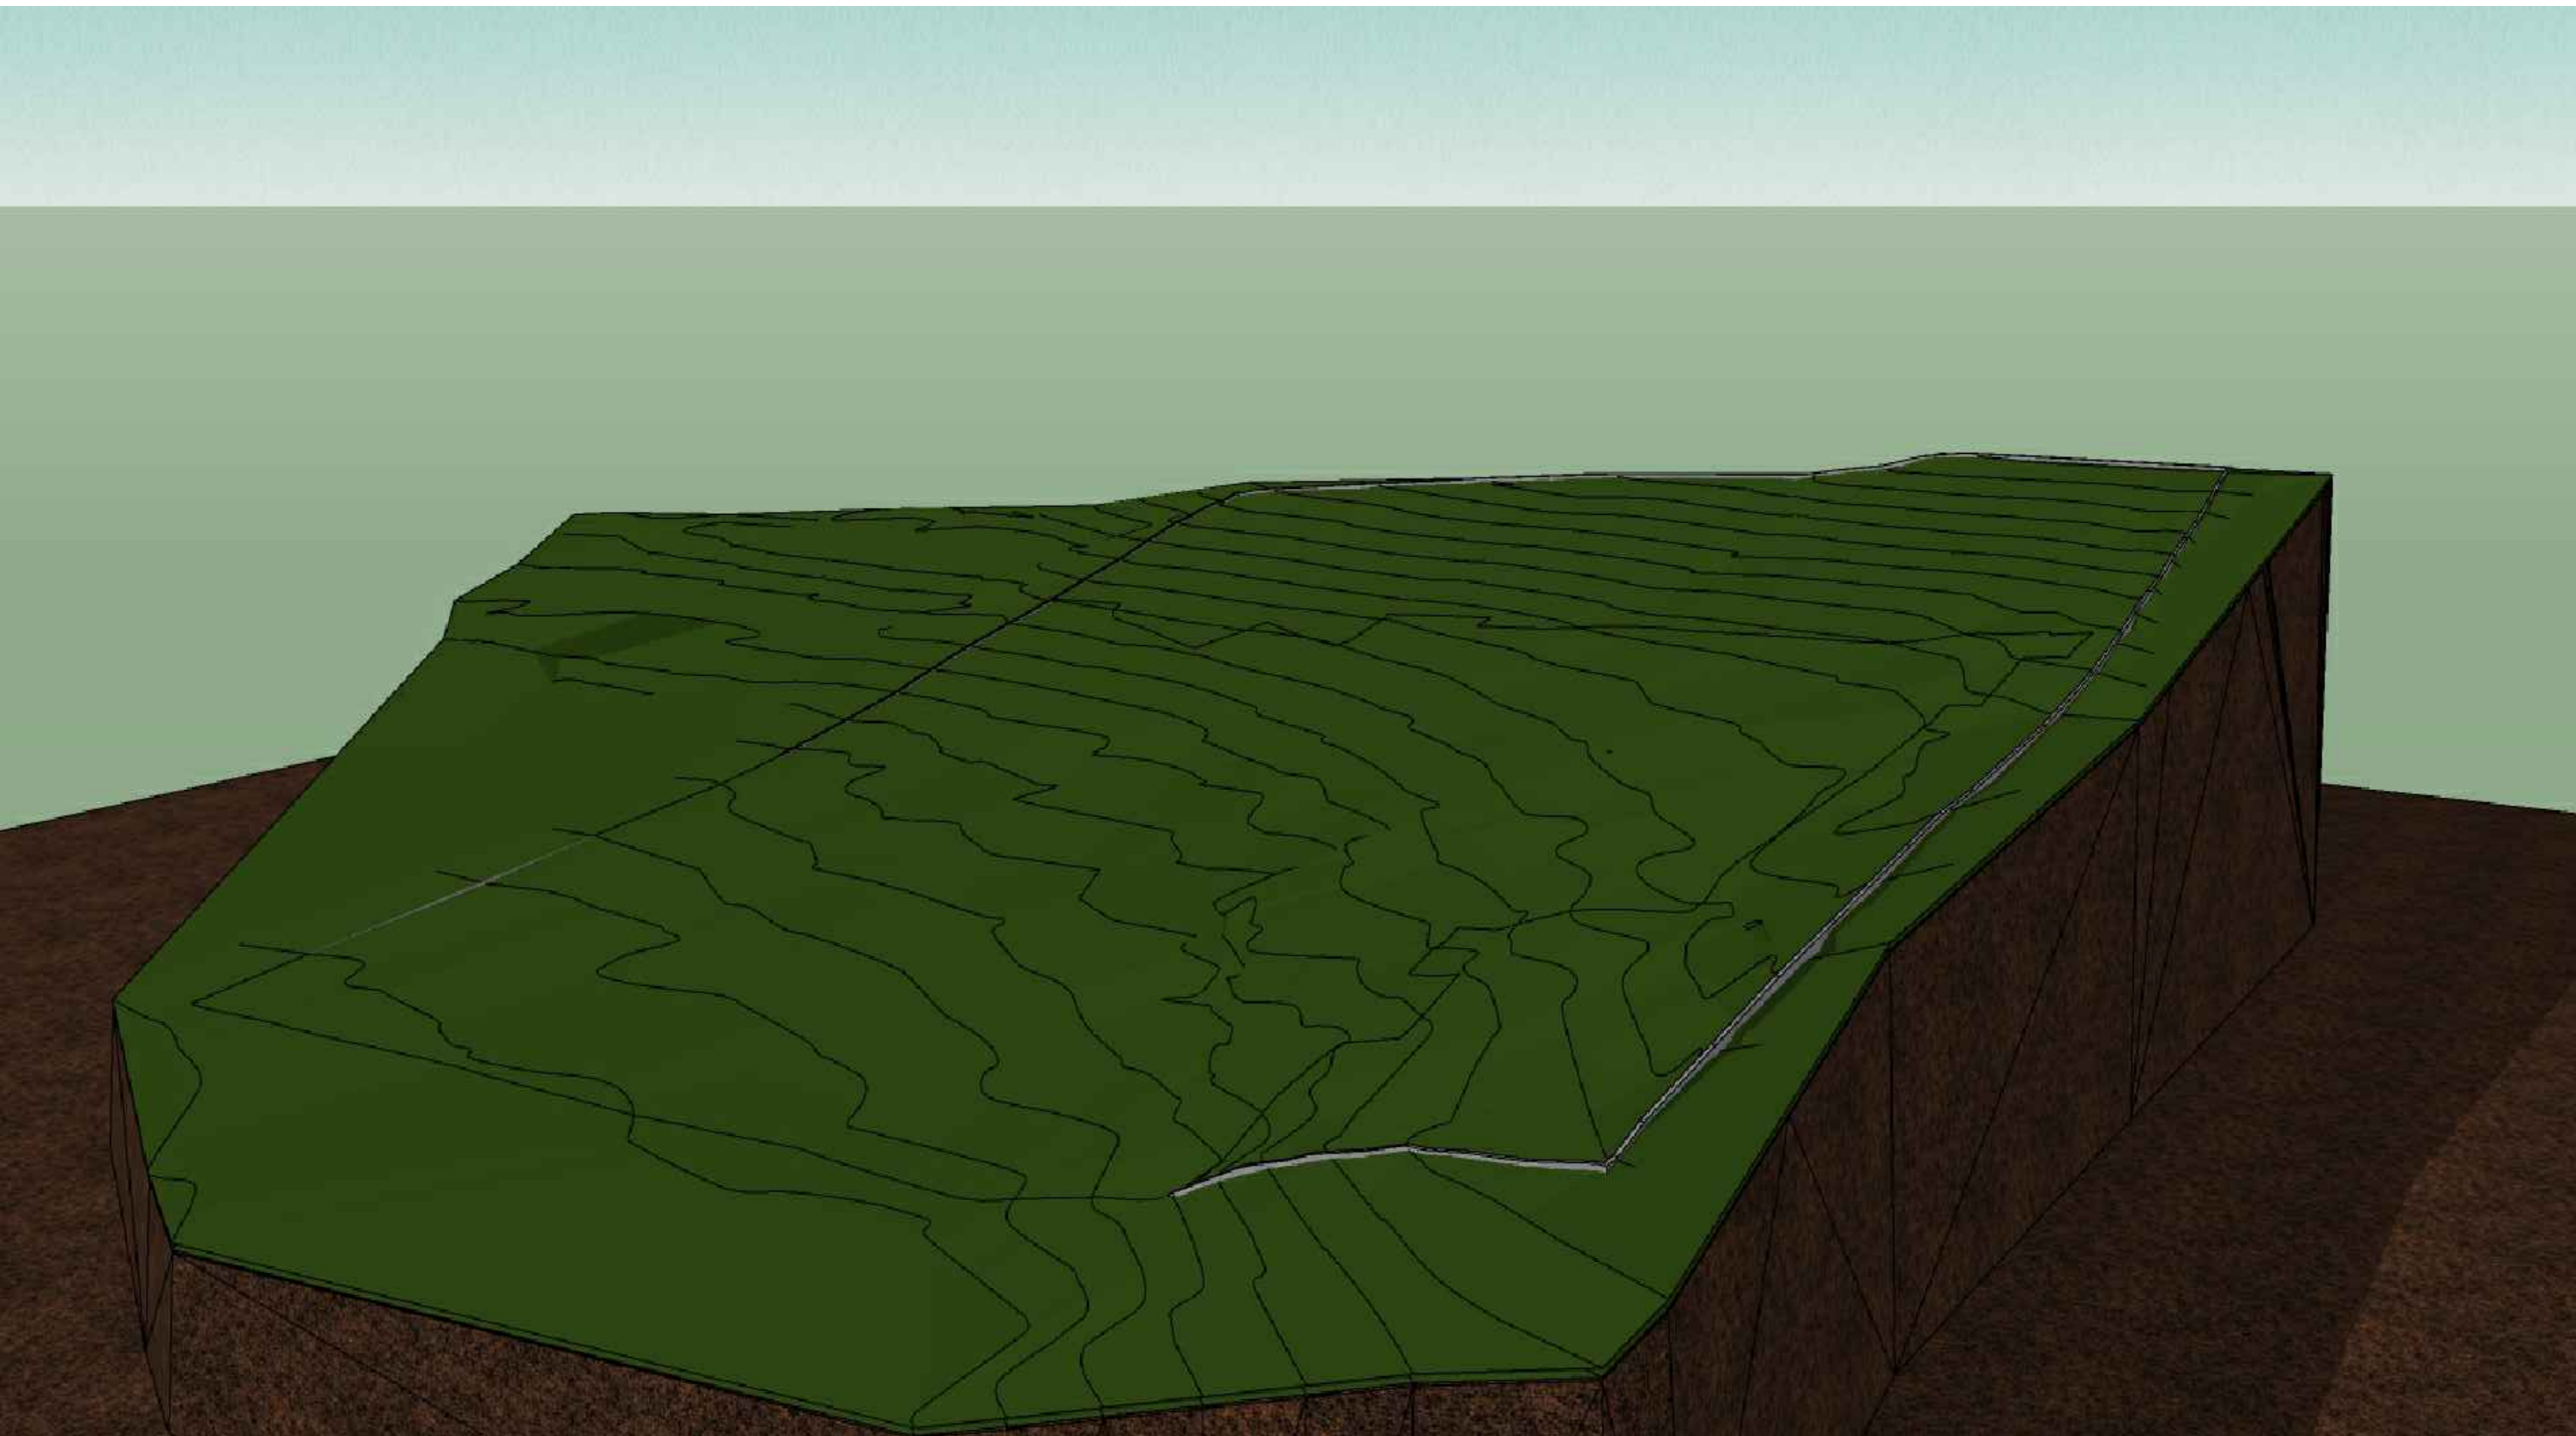
① VIEW FROM NORTH-EAST

SITE BOUNDARY WITH  
BASIC CONTOURS

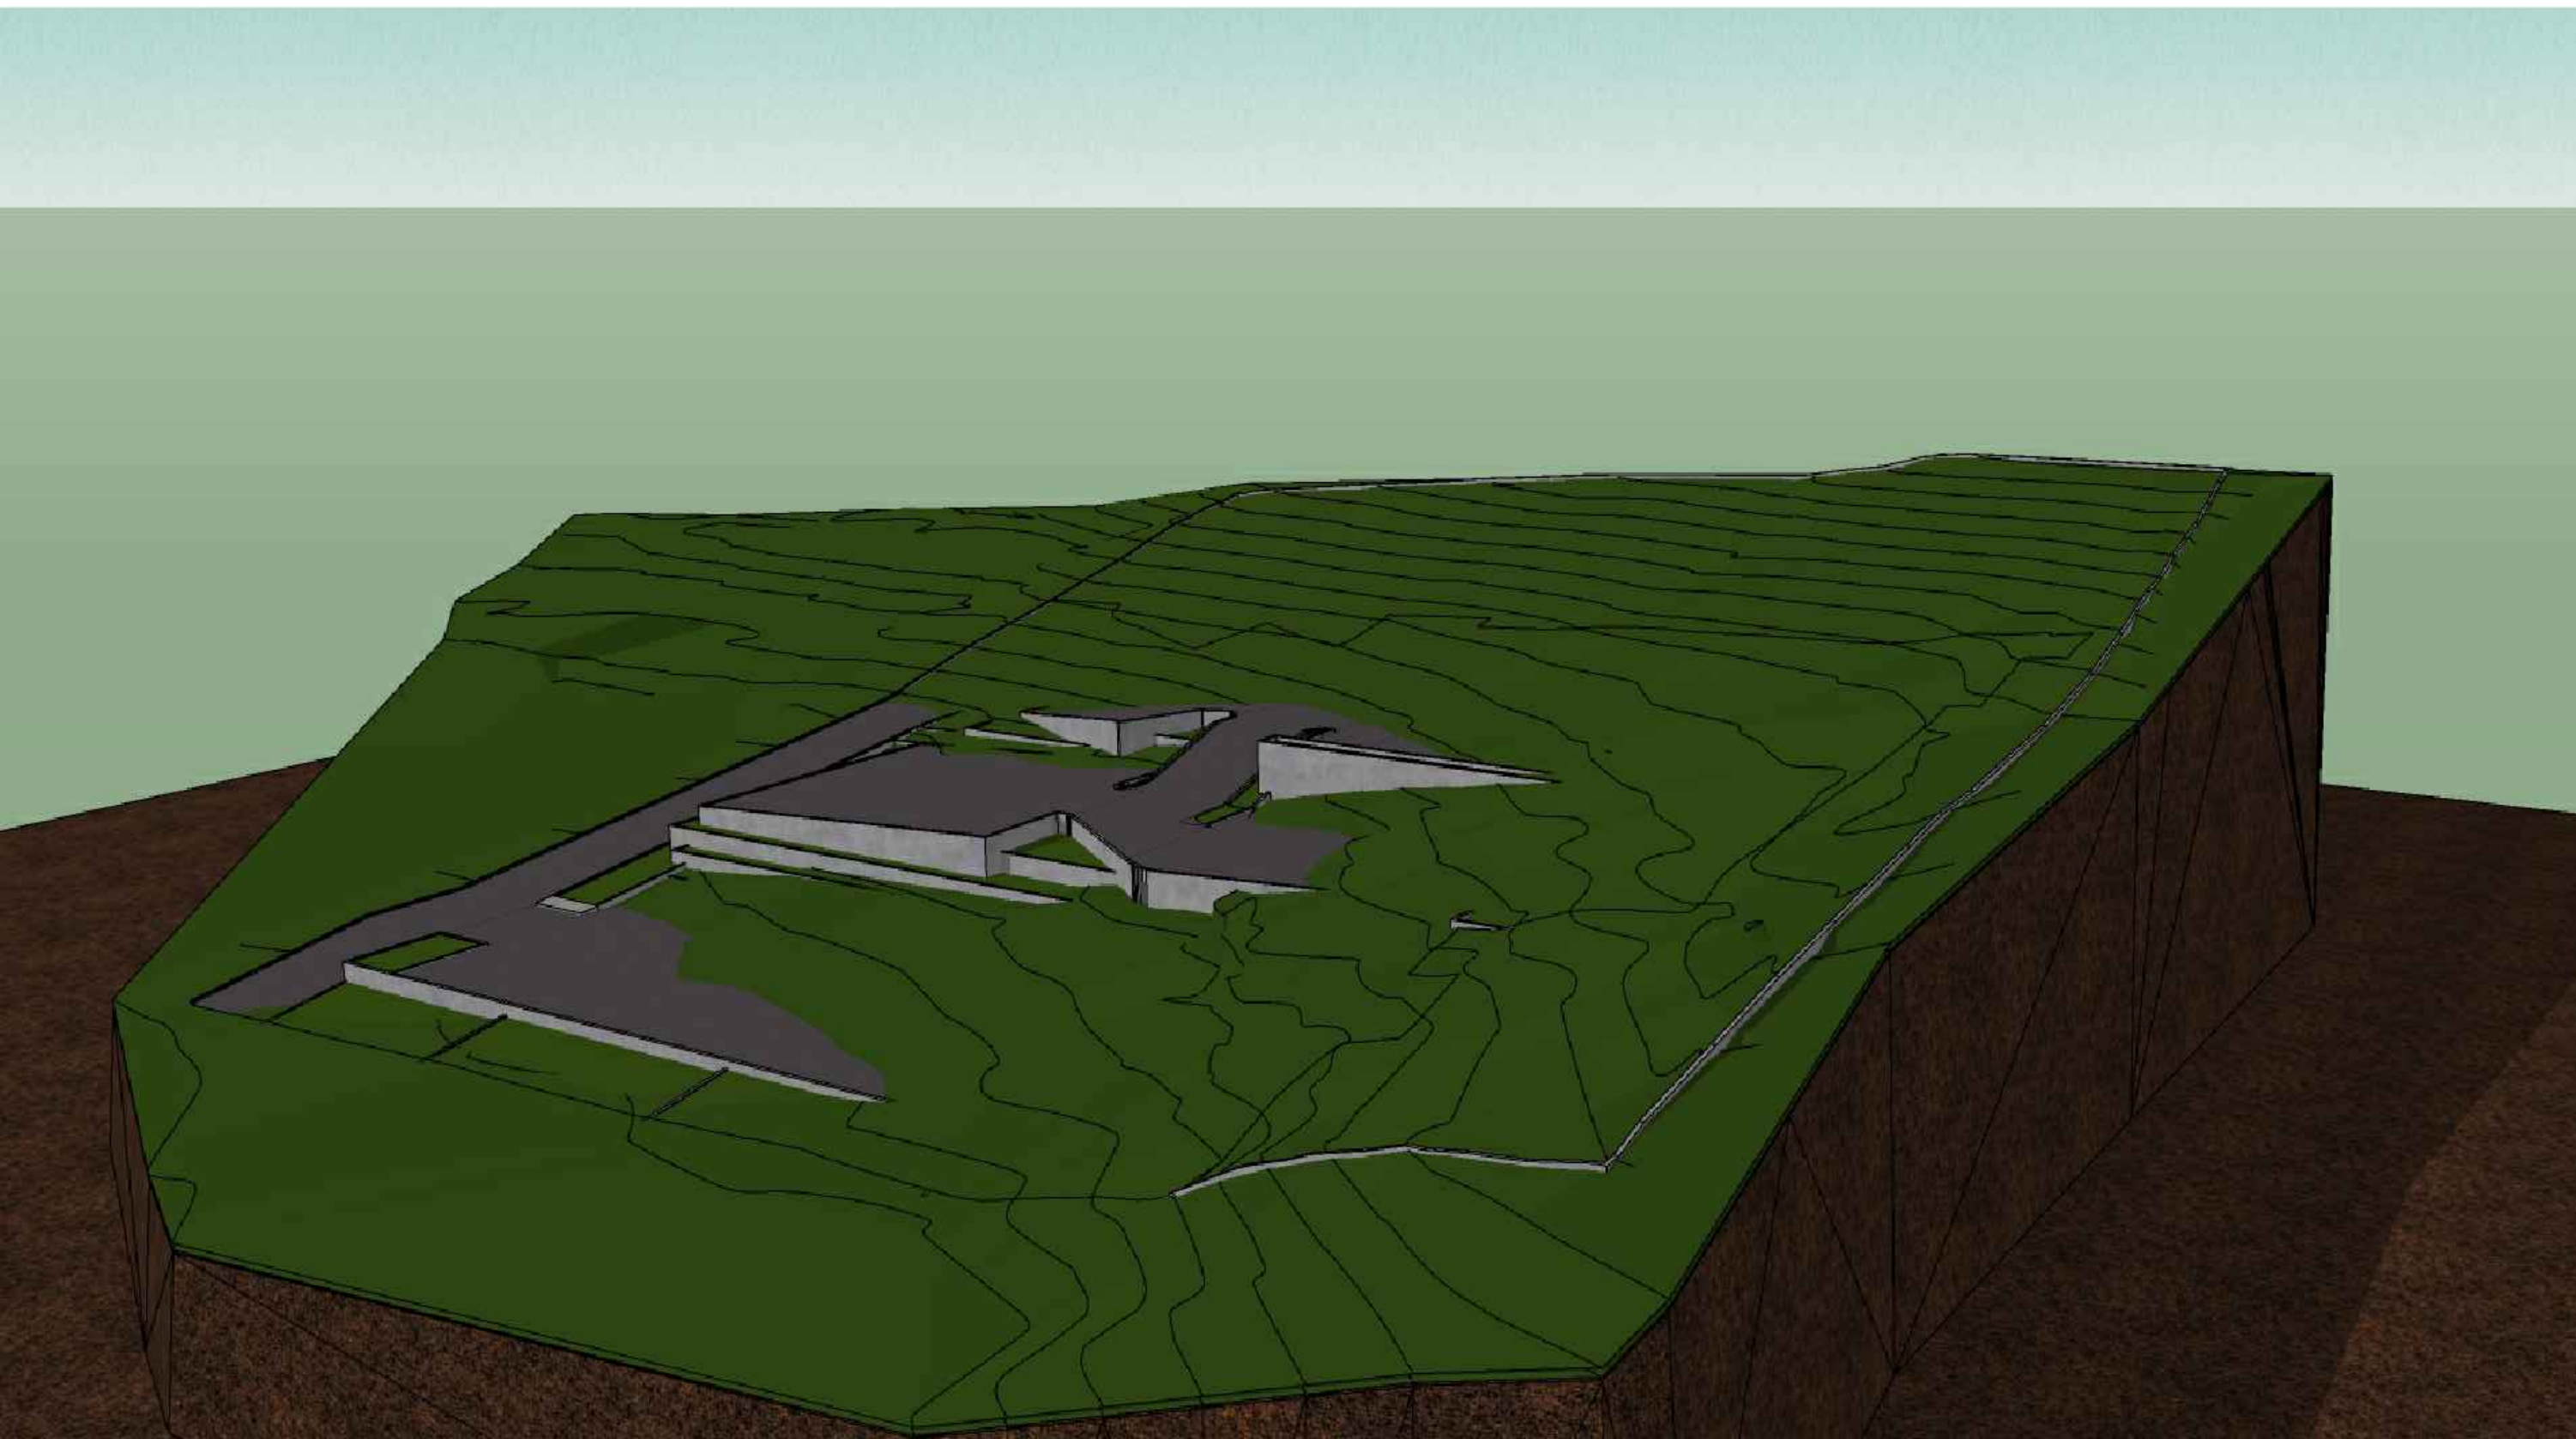
2 VIEW FROM NORTH-EAST

SITE WITH FILL

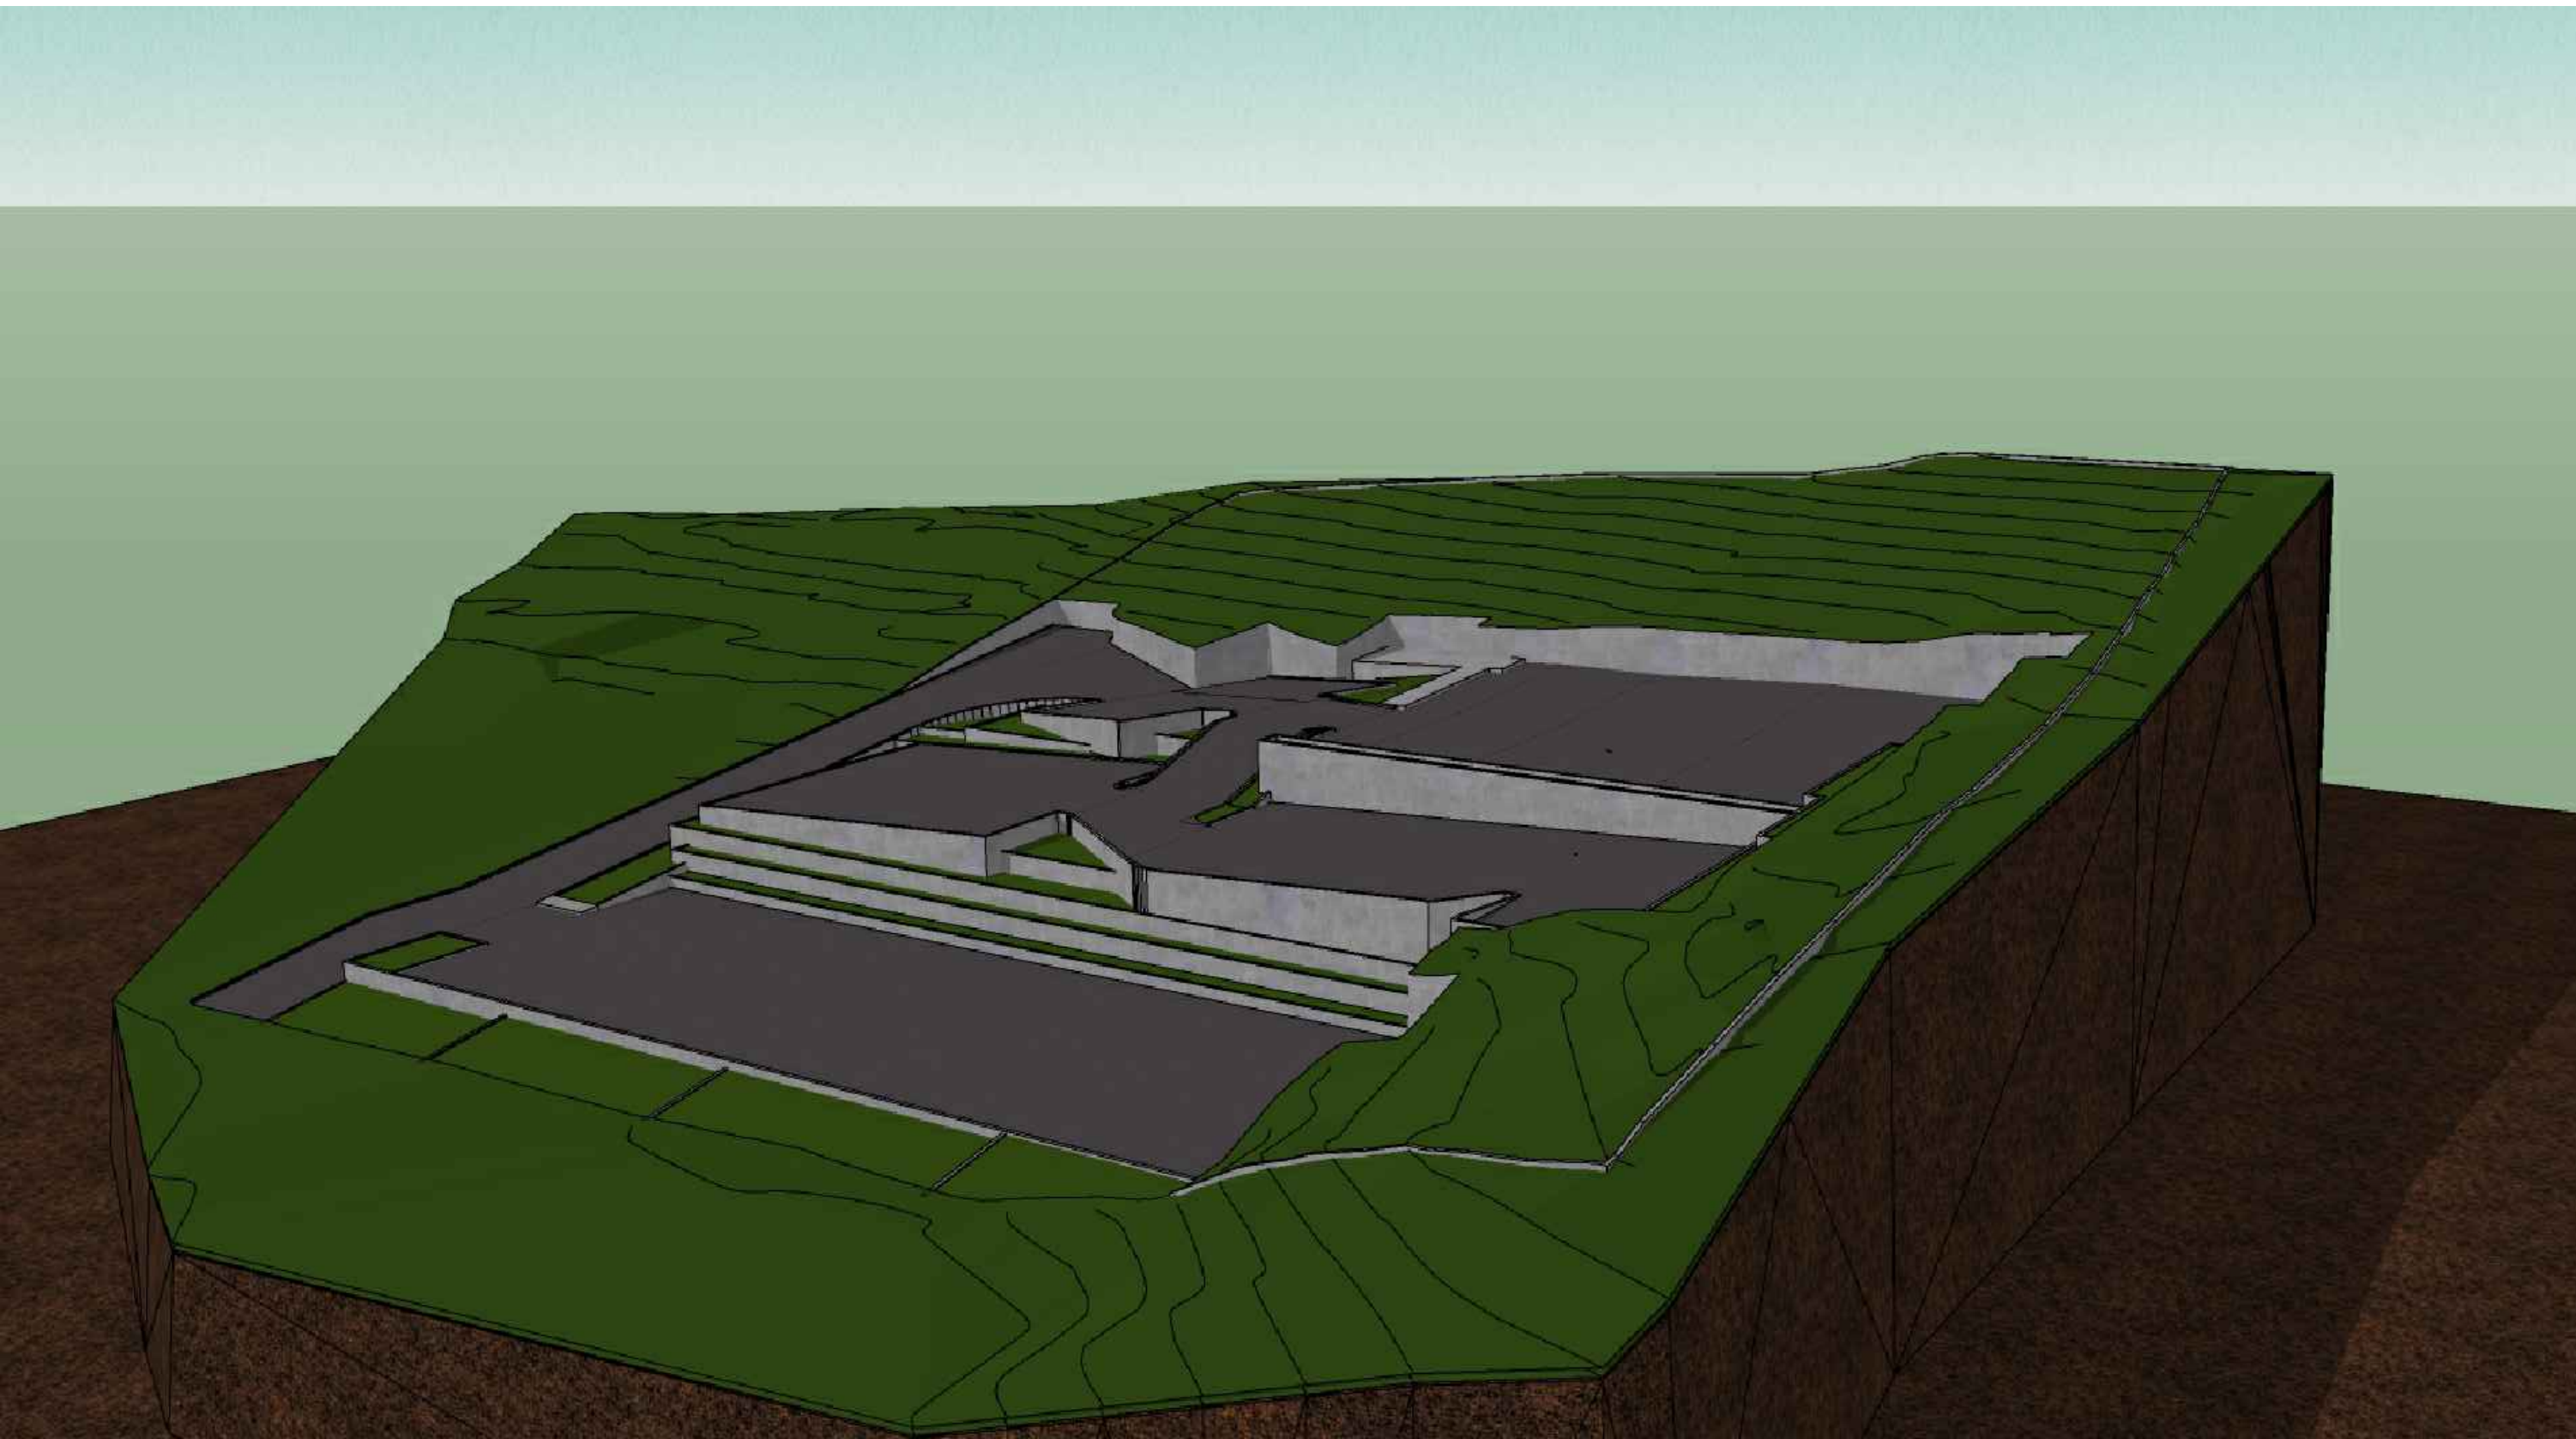
3 VIEW FROM NORTH-EAST

SITE WITH CUT AND FILL

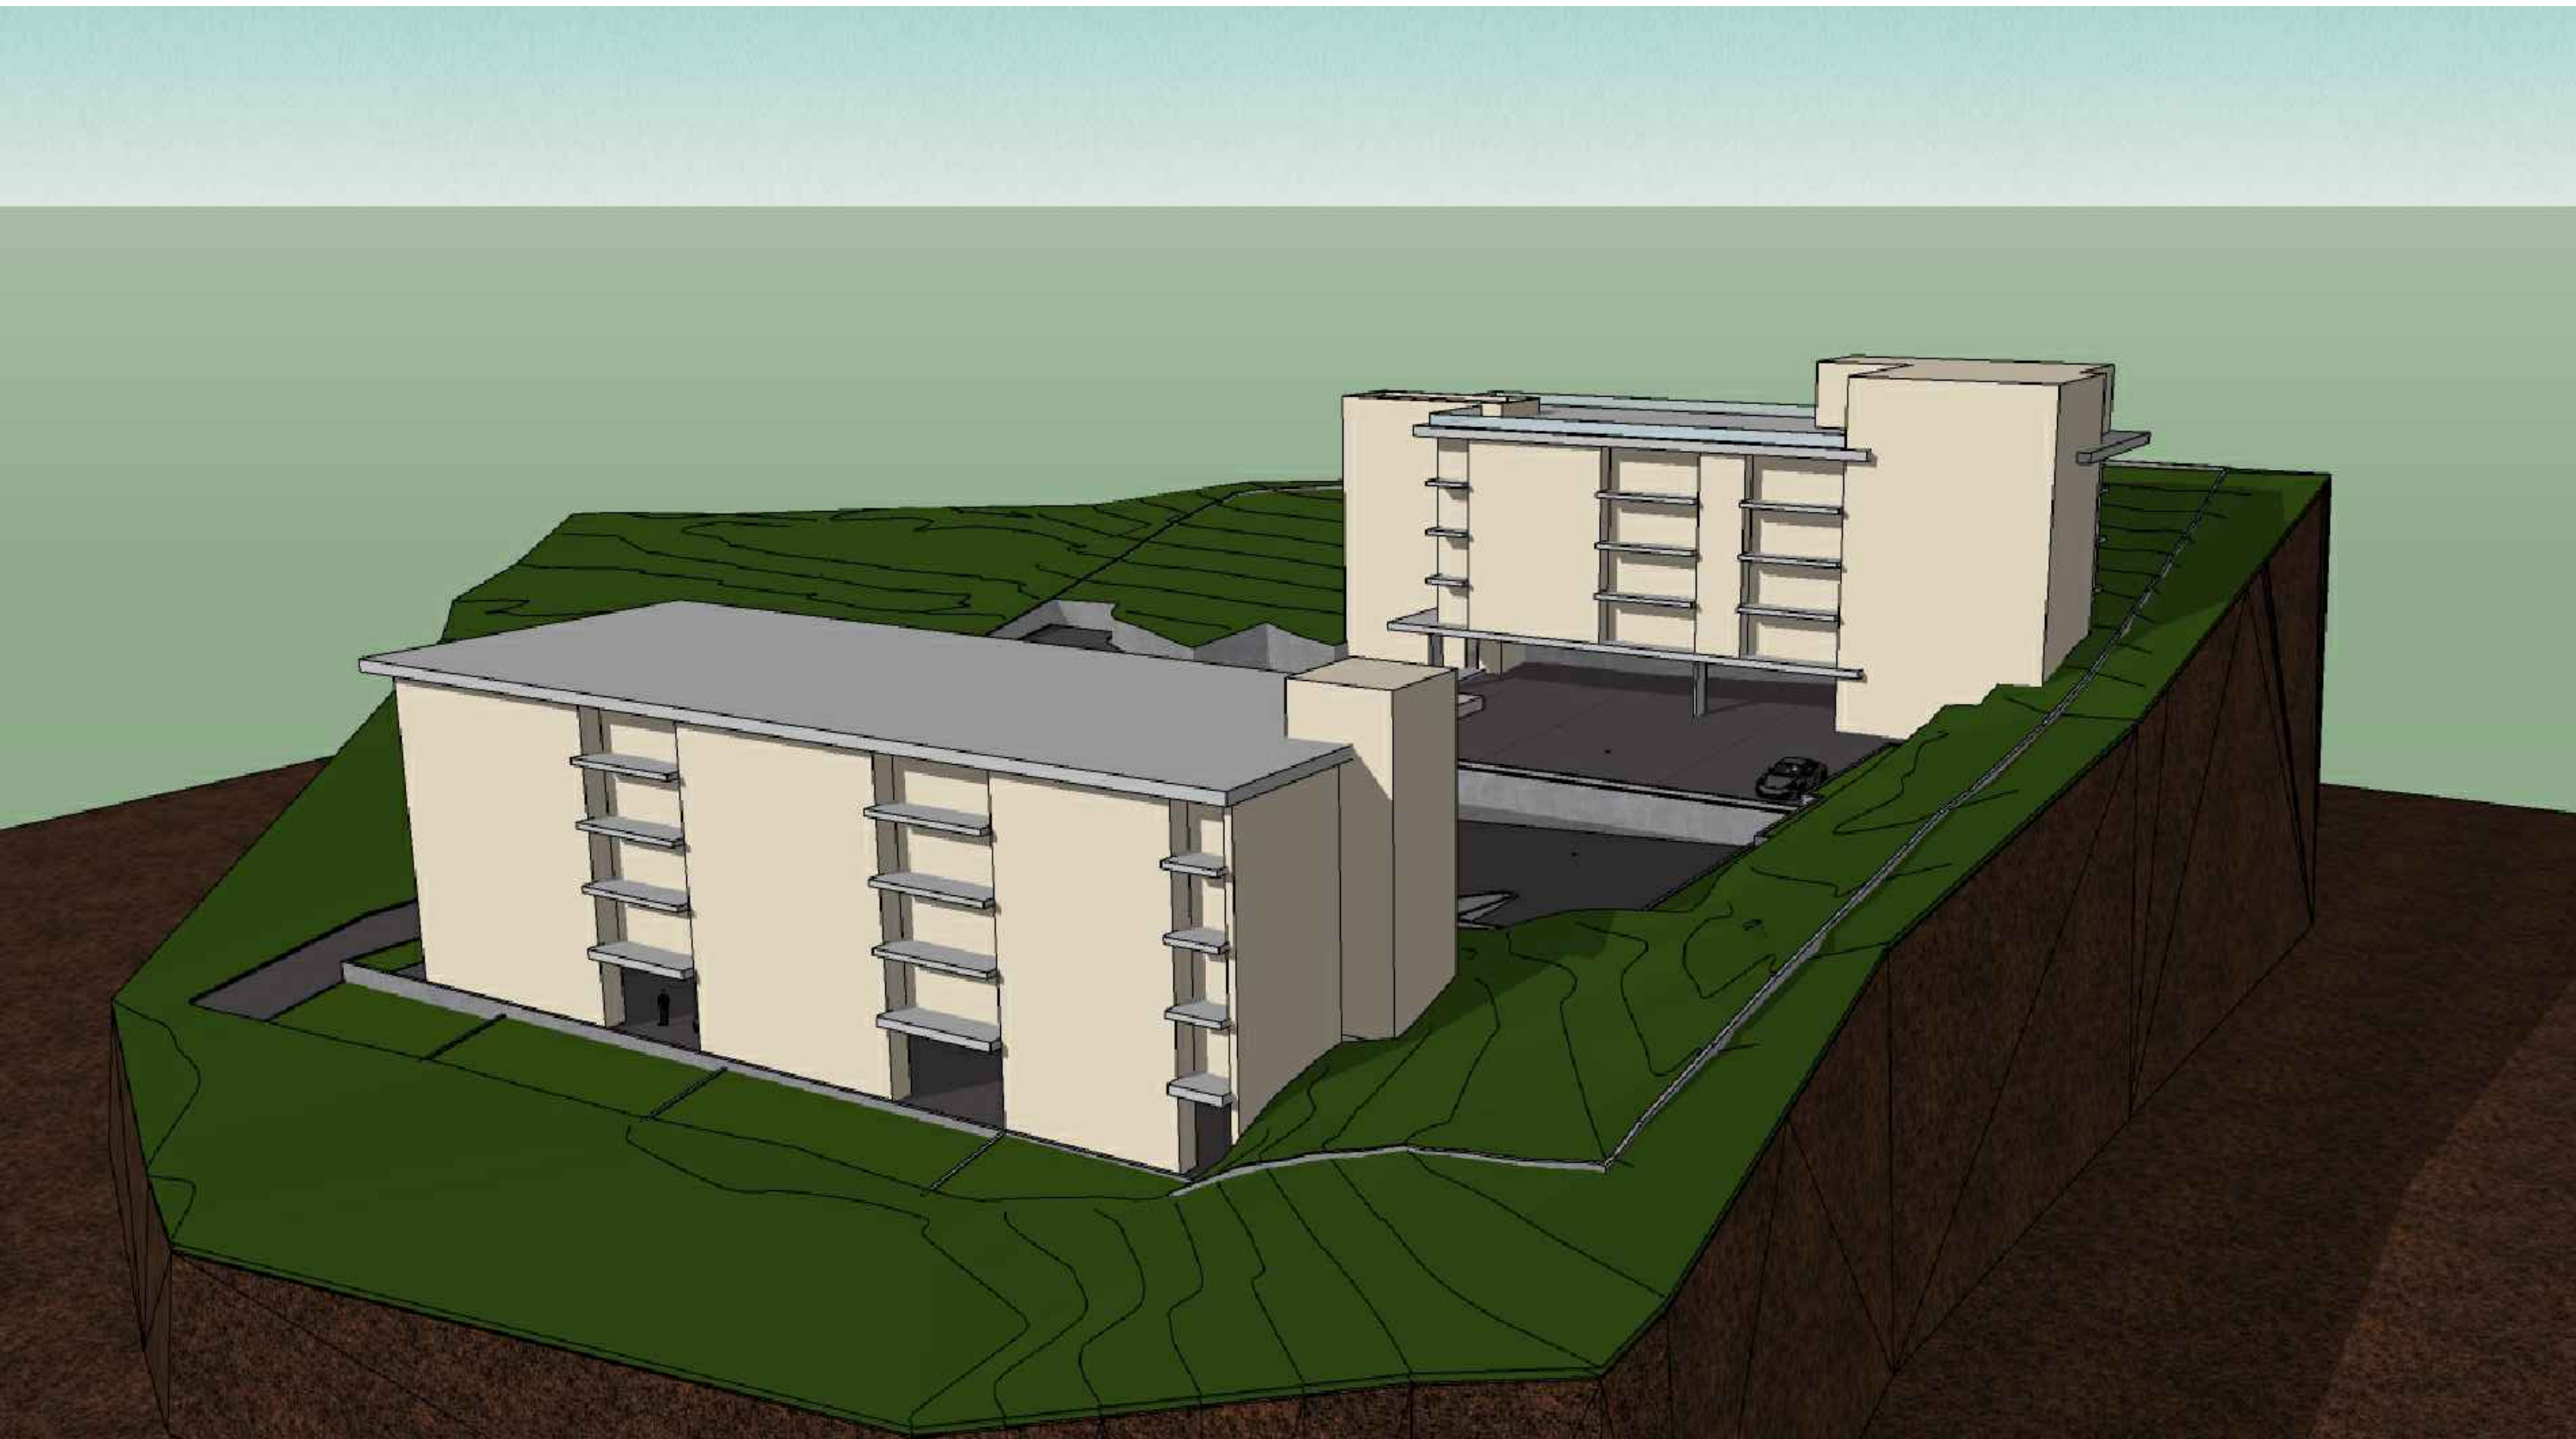
4 VIEW FROM NORTH-EAST

SITE WITH BUILDING BLOCK

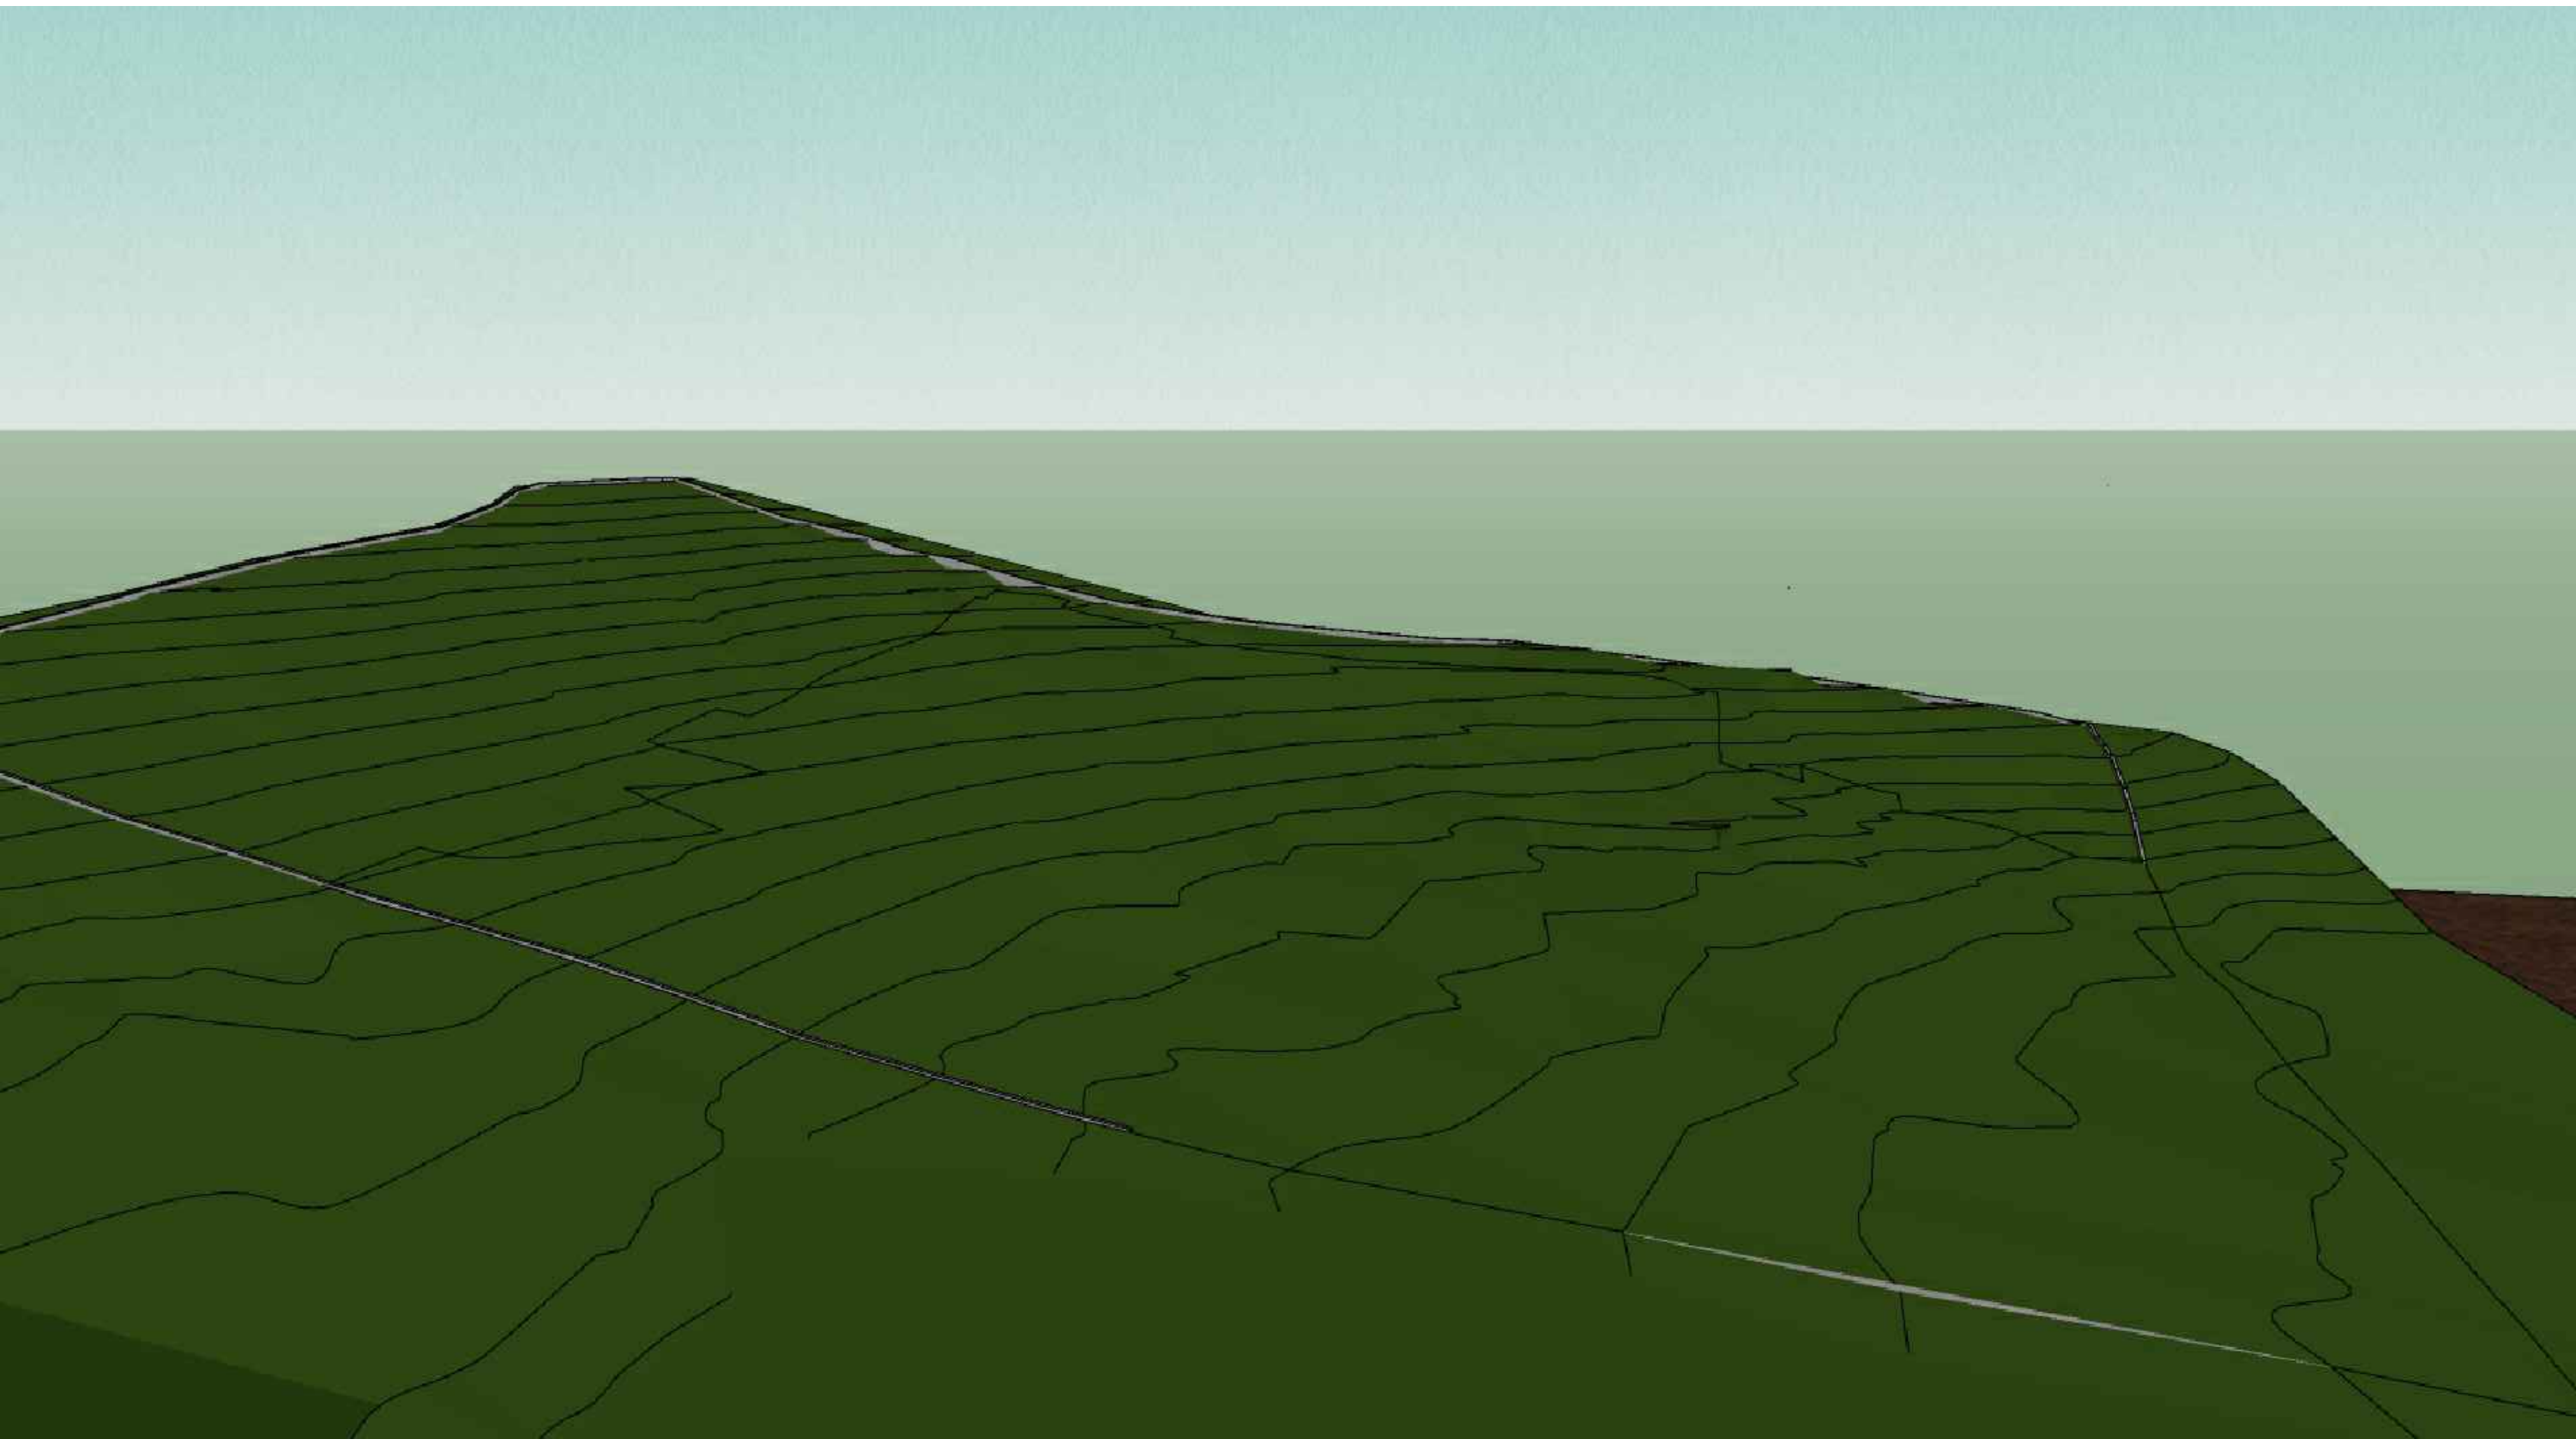
① VIEW FROM SOUTH

SITE BOUNDARY WITH  
BASIC CONTOURS
