## PROPOSED DEVELOPMENT

Proposed Development consist of 2 Residential buildings - one five storey and the other four storey.

PROJECT INFO:  
 APARTMENT BUILDING AT 5535  
 SHORNCLIFFE AVE  
 SECHELT BC  
 CLIENT:  
 GENARIS

As requested, Braun Geotechnical Ltd. (BGL) has carried out a geotechnical exploration for the above-referenced project. The geotechnical work has been performed in general accordance with the terms and conditions of the BGL Fee Estimate dated June 21, 2021 (our Ref. no. 21-9115). The scope of work included subsurface exploration and provision of geotechnical recommendations for the proposed development. No consideration has been given to any environmental aspects.

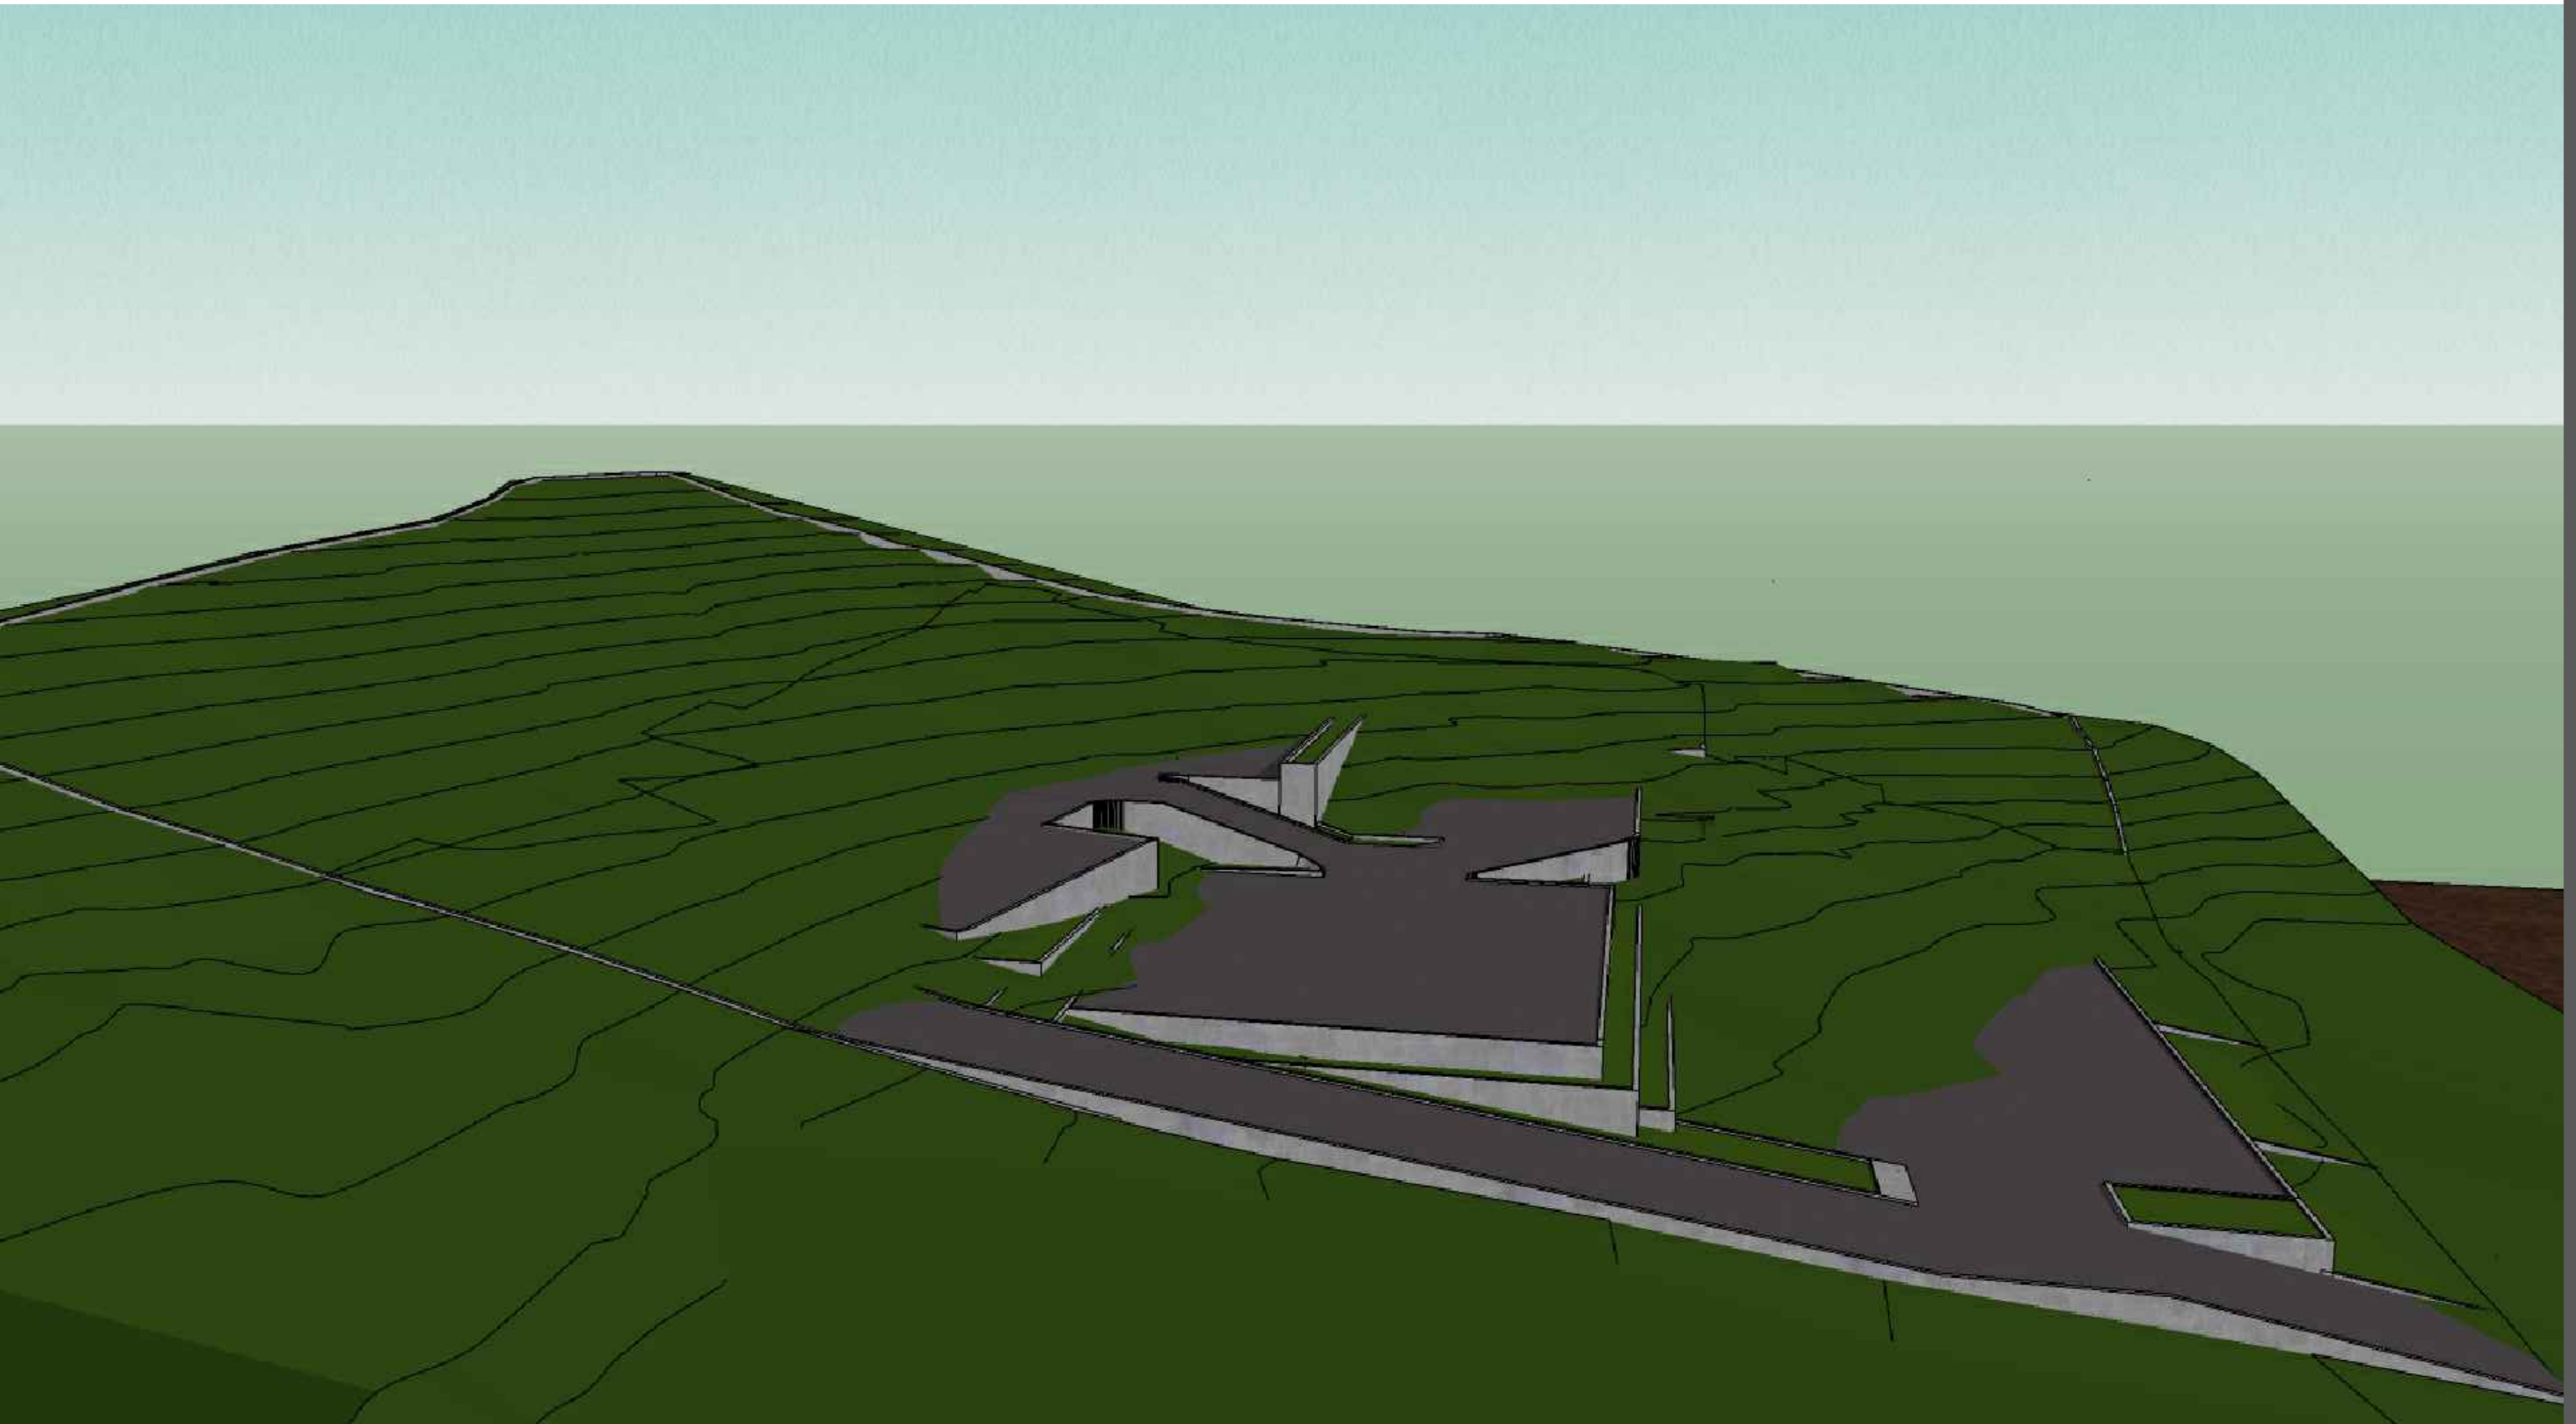
② VIEW FROM SOUTH

SITE WITH FILL

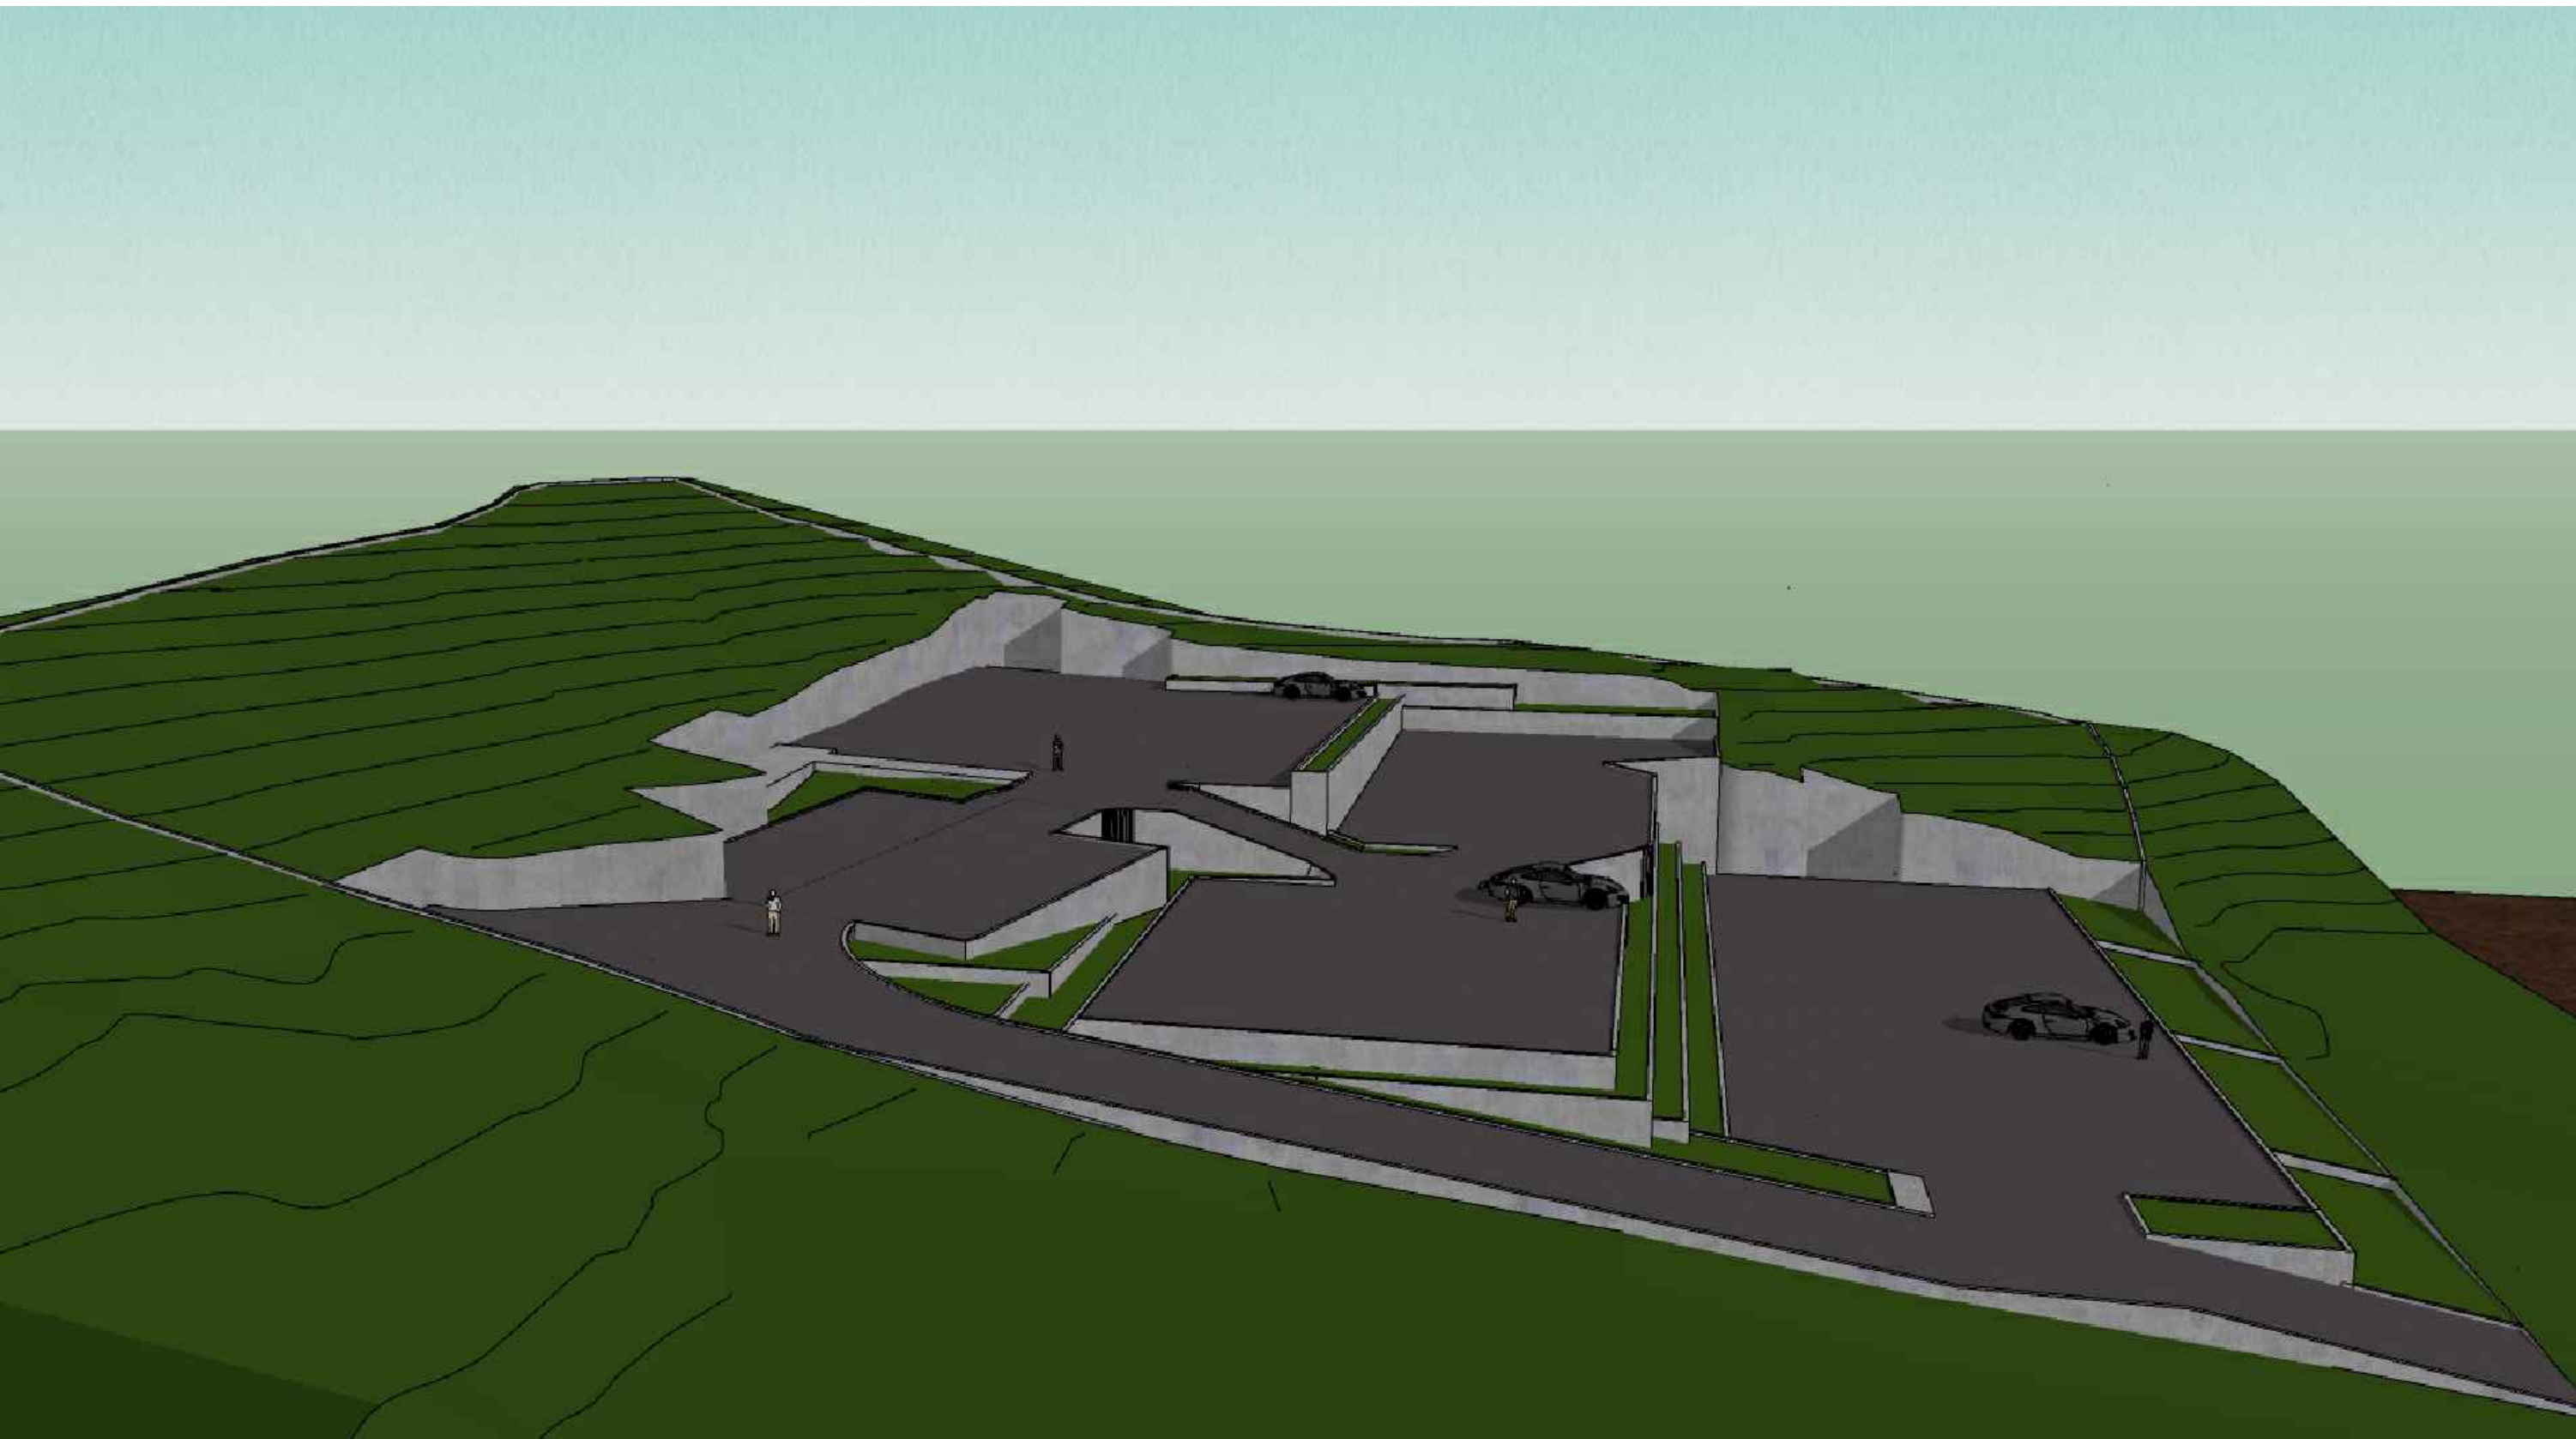
3 VIEW FROM SOUTH

SITE WITH CUT AND FILL

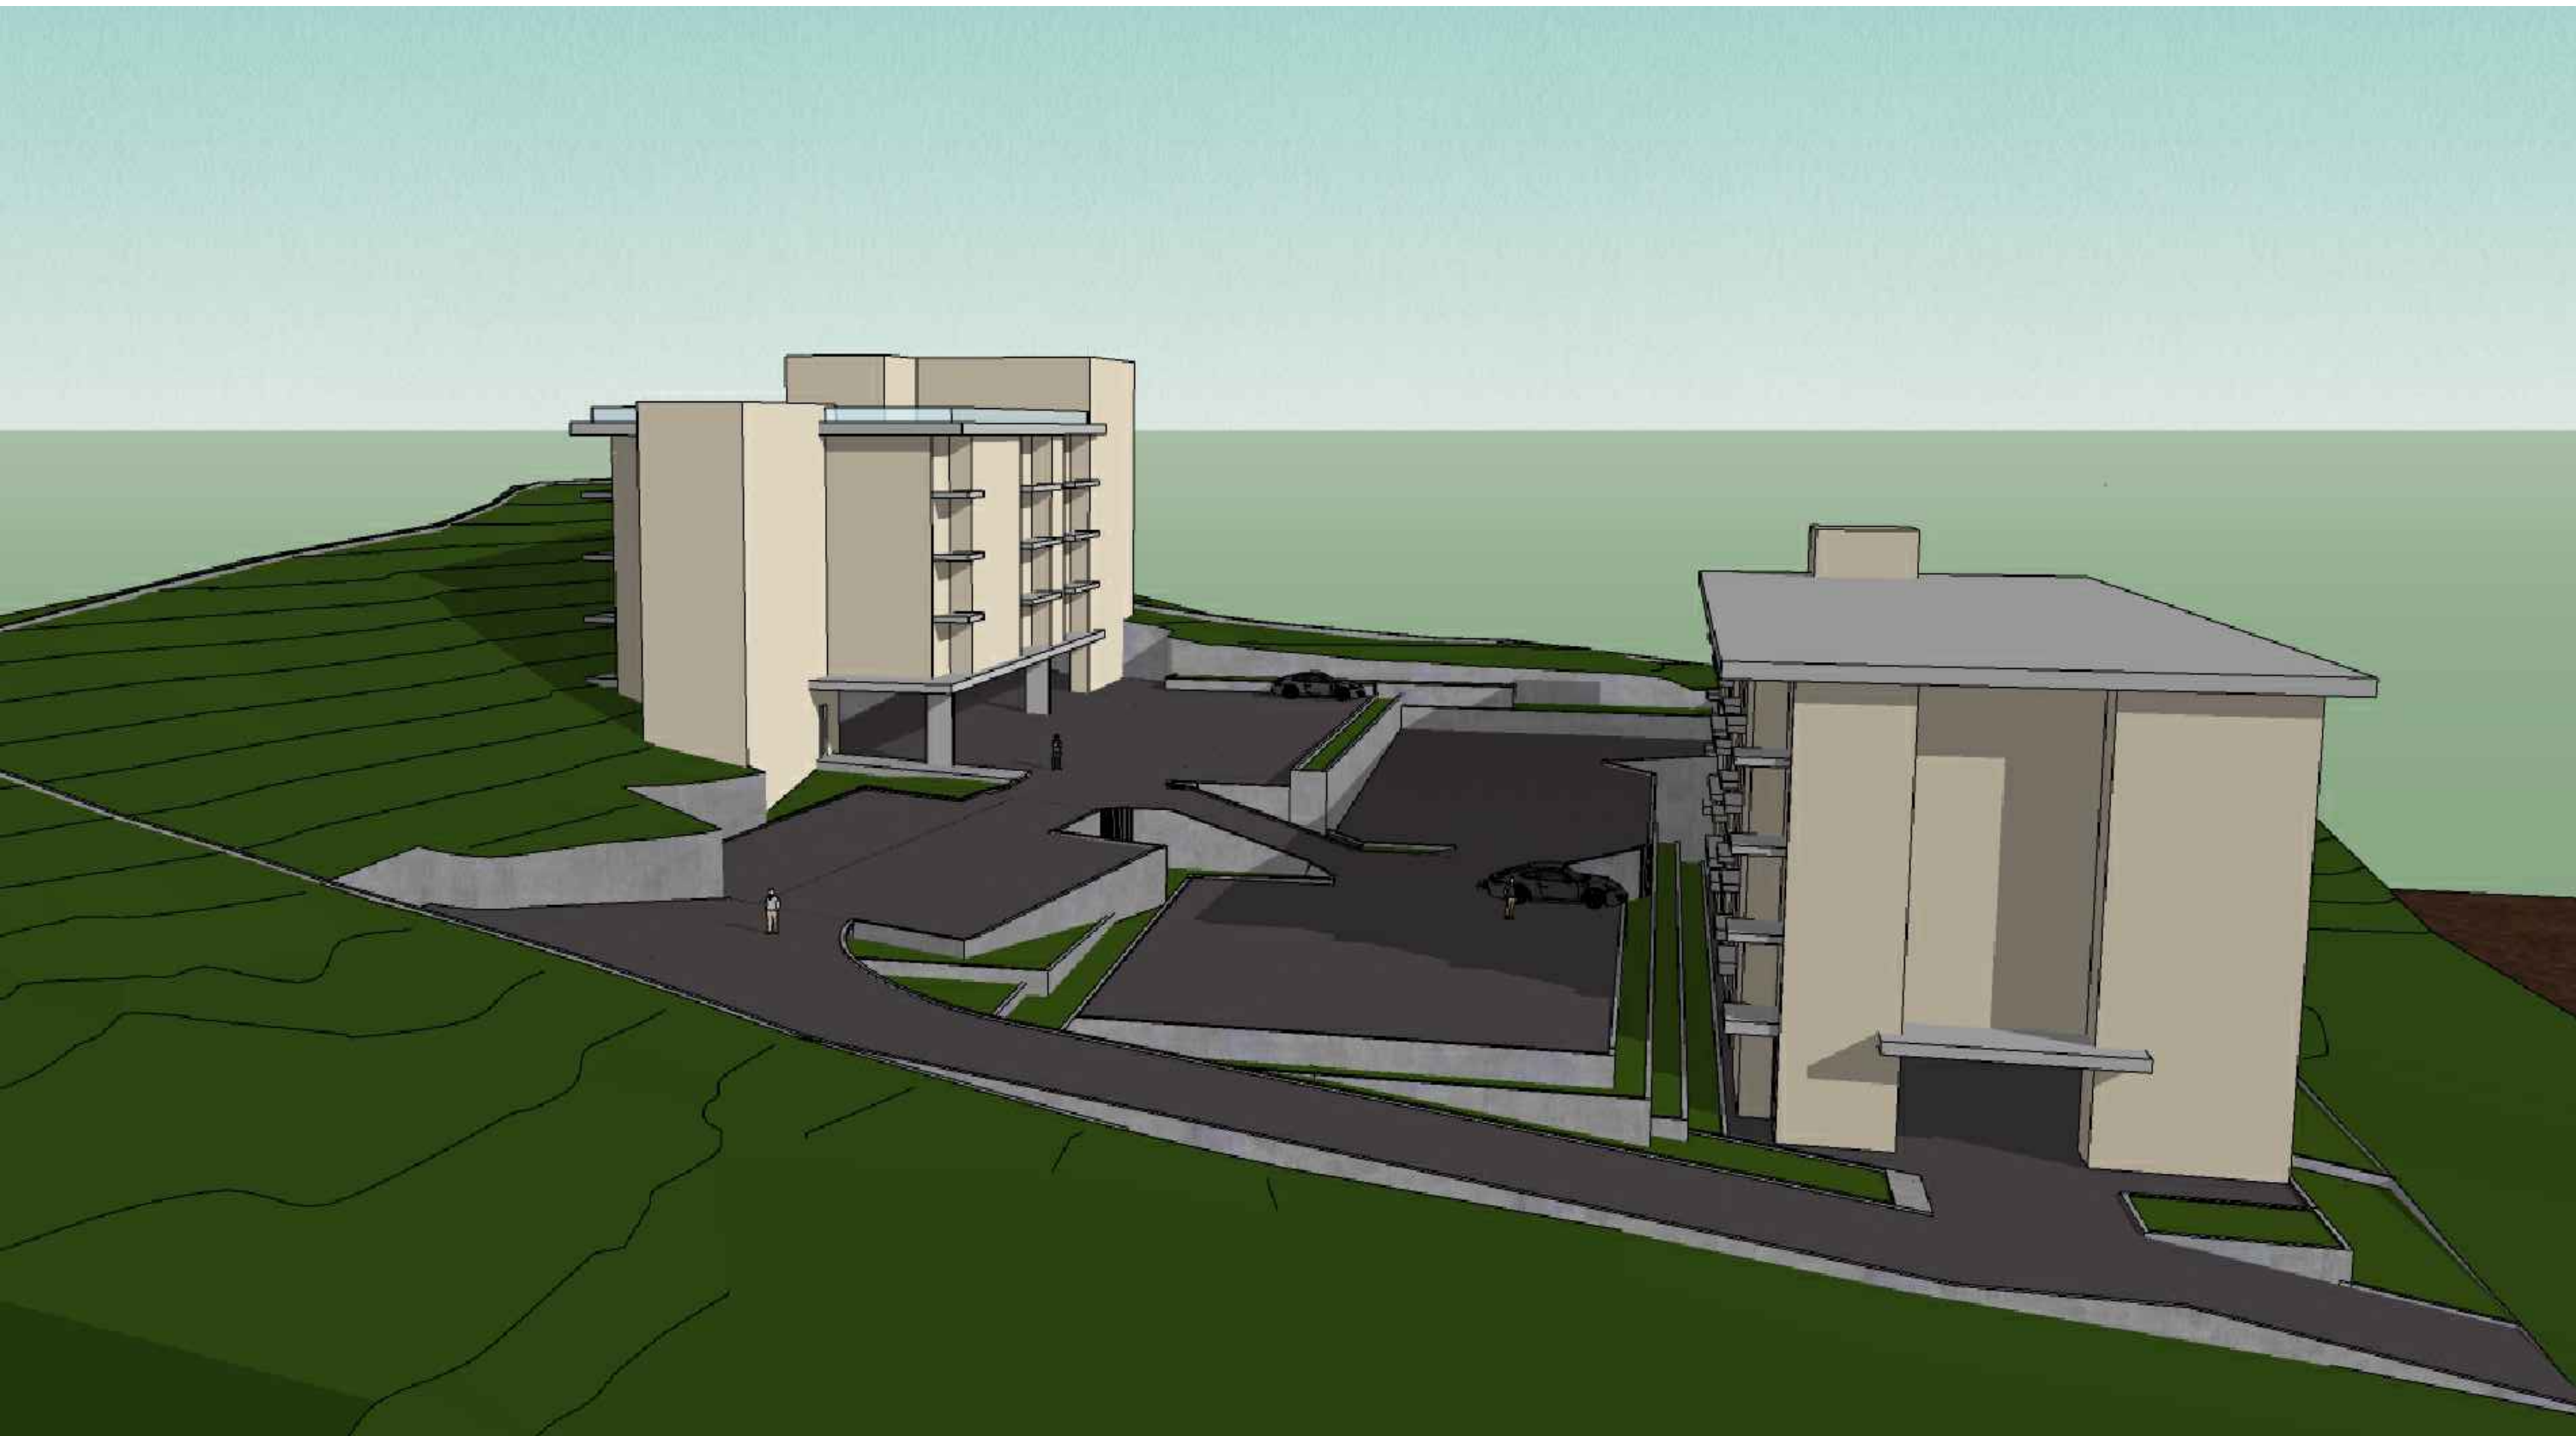
4 VIEW FROM SOUTH

SITE WITH BUILDING BLOCK

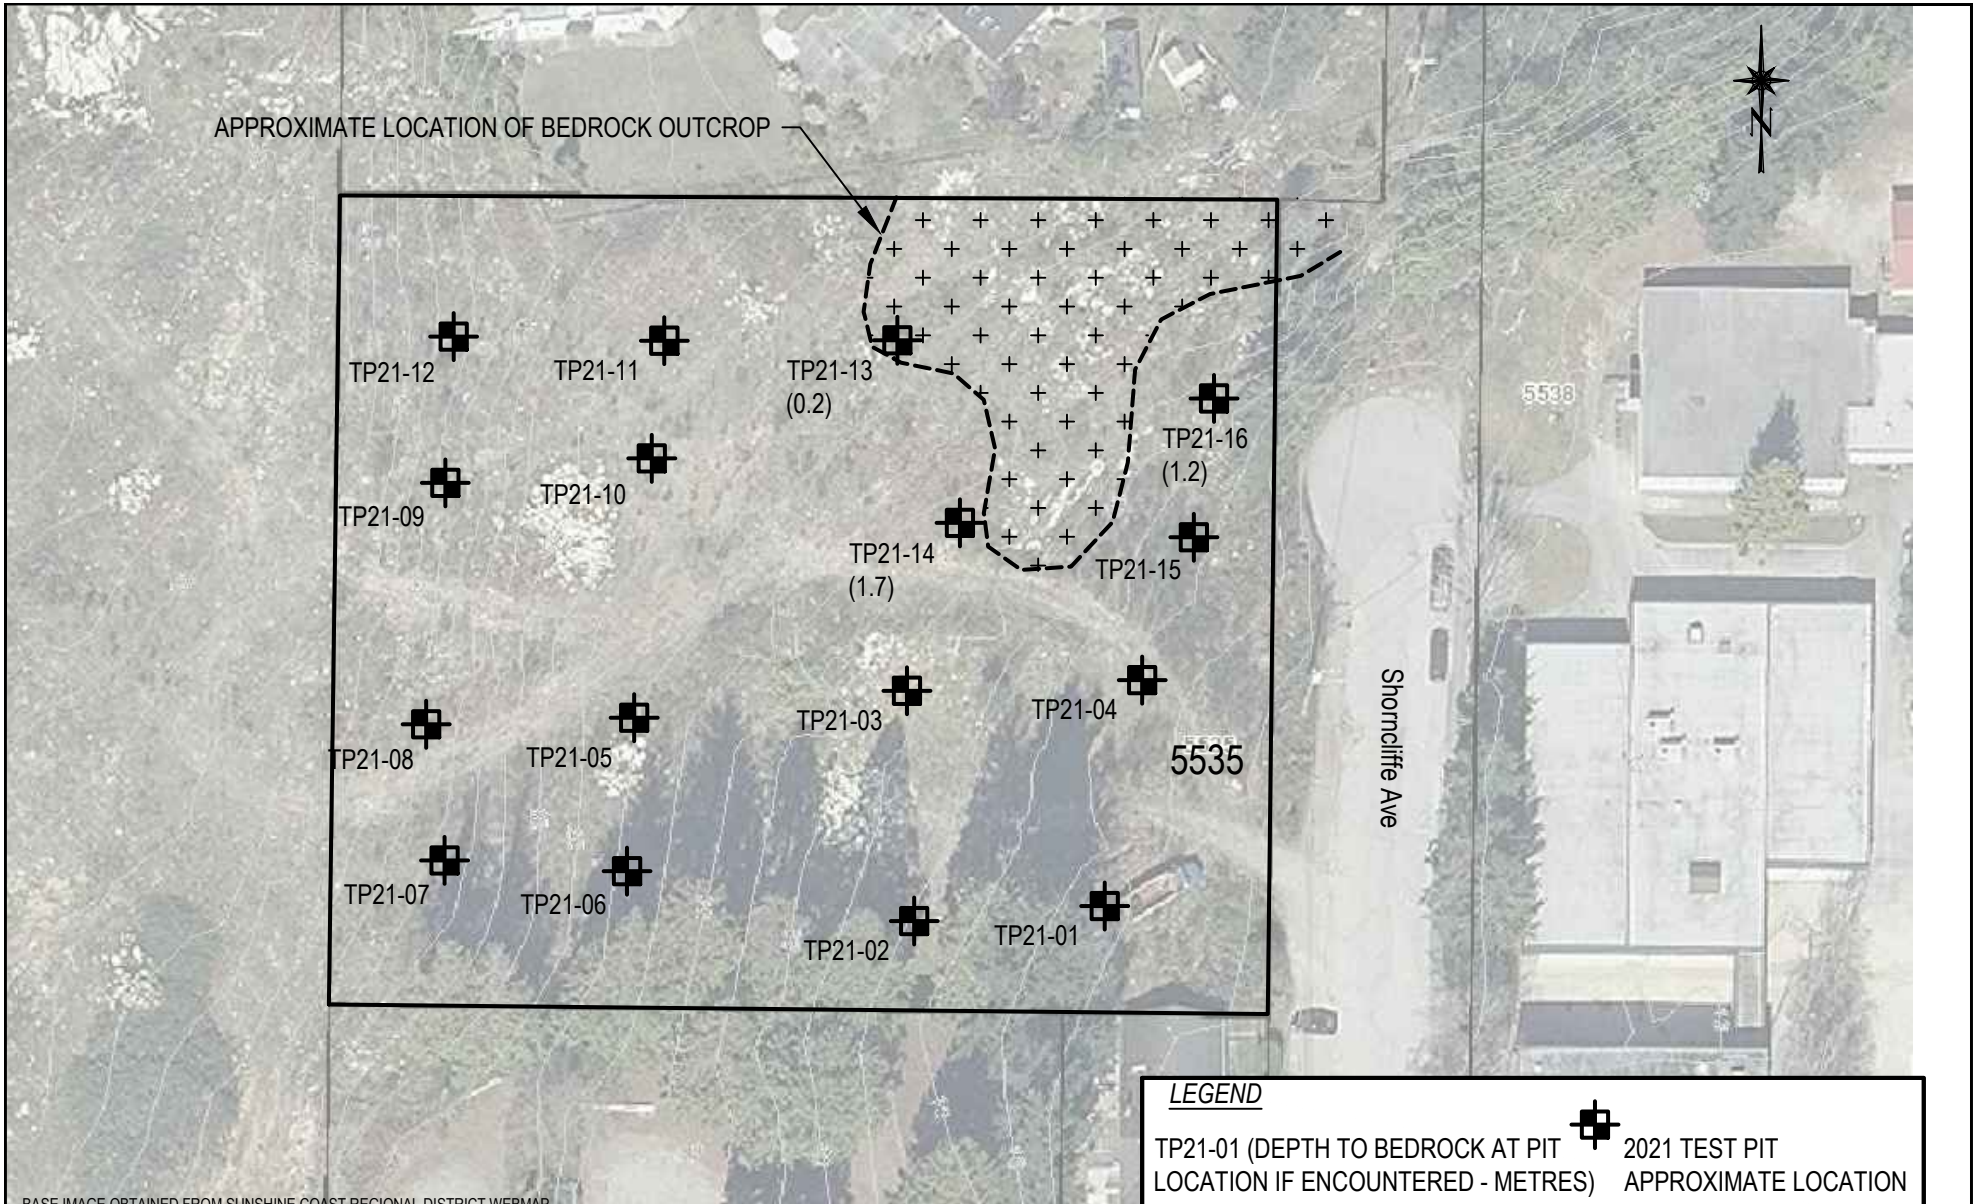
Client		Genaris Properties			Title LOCATION PLAN		
Project		Proposed Development 5535 Shorncliffe Avenue, Sechelt, BC					
Project no.	Drawn	Design	Checked	Date	Scale	Drawing no.	
21-9115	AP	SN	SH	June 21, 2021	1:750	21-9115-01

Sixteen test pits (TP21-01 to TP21-16) were excavated on June 28, 2021, using a tracked excavator under subcontract to Braun Geotechnical, to depths of 0.2 m to 2.7 m. The soil conditions were logged in the field and representative disturbed grab samples were collected for further visual classification. The approximate test pit locations are shown on the attached location plan (Dwg. No. 21-9115-01).

Test pits TP21-13, -14, and -16 encountered refusal on bedrock at approximately 0.2 m to 1.7 m. Bedrock outcrop exposures were reviewed at the northeast portion of the site. The bedrock exposures were observed to comprise granitic igneous rock. Field estimates of rock strength determined that the intrusive igneous rock exposed is Very Strong (Grade R5 or better). The enclosed location plan provides the recorded bedrock exposures.

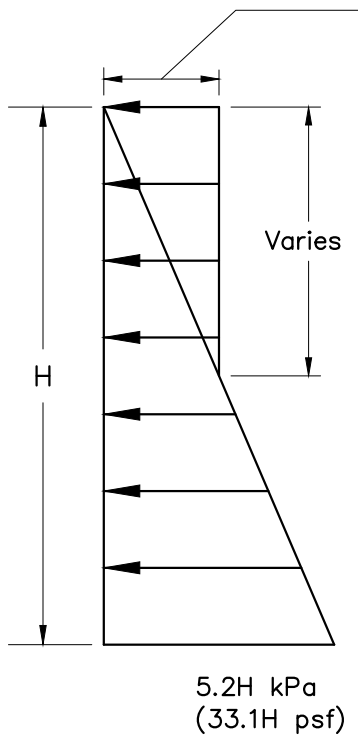
- Compaction Induced Pressure of 20kPa (400psf).
- A lower value may be feasible based on review of compaction equipment and procedure
- Compaction pressure need only be used for structural design not overall stability

STATIC

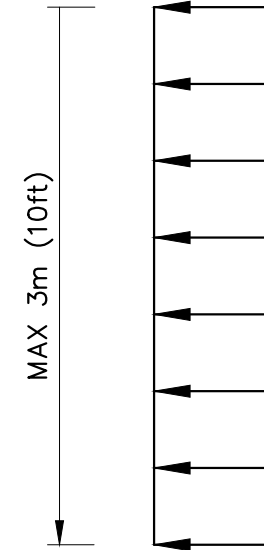
SEISMIC

$0.4 \times \text{Surcharge Press.}$

SURCHARGE
