Chapman Creek Flood Assessment

Draft Report
August 2010

KWL File No. 551.010

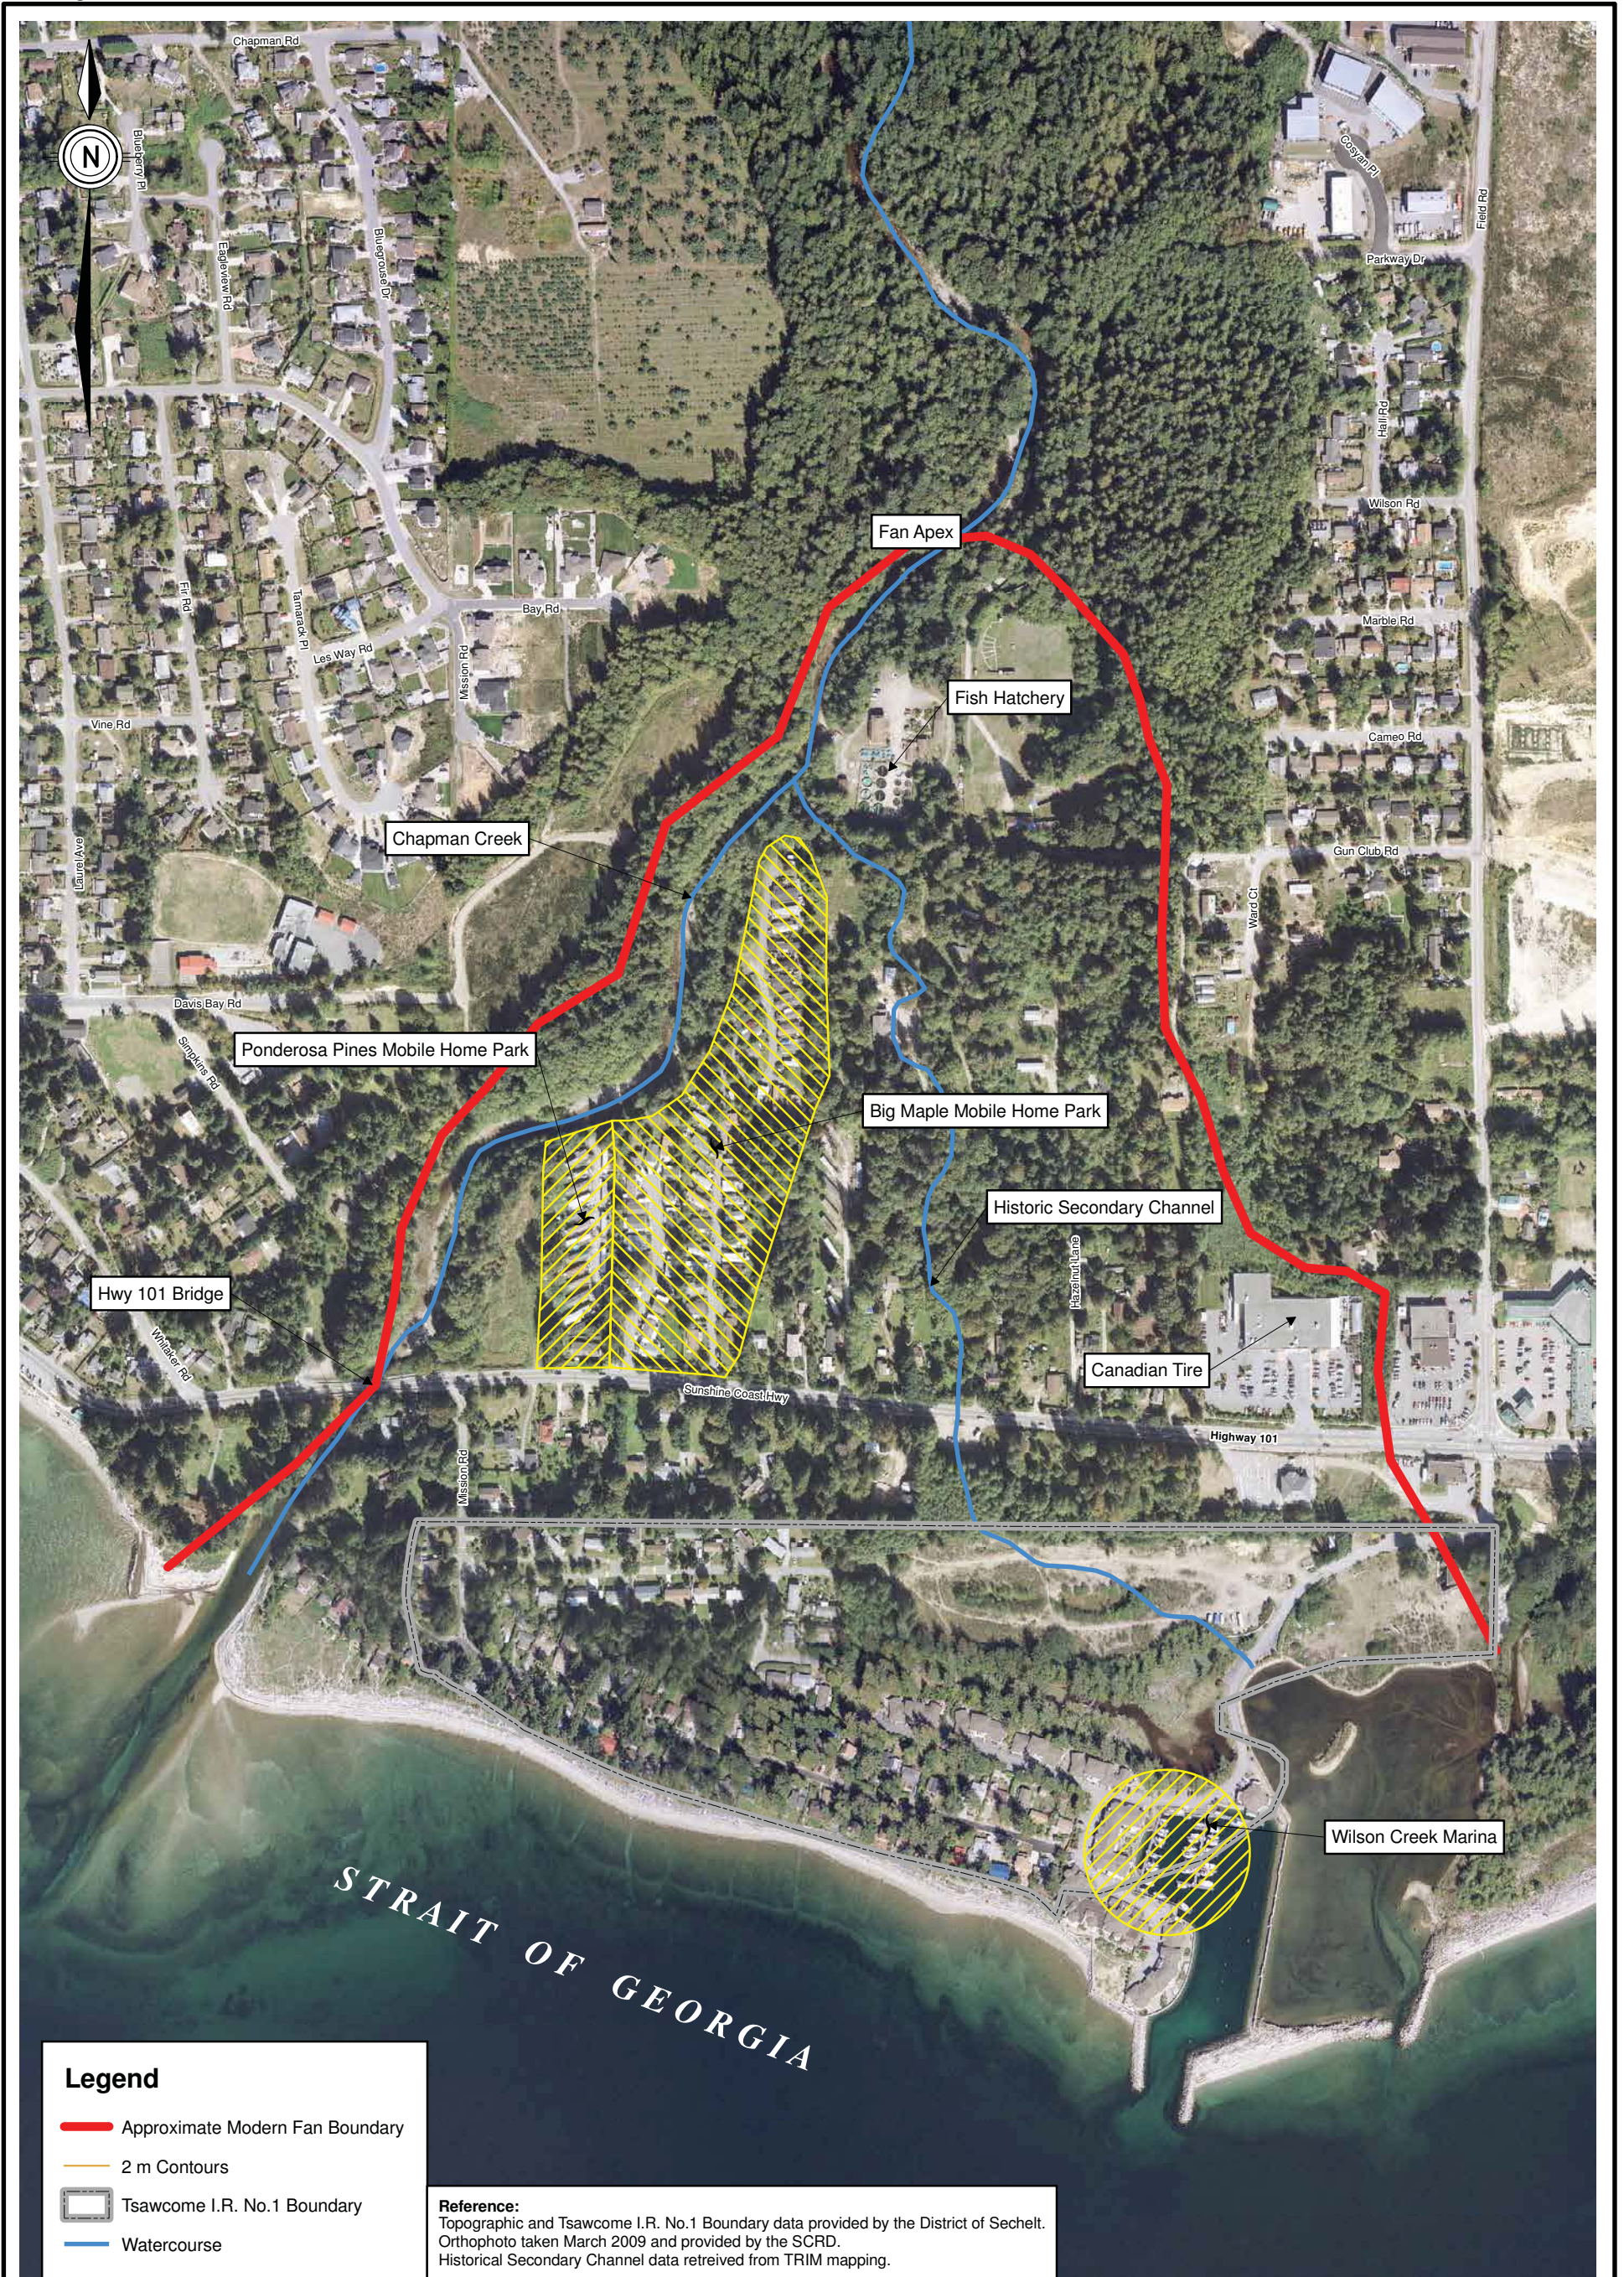
Figure 5-1

Chapman Creek Fan

The Chapman Creek fan was formed by deposition of sediment at the mouth of Chapman Creek where it meets the sea, near the town of Sechelt, BC (Figure 5-1). The fan is designated as part of Development Permit Area 9 (DPA9) in the 1993 hazard mapping (Golder, 1993). The term creek fan shall be synonymous with floodplain for the purposes of this discussion.

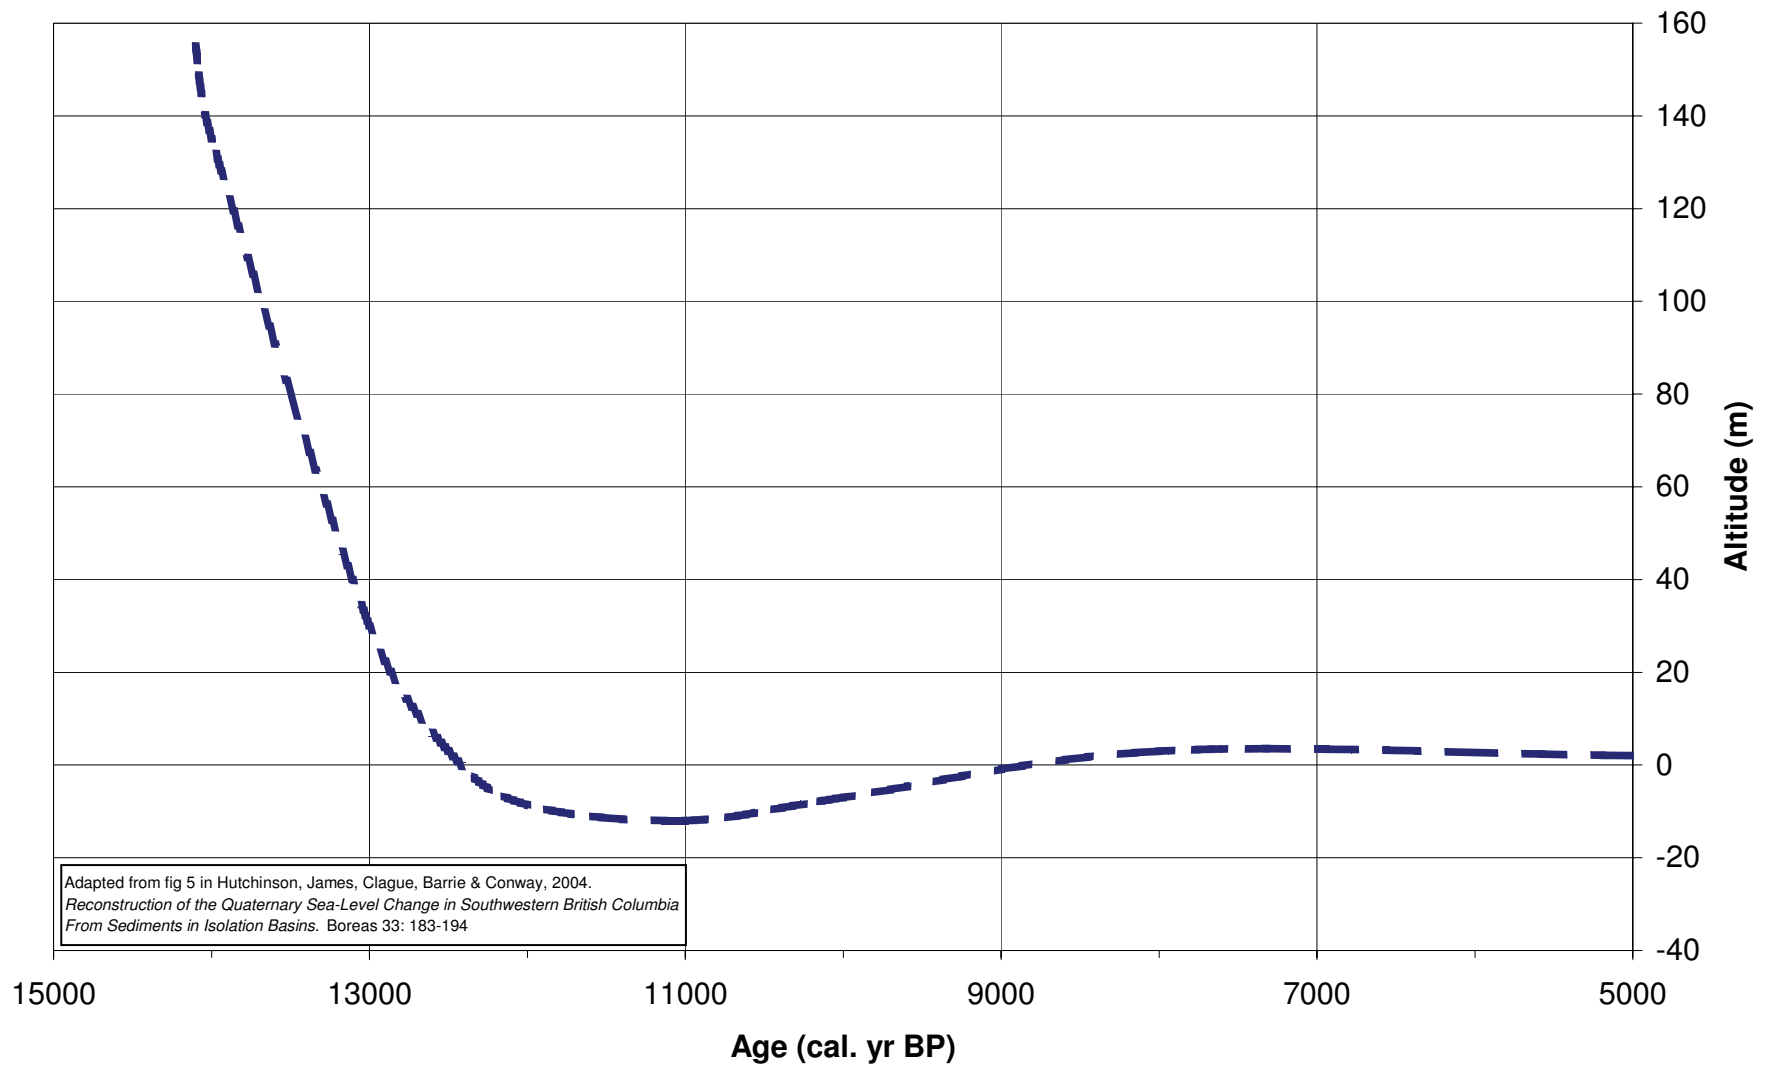
Figure 5-2

Historic Changes in Relative Sea Level for the Georgia Strait

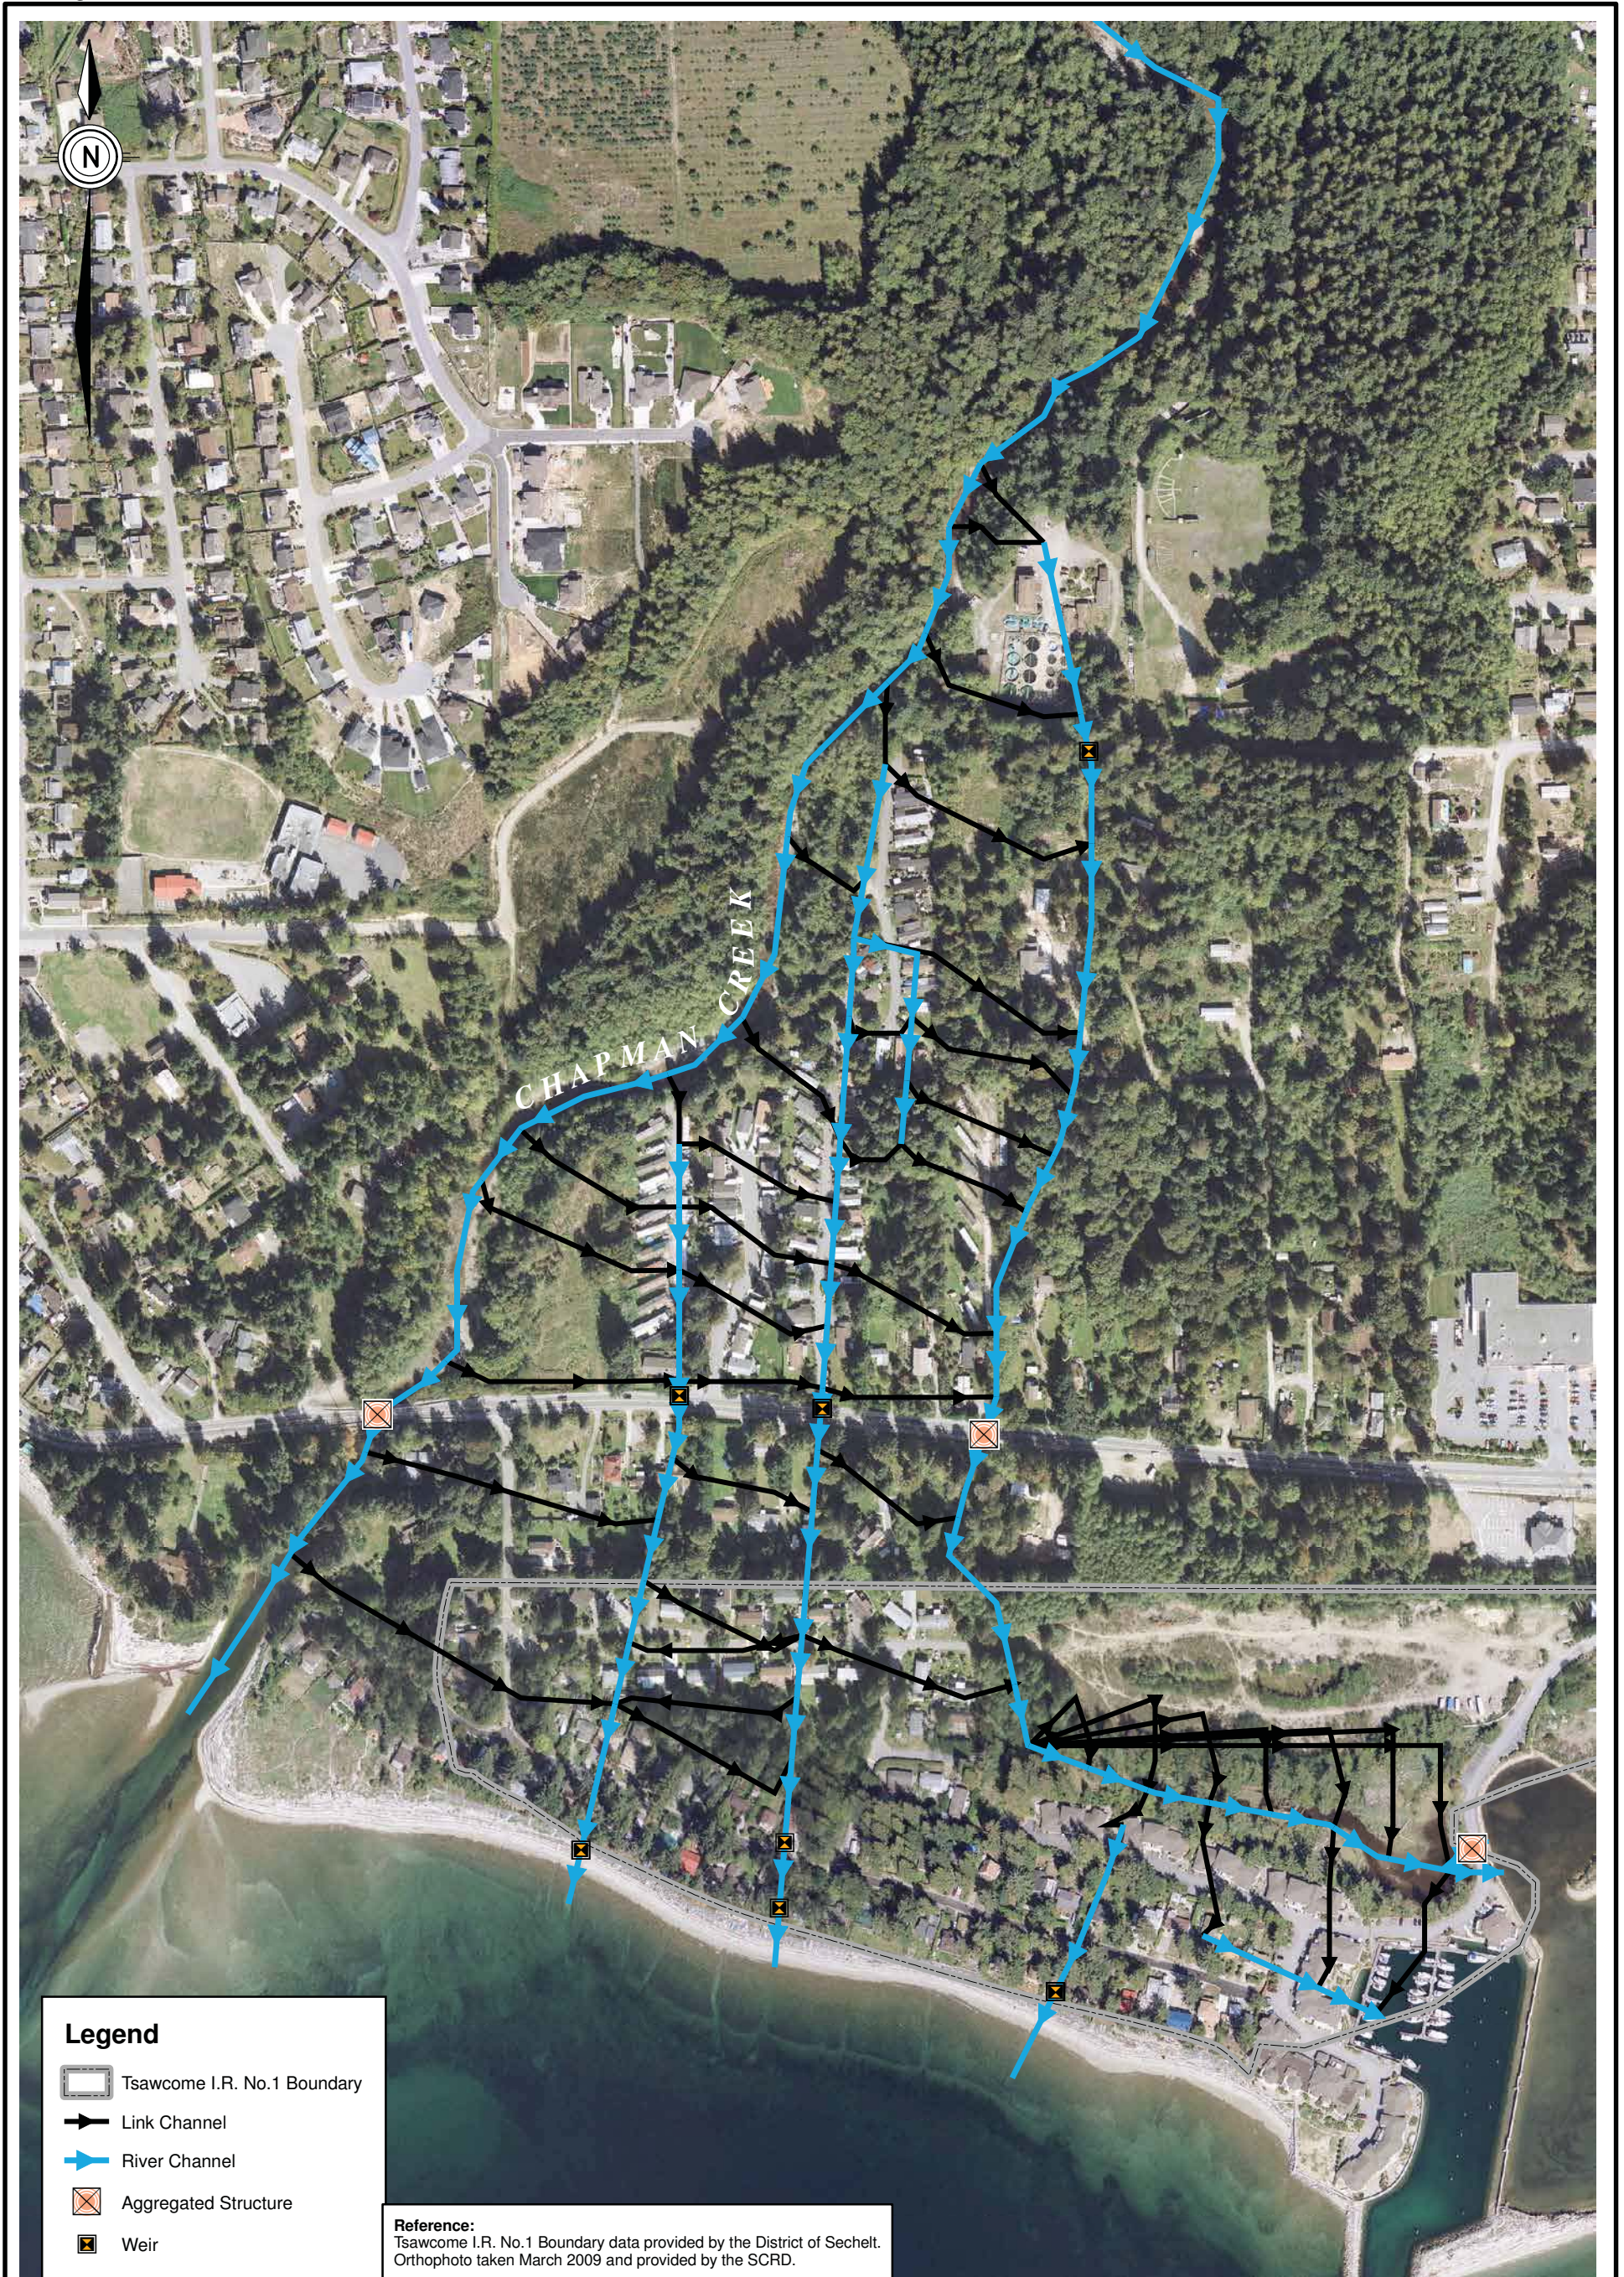
Figure 5-3

**Pseudo-2D Channel Network for Mike 11 Model
 of Chapman Creek Fan**

- Highway 101 bridge (modelled as a closed culvert skewed at an angle to the flow);
- Highway 101 bridge weir (for bridge overtopping);
- weirs at Highway 101 on each of the three main overflow channels;
- 1.5 m dia. CSP drainage culvert beneath Highway 1;
- outlet control structure at the Wilson Creek marina; and
- weirs to control artefacts caused by applying a 1D flow network to 2D topography.

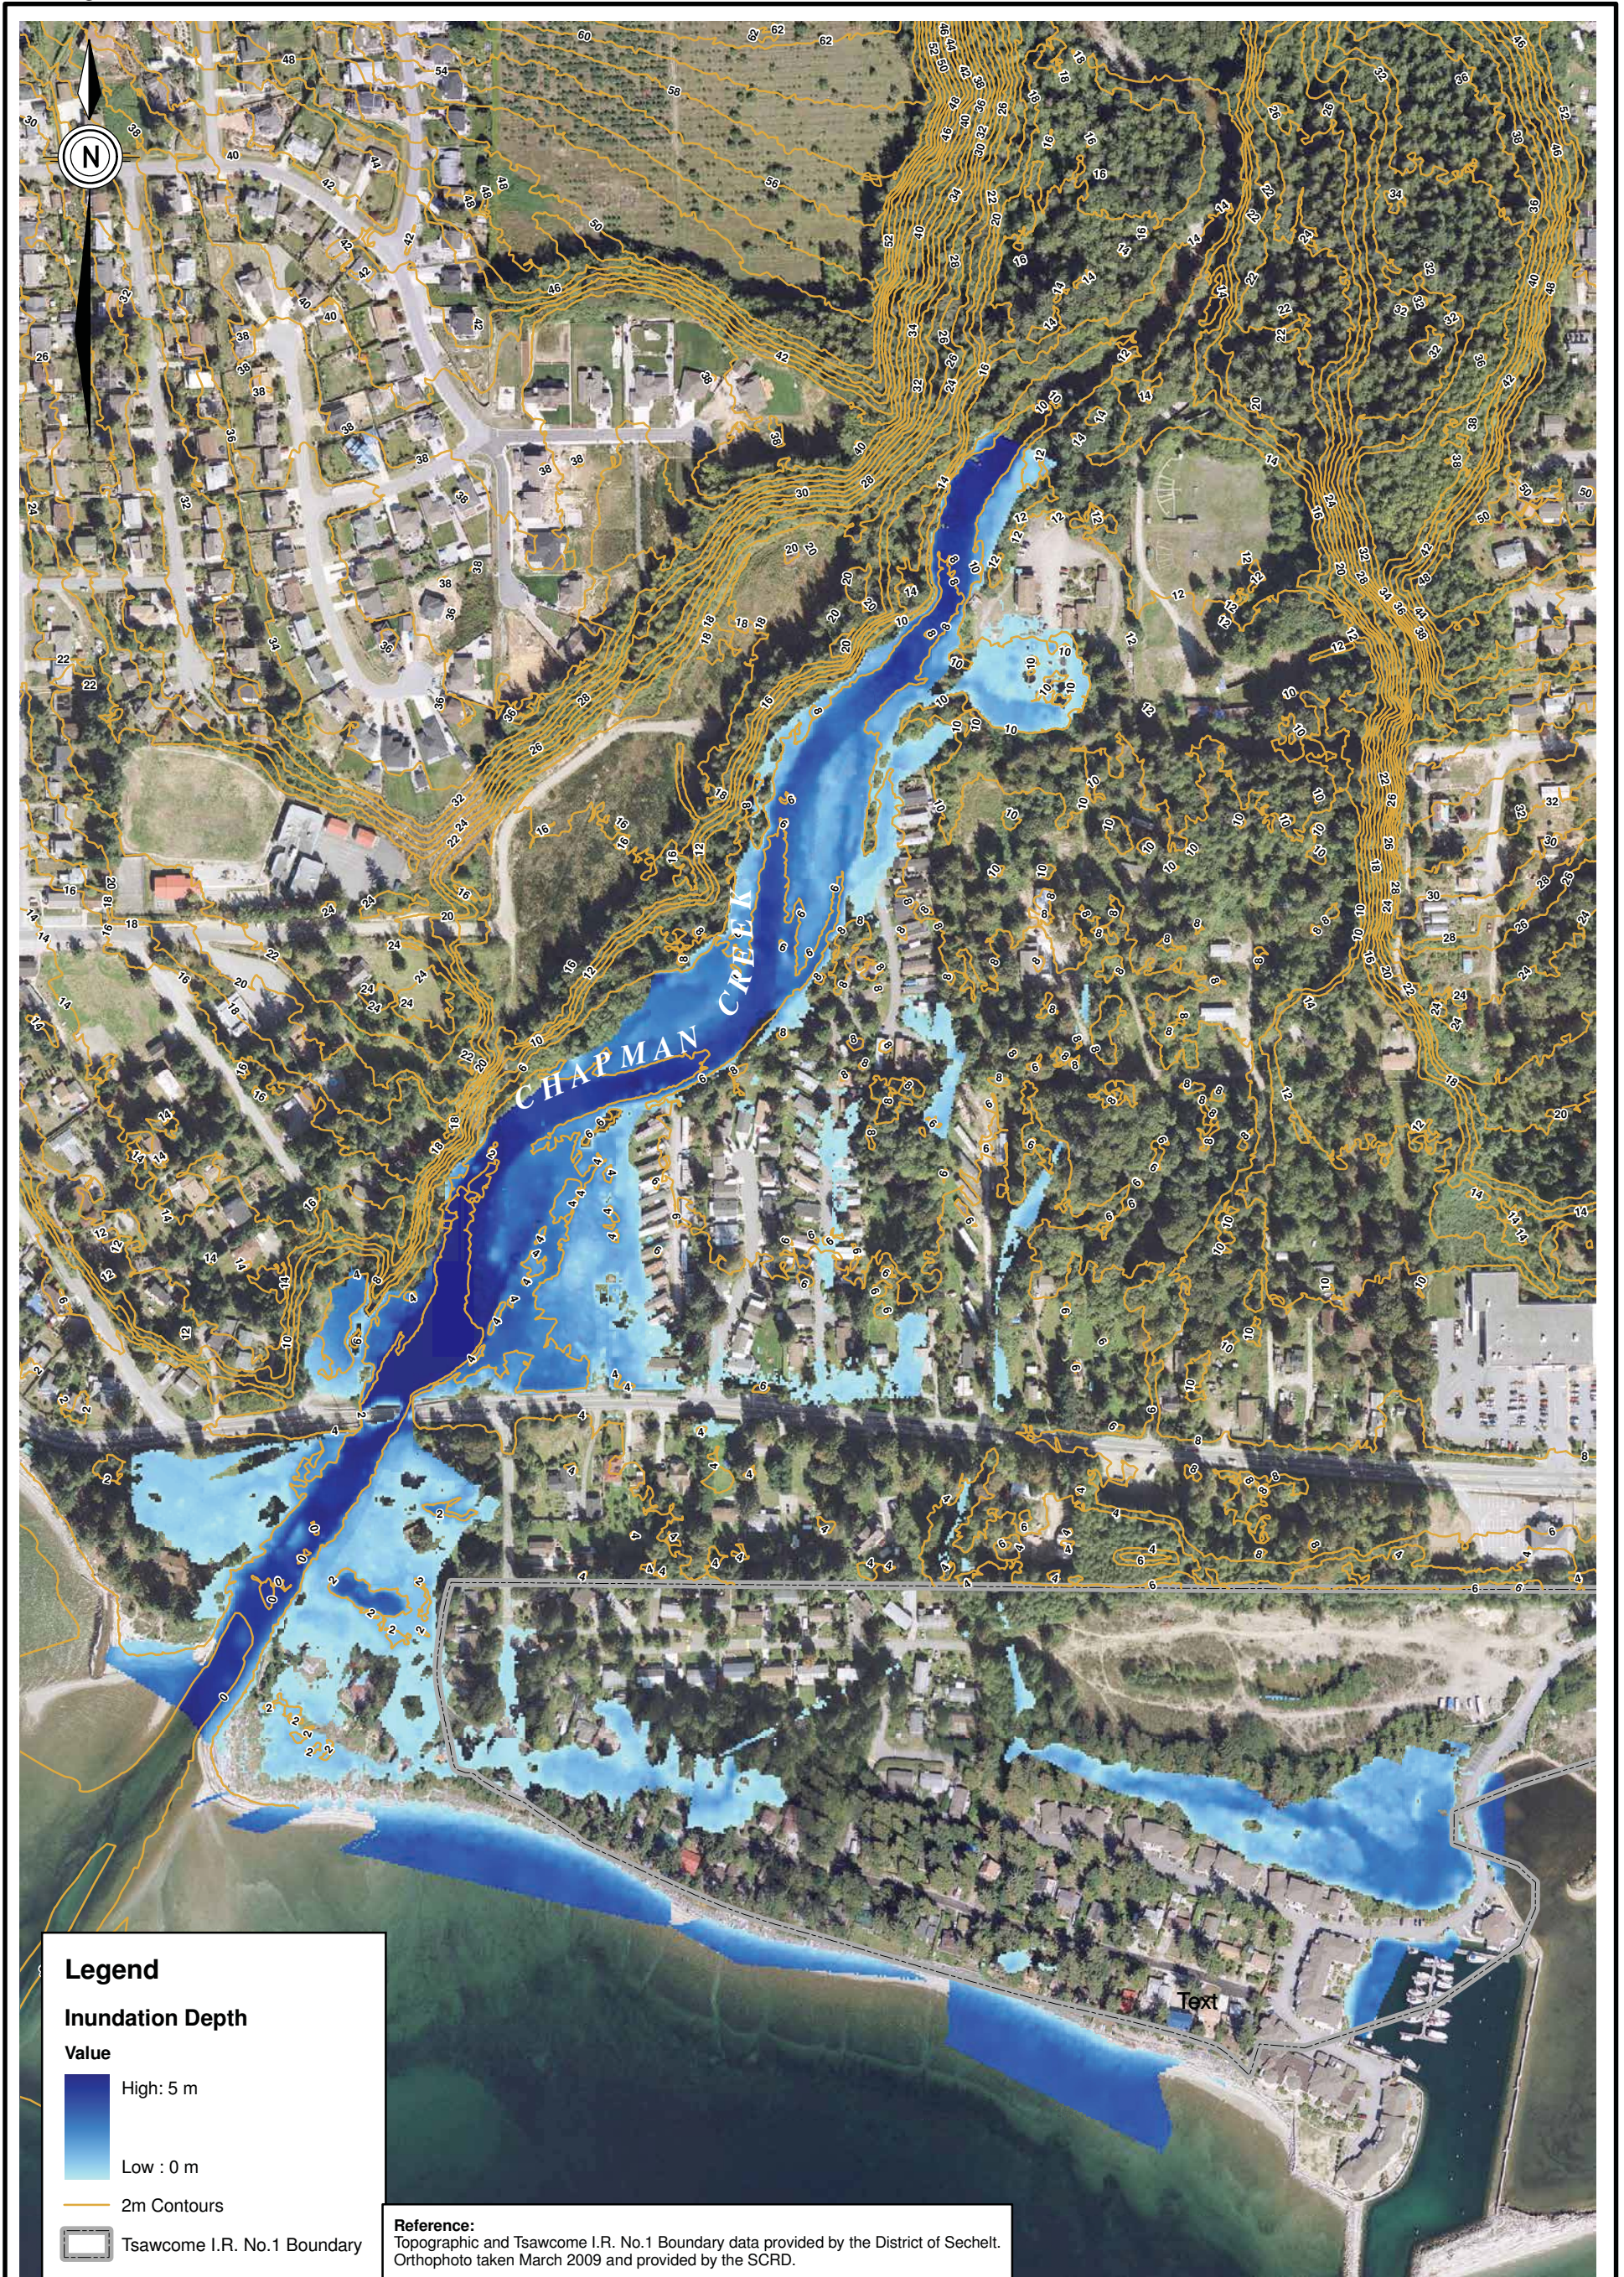
Scenario 6 Flood Inundation Map - 200-Year Return Period
Clear Water Flood Plus Landslide Dam Breach
with Decreased Manning's n Values Figure 5-9

Scenario 6: 200-year flood with landslide dam failure, minimum channel roughness

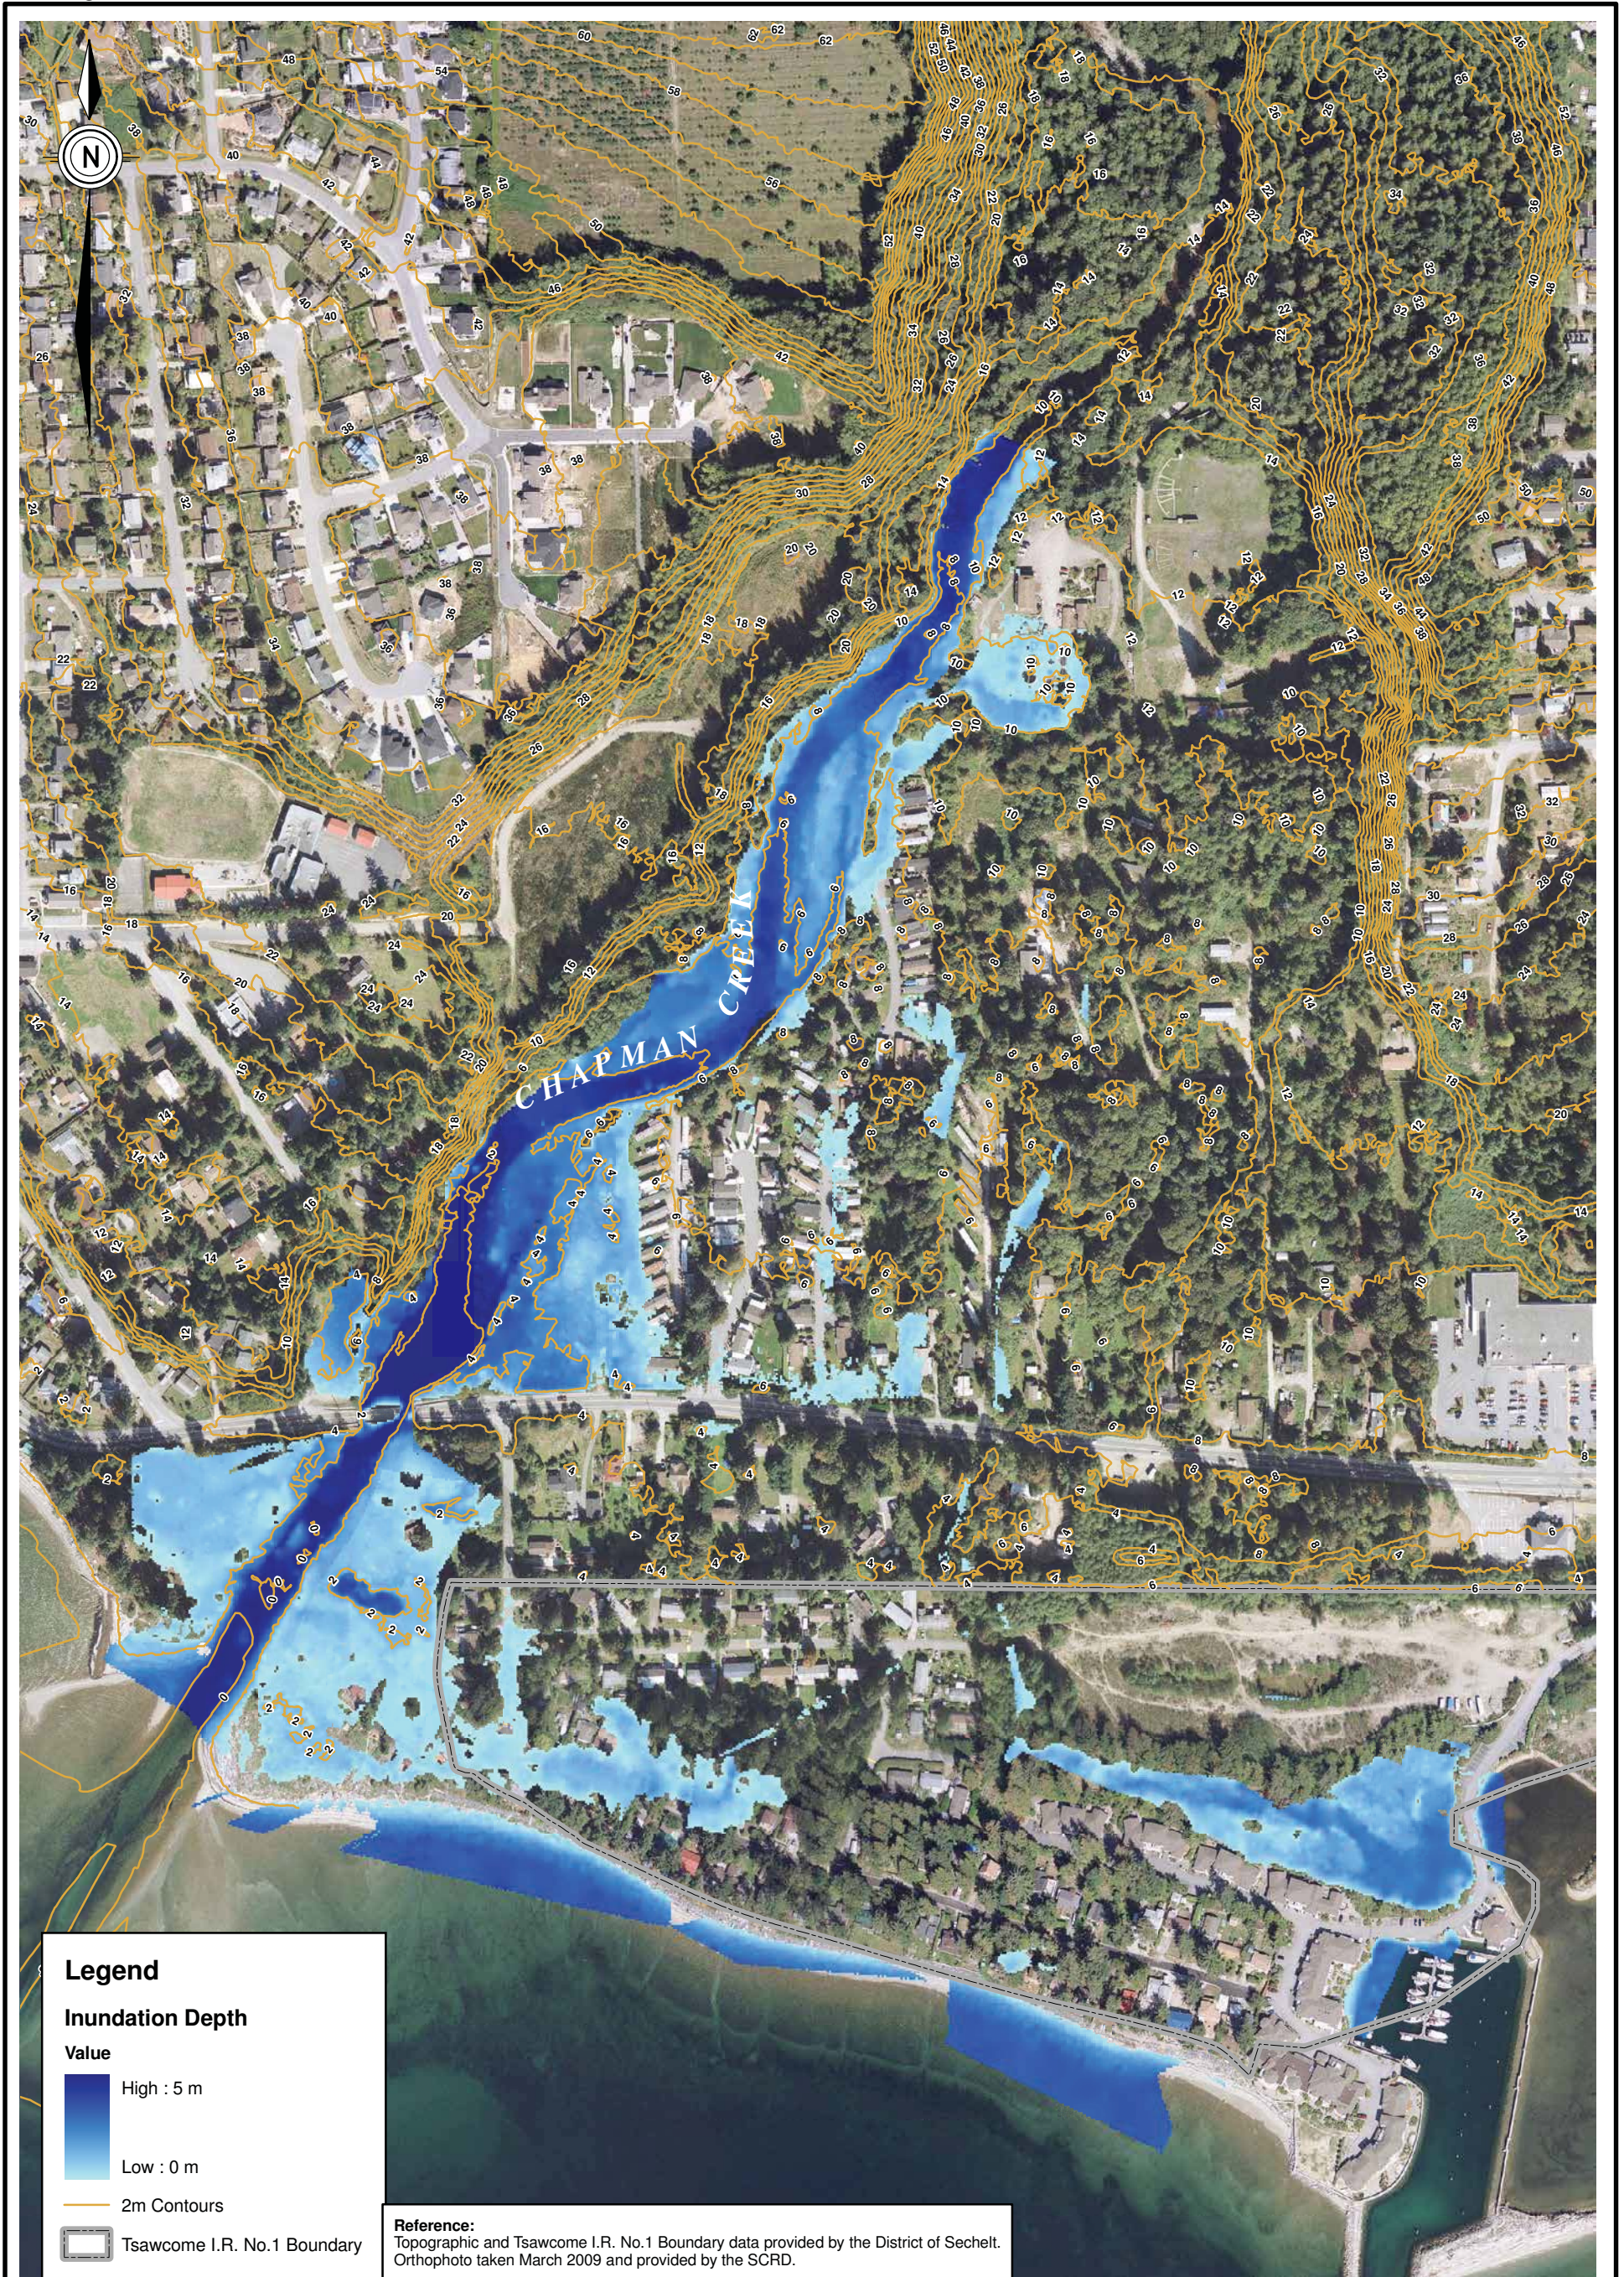
Synthetic Flood Hydrographs at Chapman Creek Fan Apex

In both cases the results suggest a peaking factor of approximately 1.5. A synthetic flood hydrograph was constructed for use in the hydraulic modelling described in Section 5. The synthetic hydrograph is based on the Q200 daily average flood estimate, a peaking factor of 1.5, and assumed baseflow conditions.

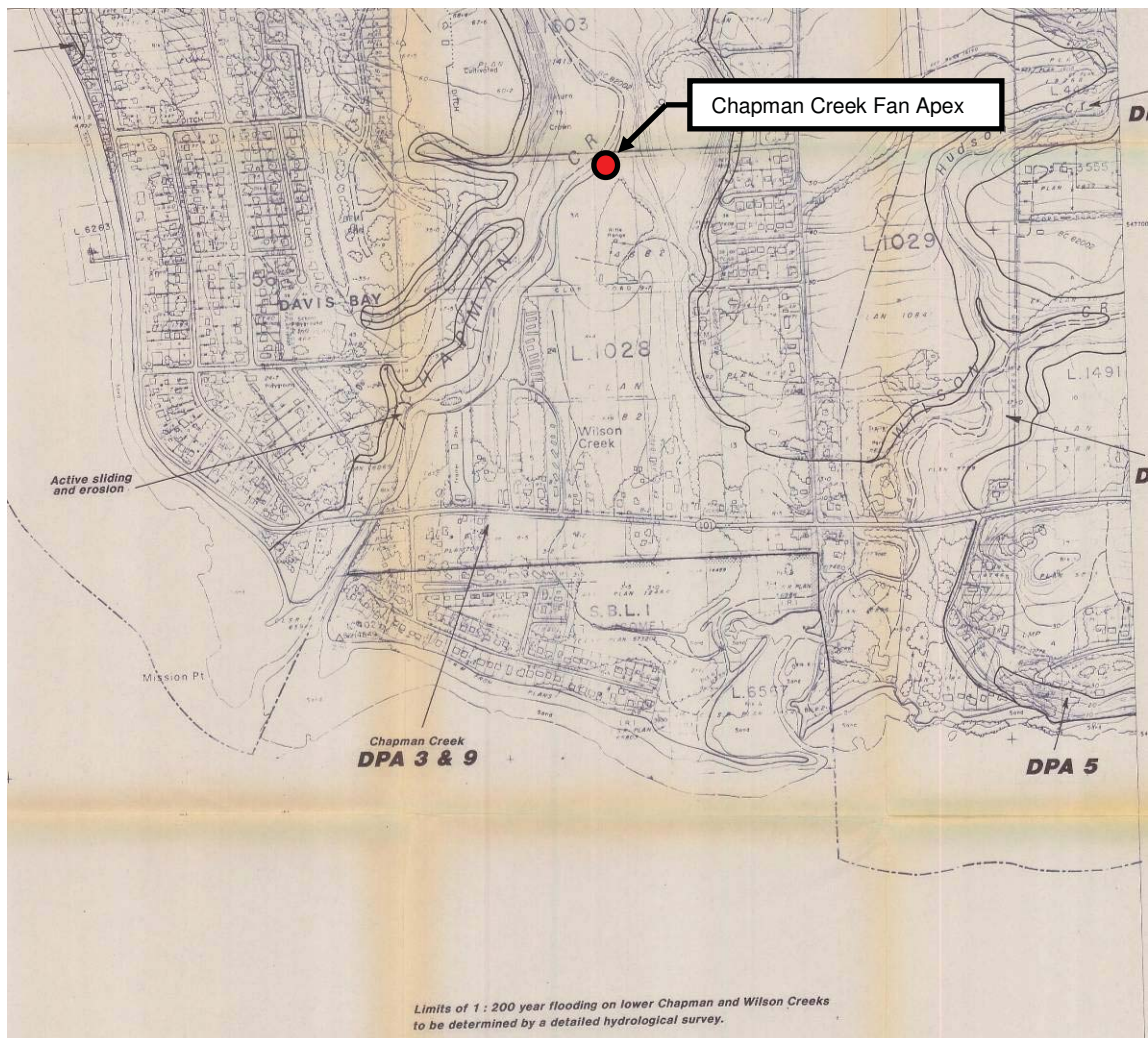
Figure 6-1: Development Permit Area 9 – Chapman Creek Fan

The above figure indicates a broad development permit area for Chapman Creek that includes the entire historic fan surface, creek corridor, tributary creeks, foreshore and is contiguous with the Wilson Creek fan.

The following Figure 6-1 is a portion of the DPA mapping from the 1993 Golder report for reference.

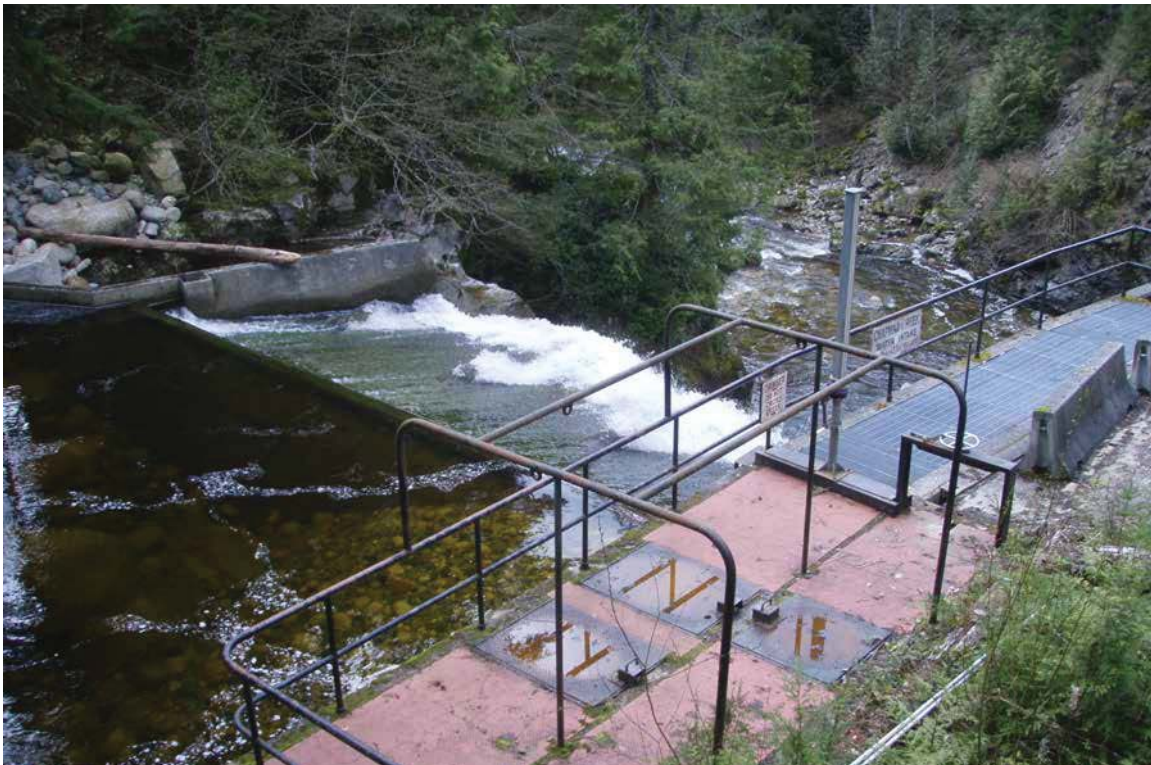
Photo 3
Chapman Creek SCRD Water Intake

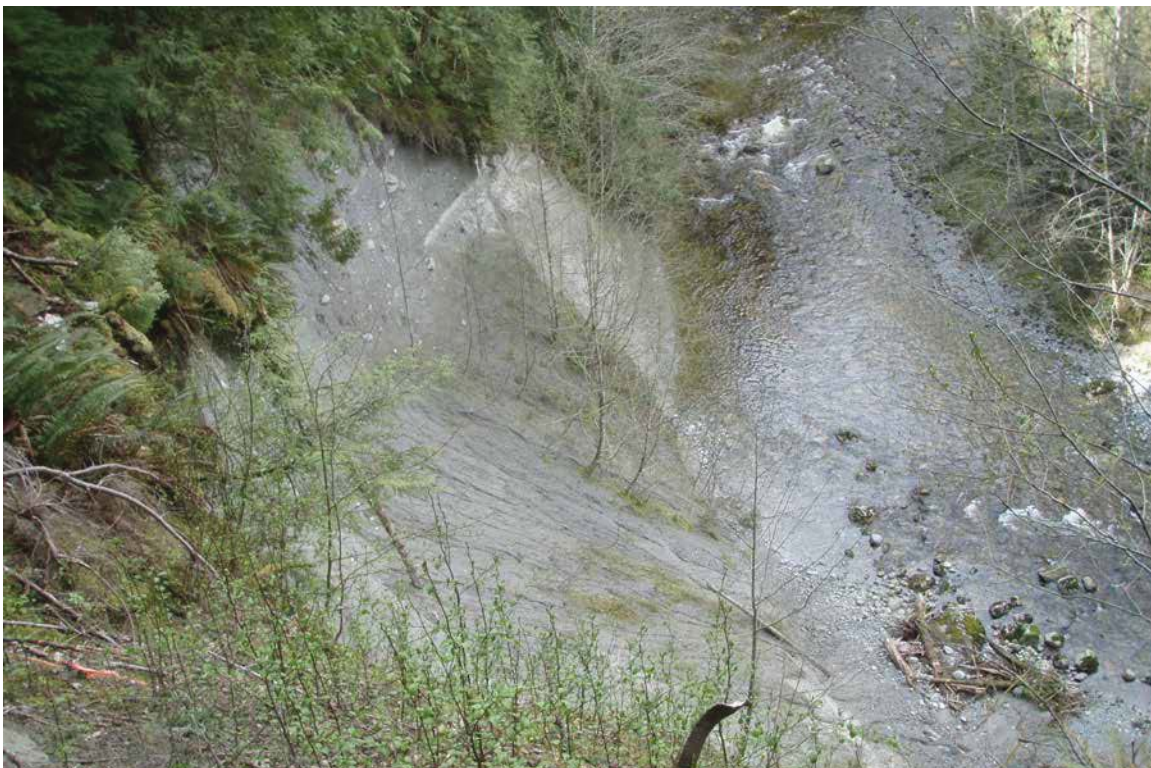
Photo 4
Eroding Bank on Bend Upstream of Chapman Creek Fan

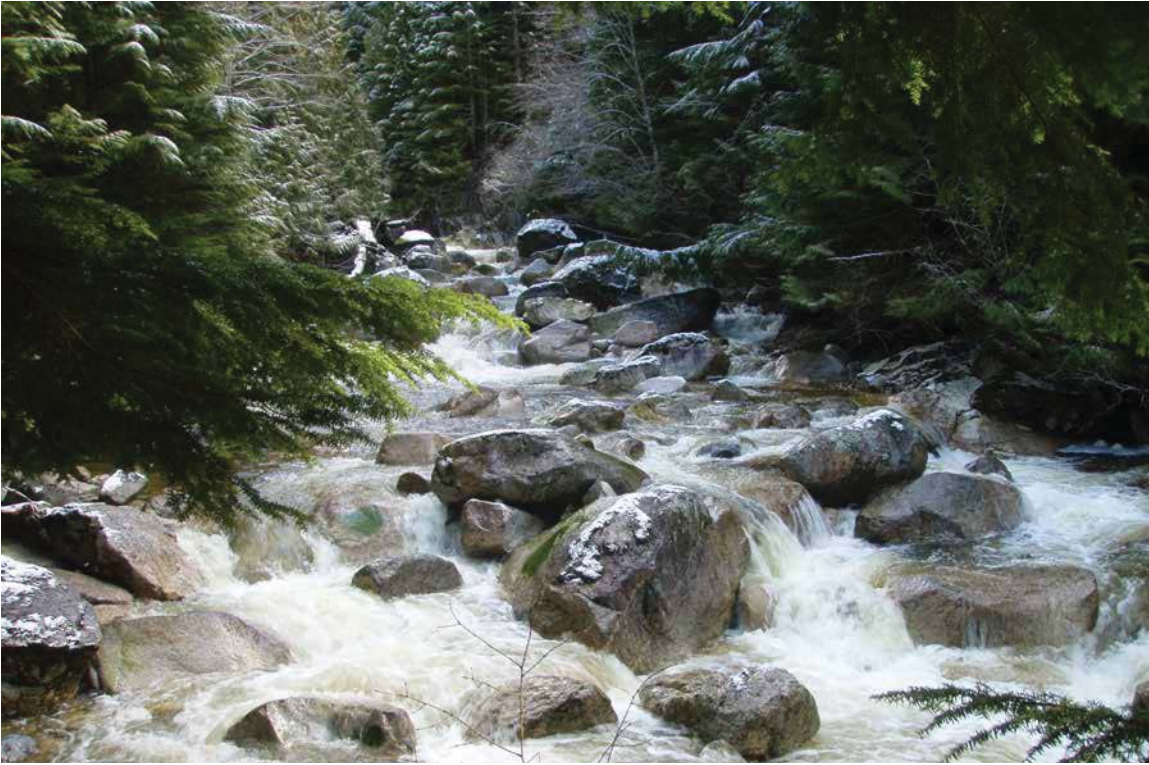
Photo 5
Typical Confined higher energy channel section upstream of Chapman Creek fan

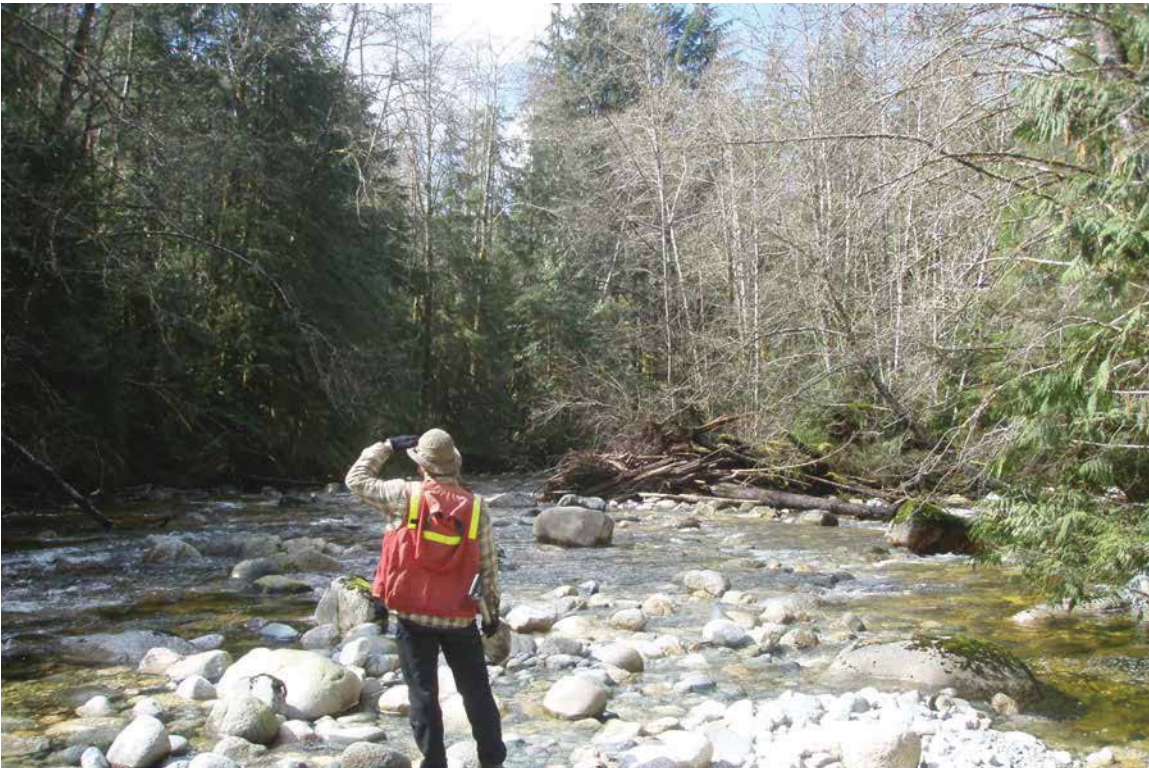
Photo 6
Typical channel section on Chapman Creek fan – note substrate size and rafted wood

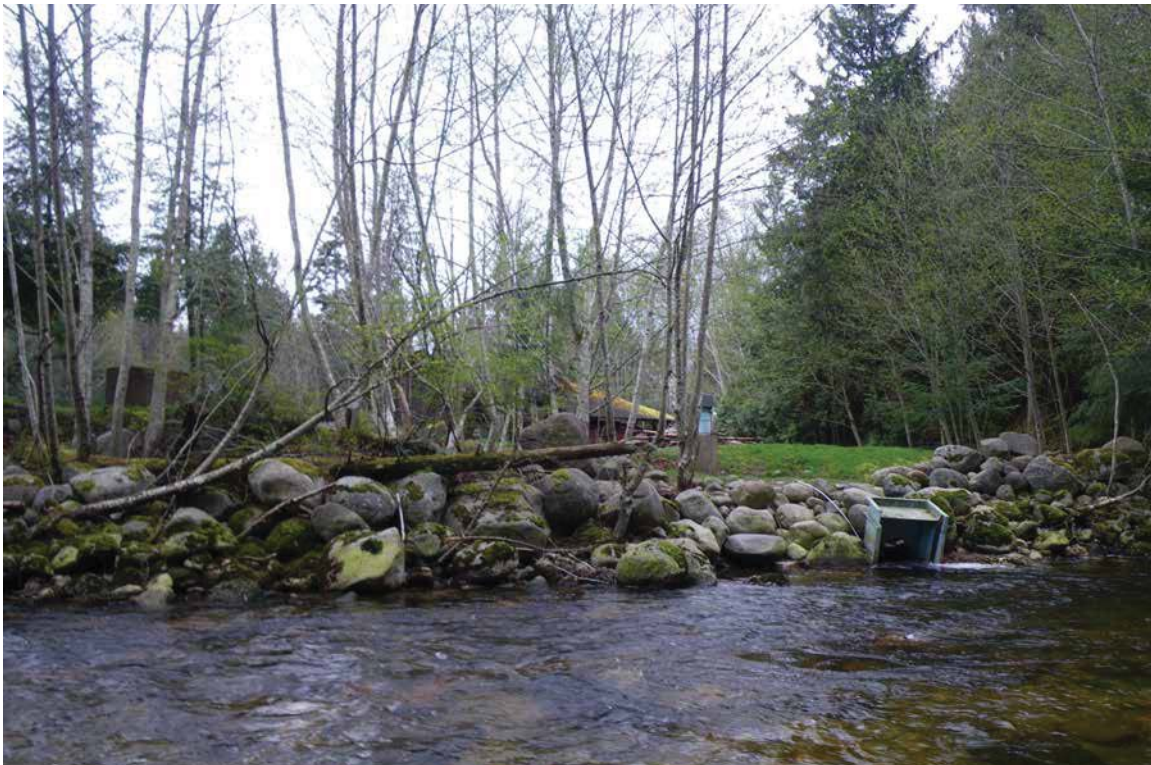
Photo 7
Informal bank protection works and intake structure at DFO hatchery
