Chapman Creek Flood Assessment

Draft Report
August 2010

KWL File No. 551.010

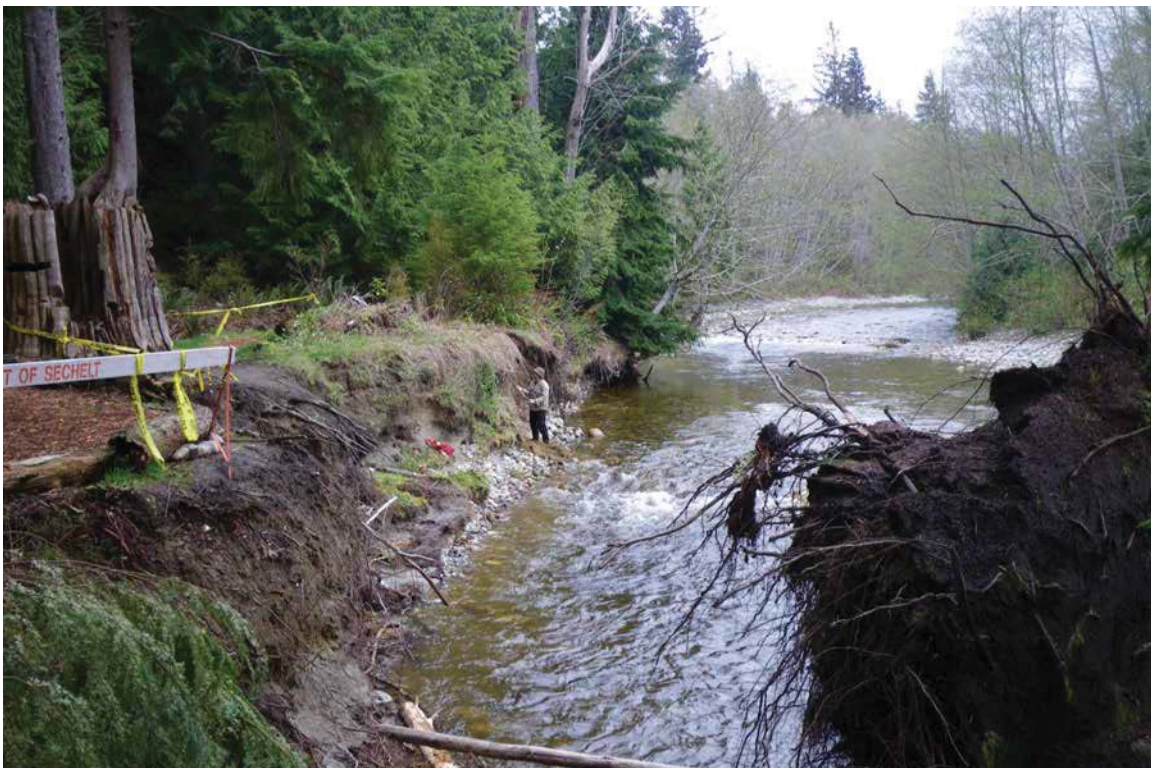
Photo 8
Recent bank erosion upstream of Hwy 101

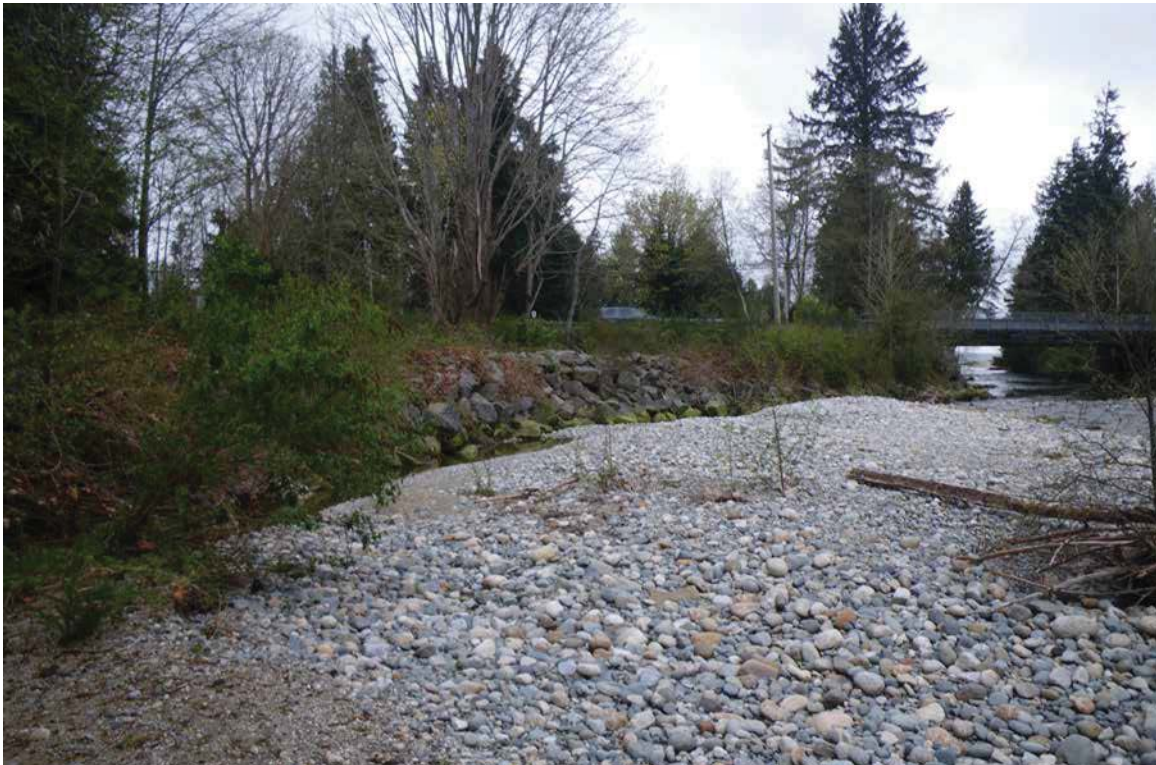
Photo 9
Looking downstream at Highway 101 bridge and riprap on left bank

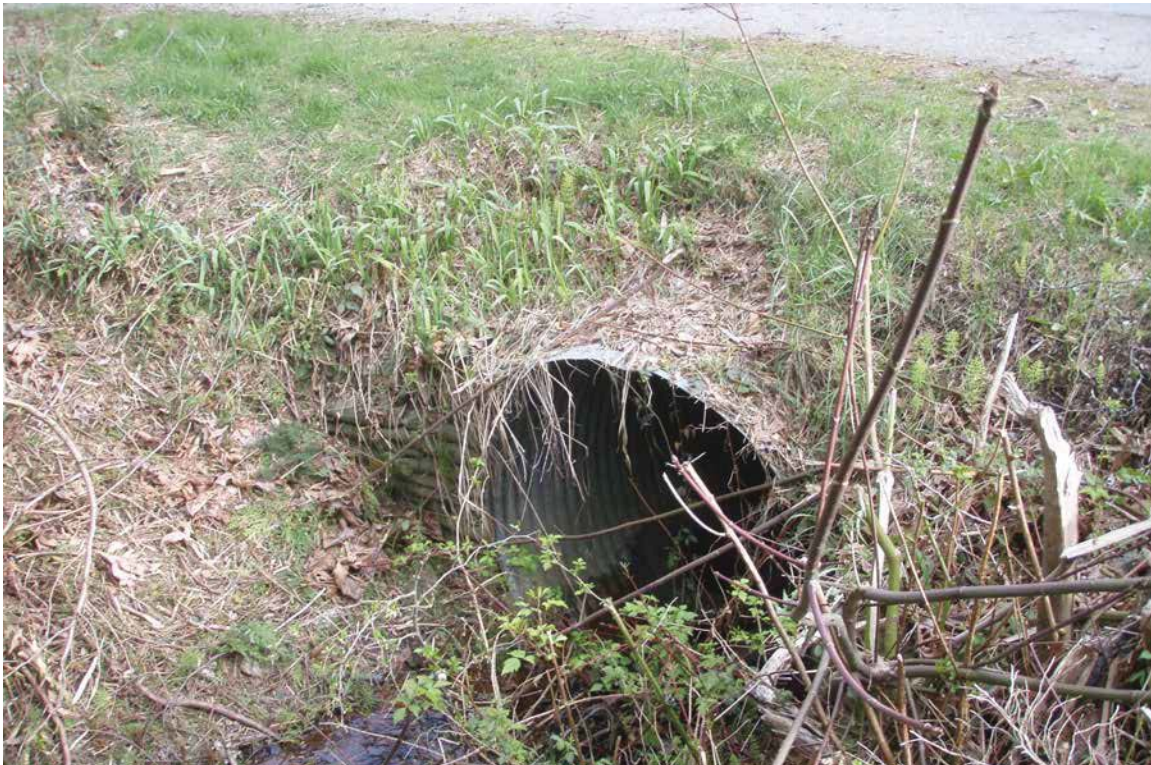
Photo 11
Typical drainage structure in Highway 101
